PROJECT: #585 - 19TH STREET EAST
MUNICIPAL HERITAGE REMEDIAL WORK

DATE: 04-07-2024 PAGE NO.: 1 OF 4

COMMUNICATION / DESIGN NOTES

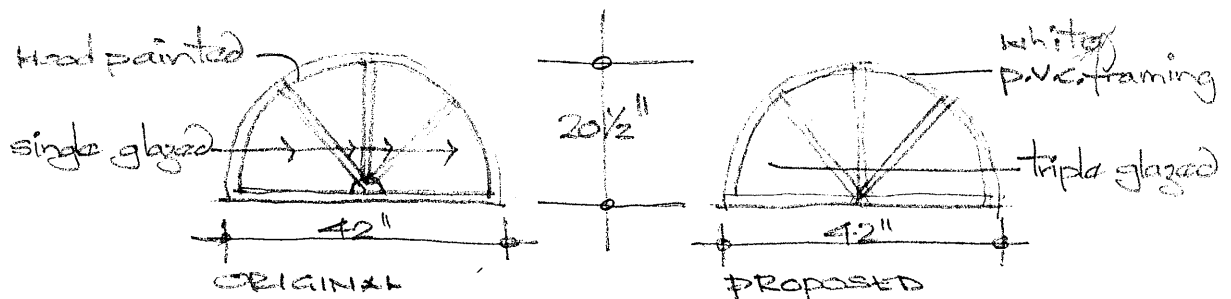
1. THE TWO HALF-ROUND WINDOWS (NORTH ELEVATION ON THE THIRD FLOOR) WILL BE REPLACED WITH NEW UNITS TO MATCH THE ORIGINAL DESIGN BUT WITH P.V.C. FRAMING AND TRIPLE GLAZING.

NOTE: PRIOR TO THE FIRE ONE WINDOW WAS WHITE P.V.C. FRAMING WITHOUT GLAZING BARS AND DOUBLE GLAZED, THE OTHER HAVING DAMAGED AND ROTTEN WOOD FRAMING WITH SINGLE PANE GLAZING.
