FACILITY REVIEW 2025 – 2029

Parks, Recreation &
Culture Department

City of
Prince Albert

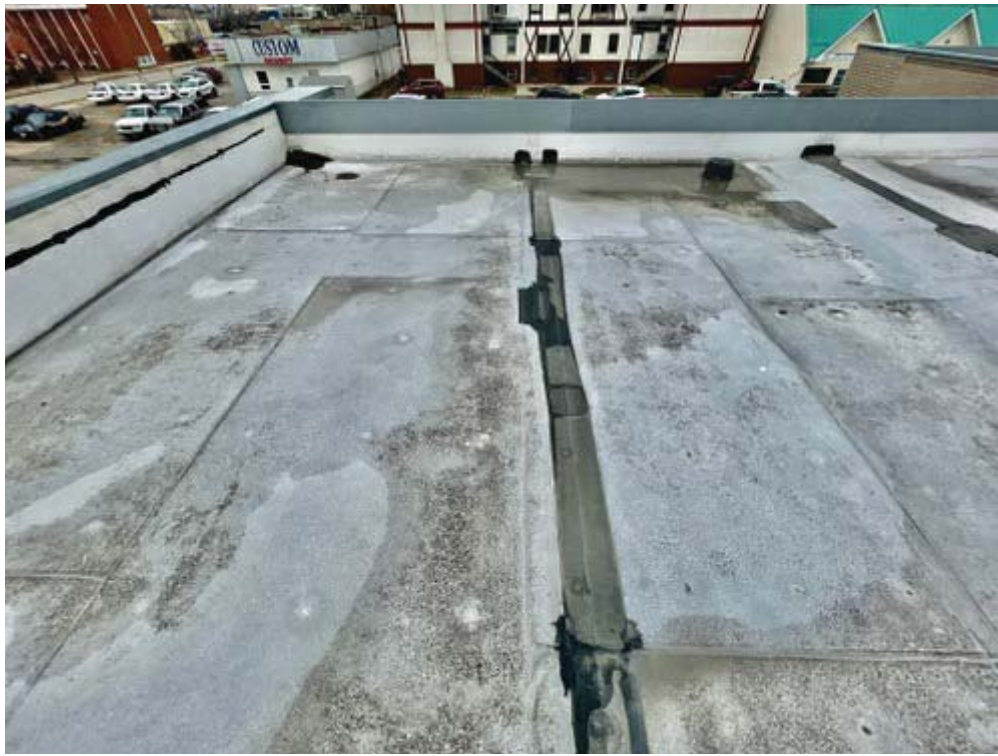
Photo 2

Previously reinforced seams, approximately 10 years old.

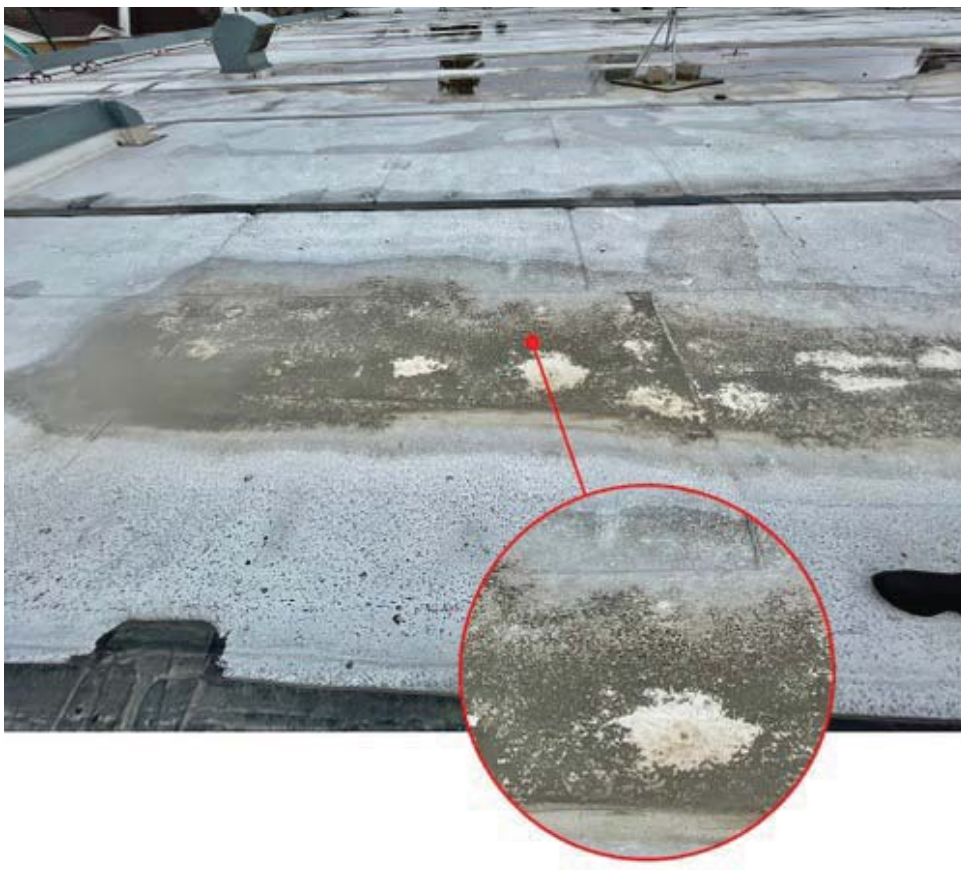
Photo 4

Fastener Back-Out: This condition can occur on mechanically fastened roof systems depending upon the location of the fastener. Typically this condition is found where the system configuration has the fastener immediately below the surface membrane. In these conditions thermal bridging and condensation from the thermal bridge creates a situation whereby the fastener begins to back out. Additionally, wind loads, incorrect fastener type for the substrate and dimensional instability of the insulation also contributes to this condition. In some cases, what appears to be fastener back out is actually insulation dimension loss typically due to the use of low density insulation and/or moisture contamination. Roof traffic can also create conditions that appear to be fastener back out as well. With fastener back out comes the high probability of the fastener puncturing the waterproofing surface membrane and eventually causing a leak. Proper design reduces or eliminates fasteners having direct contact with the surface membrane.

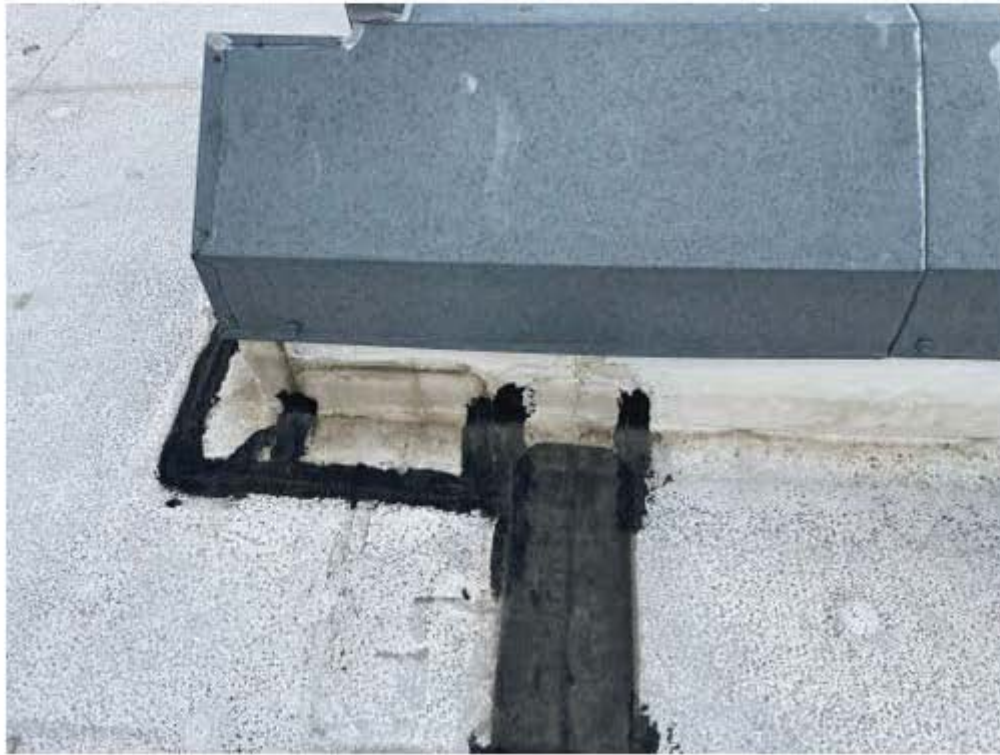
Photo 6

Previously reinforced seams, approximately 10 years old.

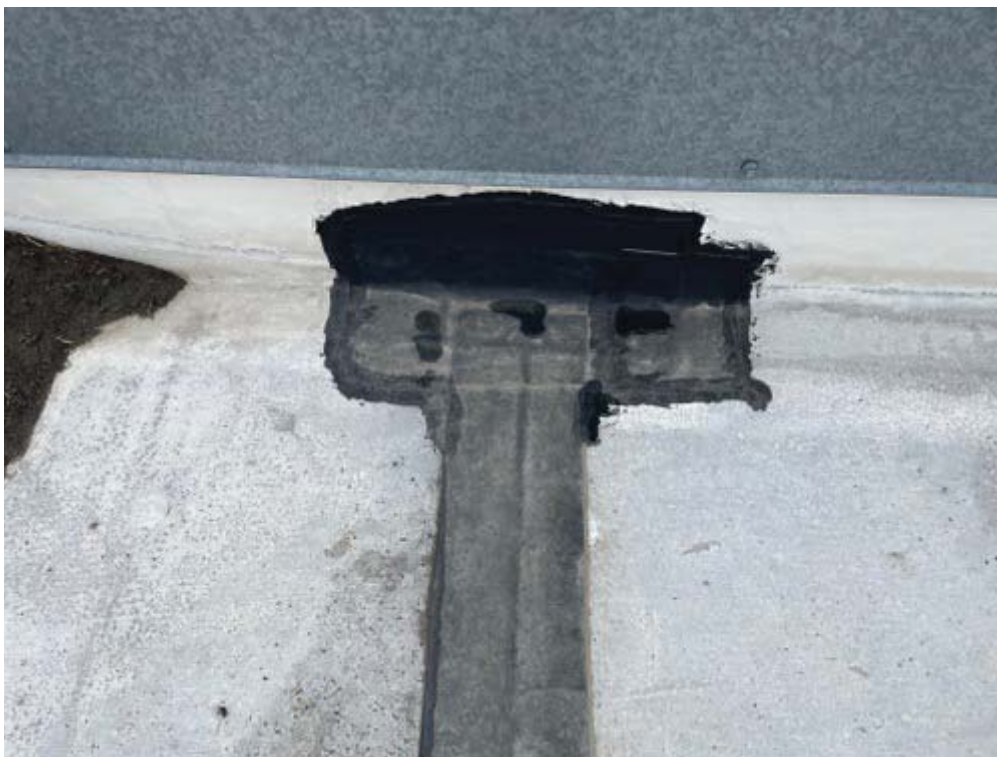
Photo 8

Previously reinforced seams, approximately 10 years old.

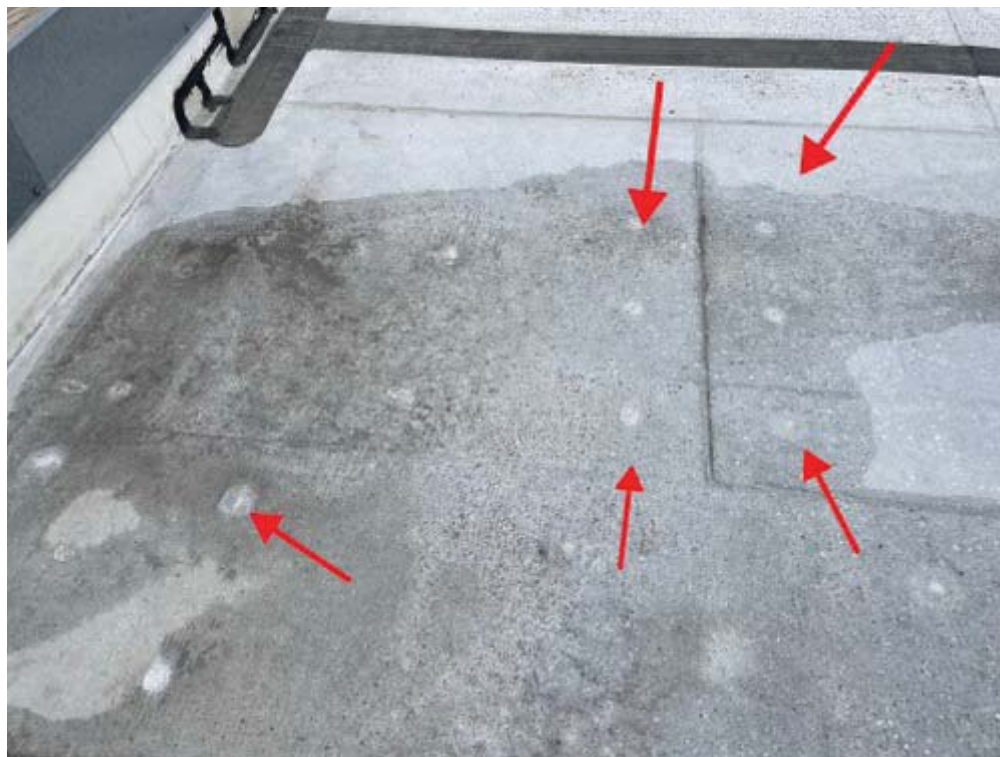
Photo 9

Fastener Back-Out: This condition can occur on mechanically fastened roof systems depending upon the location of the fastener.

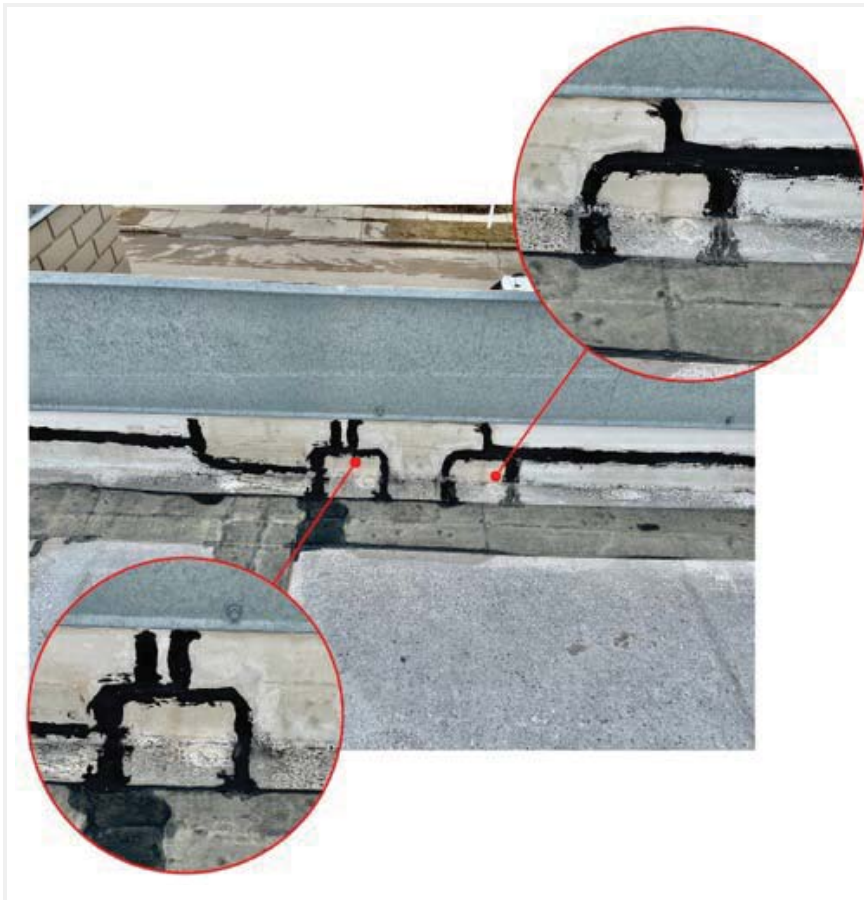
Photo 10

Previously reinforced seams, approximately 10 years old.

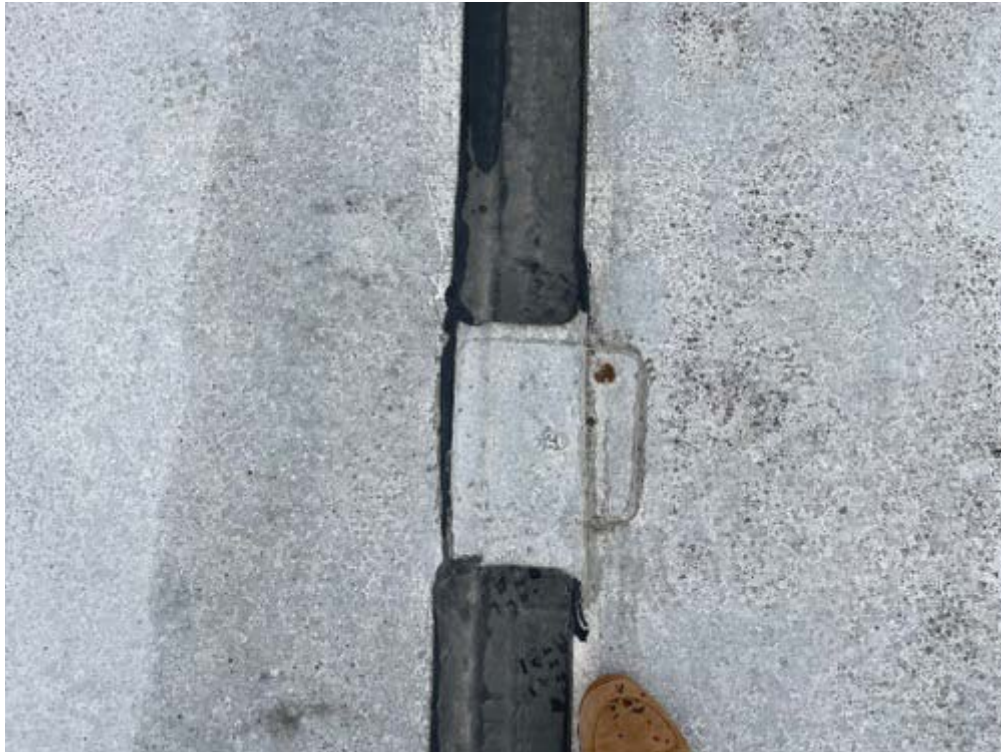
Photo 11

Previously reinforced seams, beginning to fail in spots.

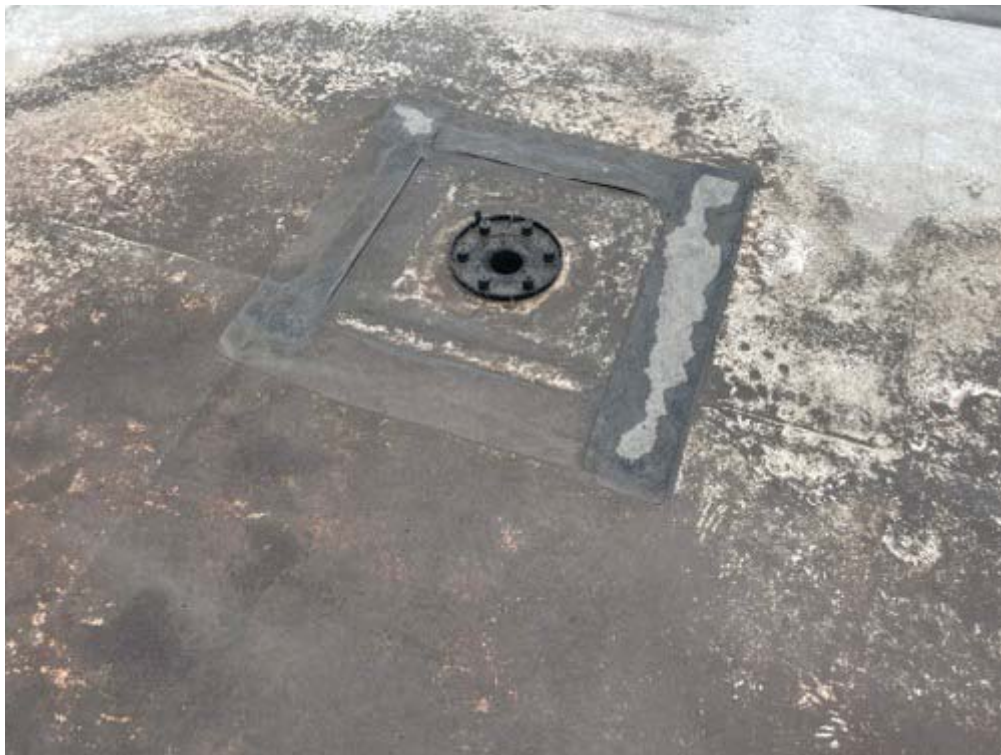
Photo 12

Drain Screen: Missing

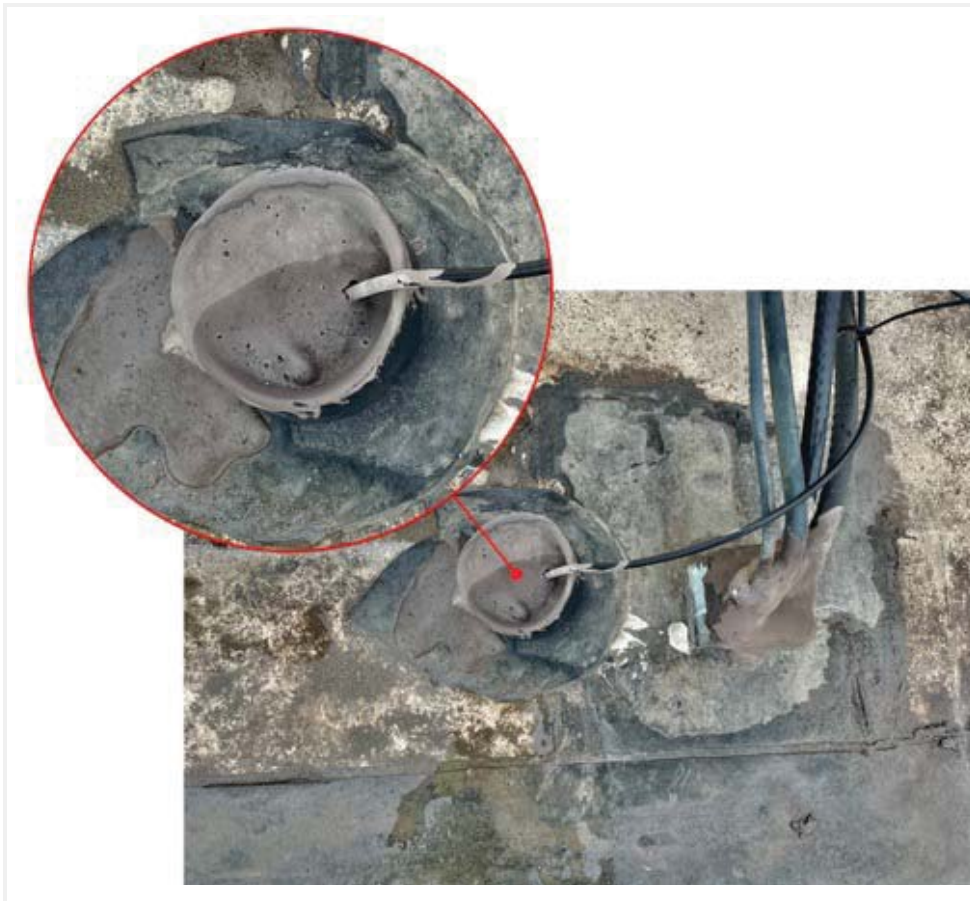
Photo 13

Pitch Pocket Deterioration:

Metal protrusions that penetrate the roof system to allow conduits to run from the rooftop into the building. Movement from the protrusion can break the waterproofing compound, creating cracks. Over time, the release of solvents from the compound can cause the material to shrink, leaving gaps along the edges of the pan and around structural support. Water can enter through a defective pitch pan and find its way into the interior of the building. Moisture can also penetrate into the roof system leading to premature failure.

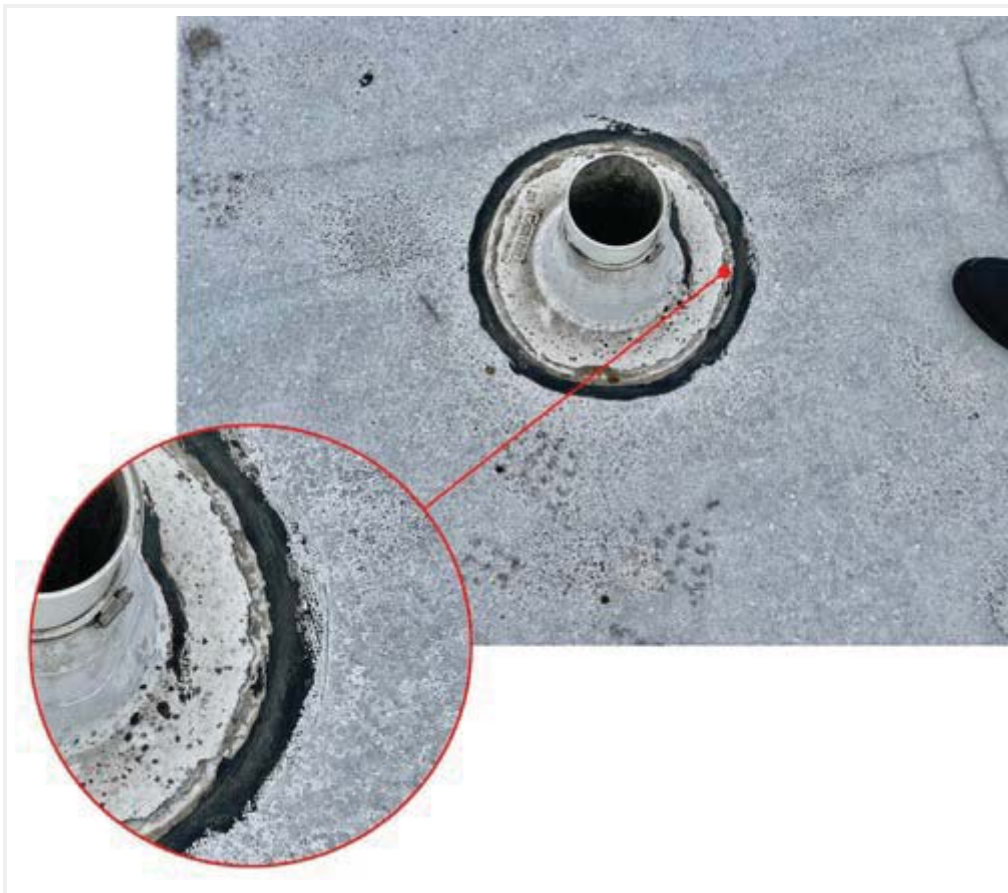
Photo 14

Penetrations:

Waterproofing around some penetrations beginning to deteriorate.

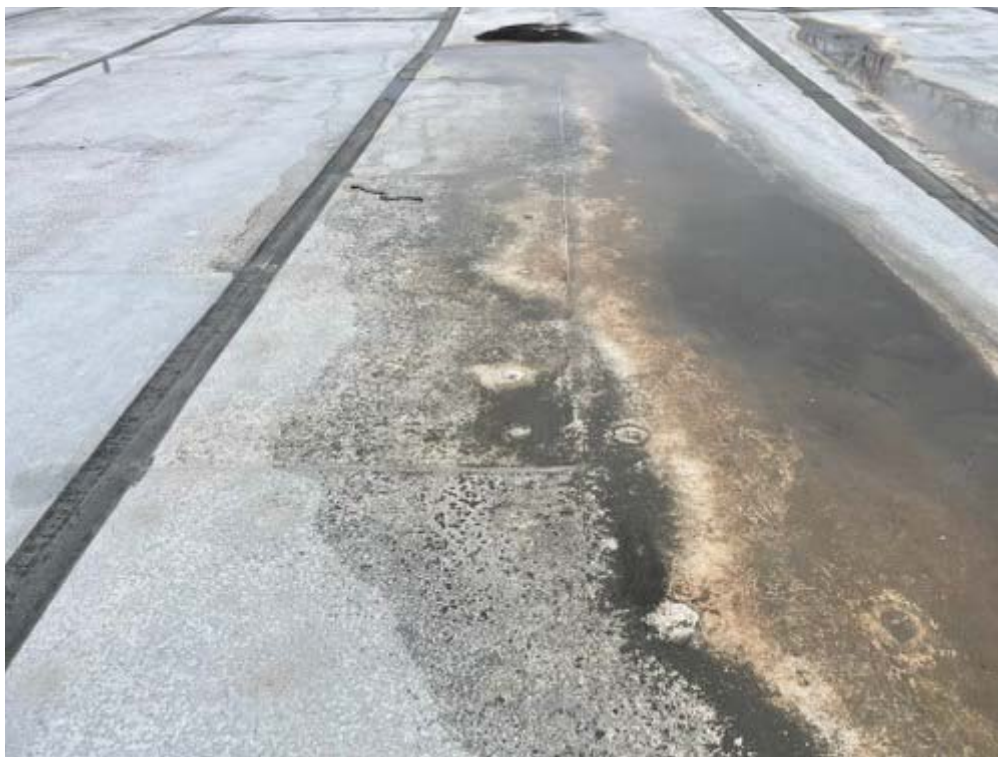
Photo 16

Ponding: Ponding water occurs when moisture collects in large pools on the surface of a roof system

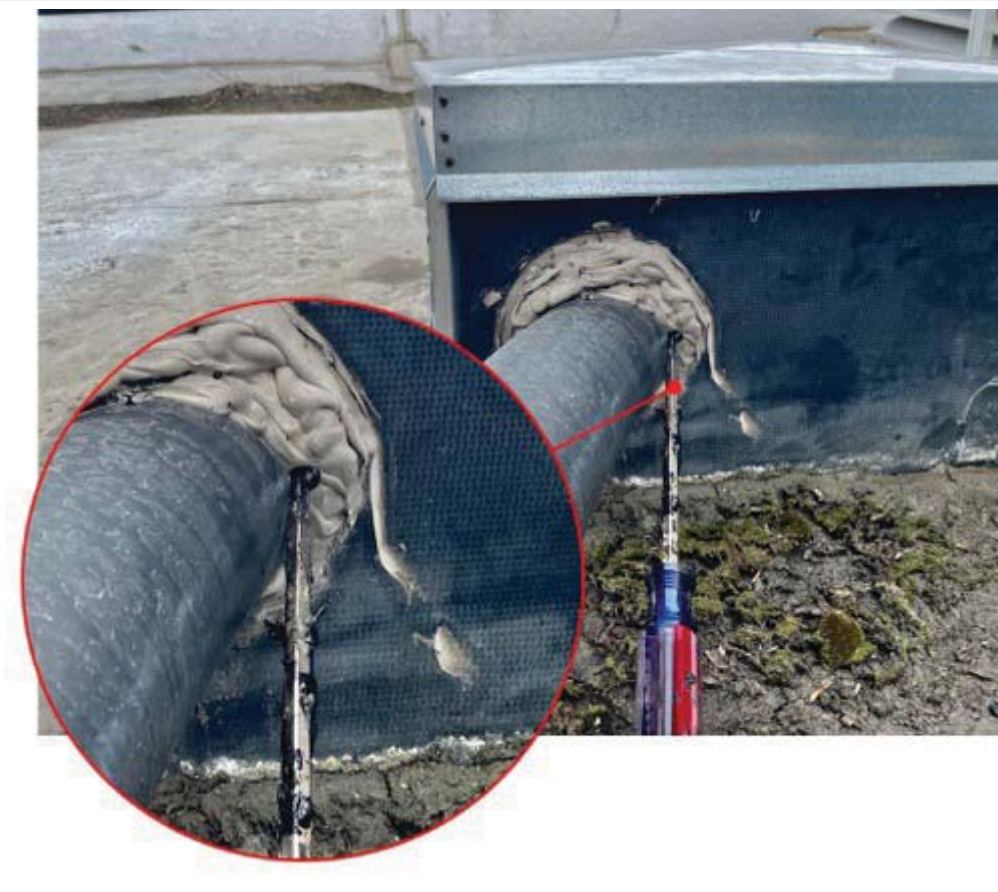
Photo 18

Caulking Deterioration: As caulking is exposed to UV rays and temperature fluctuations it loses its flexibility and develops cracks. Once this occurs splits develop allowing water to penetrate walls and buildings causing damage as well as leaks.

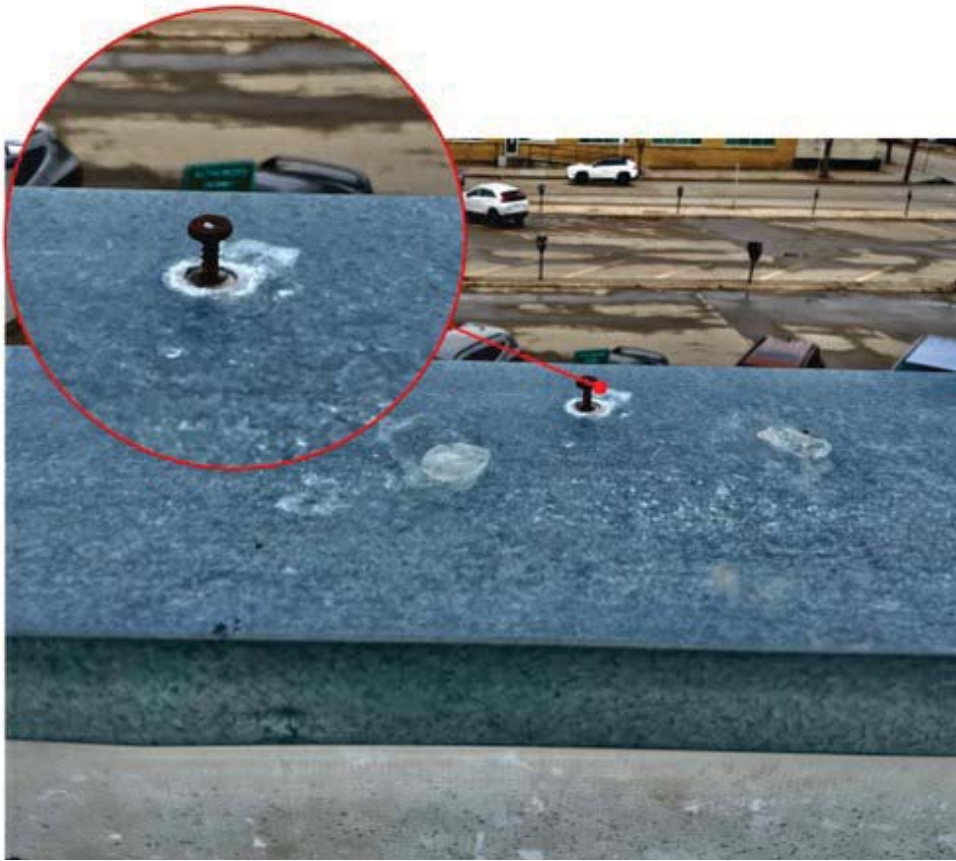
Photo 21

Fastener Back-Out: This is a common condition with through fastened metal roof systems. Metal expands and contracts at a higher rate than other building components. Seasonal expansion on a one foot section of metal typically exceeds 1,000 lb per foot. As most of the fasteners used with this system have about 300 lbs per foot shear resistance you would need more than three of these fasteners per foot to control the movement. Spacing typically is 8" - 12" on center in this application. This extra stress leads to two conditions 1) fastener back-out and 2) fastener shear or panel damage. The fasteners used are called cap screws and feature a neoprene grommet as the primary seal at the fastener penetration through the panel. Unfortunately these grommets typically dry out after 5-7 years creating a leak source at the fastener. Additionally there is an element of thermal bridging with the fastener that helps to exacerbate the condition. In this case water can then enter the building and walls leading to structural element damage.

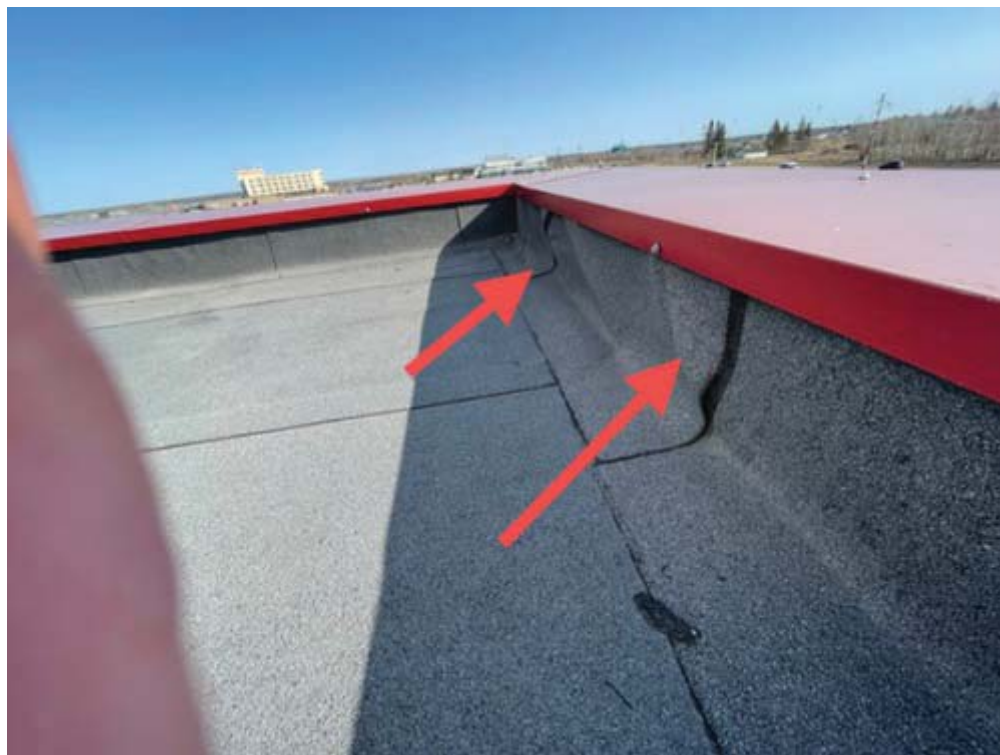
Photo 3

Fish mouths: Wrinkles or openings at the edge of the membrane caused by poor adhesion or installation.

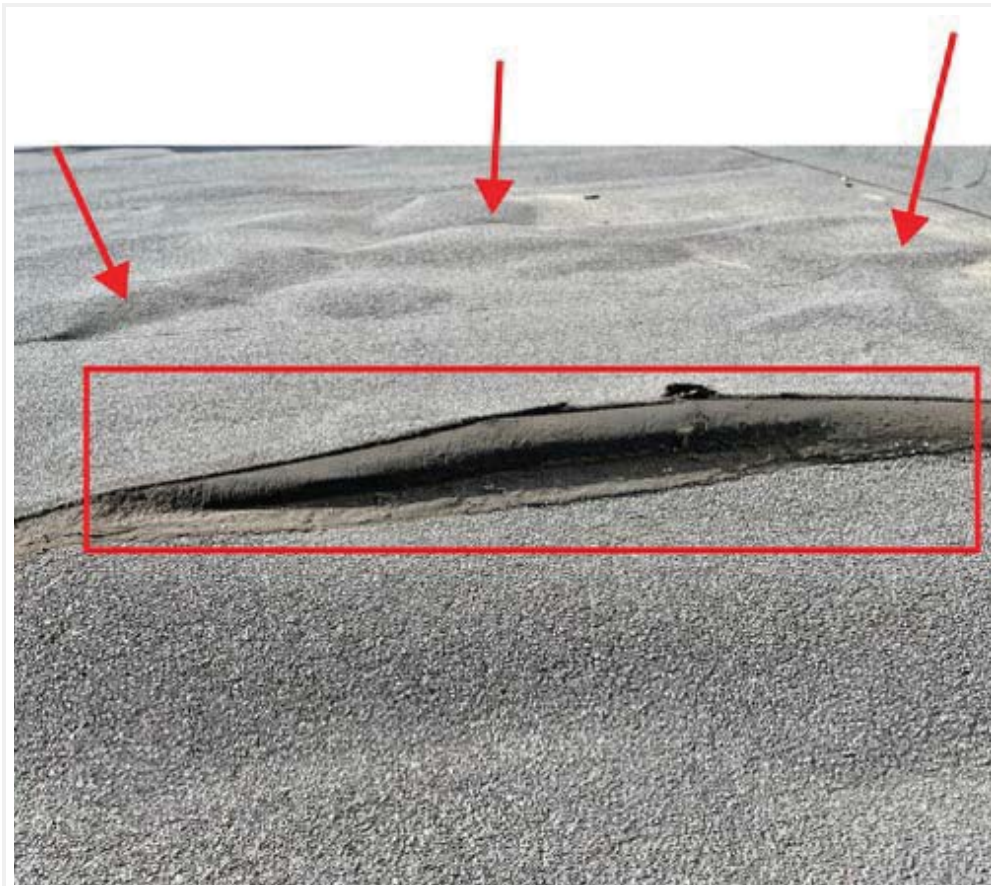
Photo 9

Blisters: Soft spongy pockets or swellings in the roofing material.

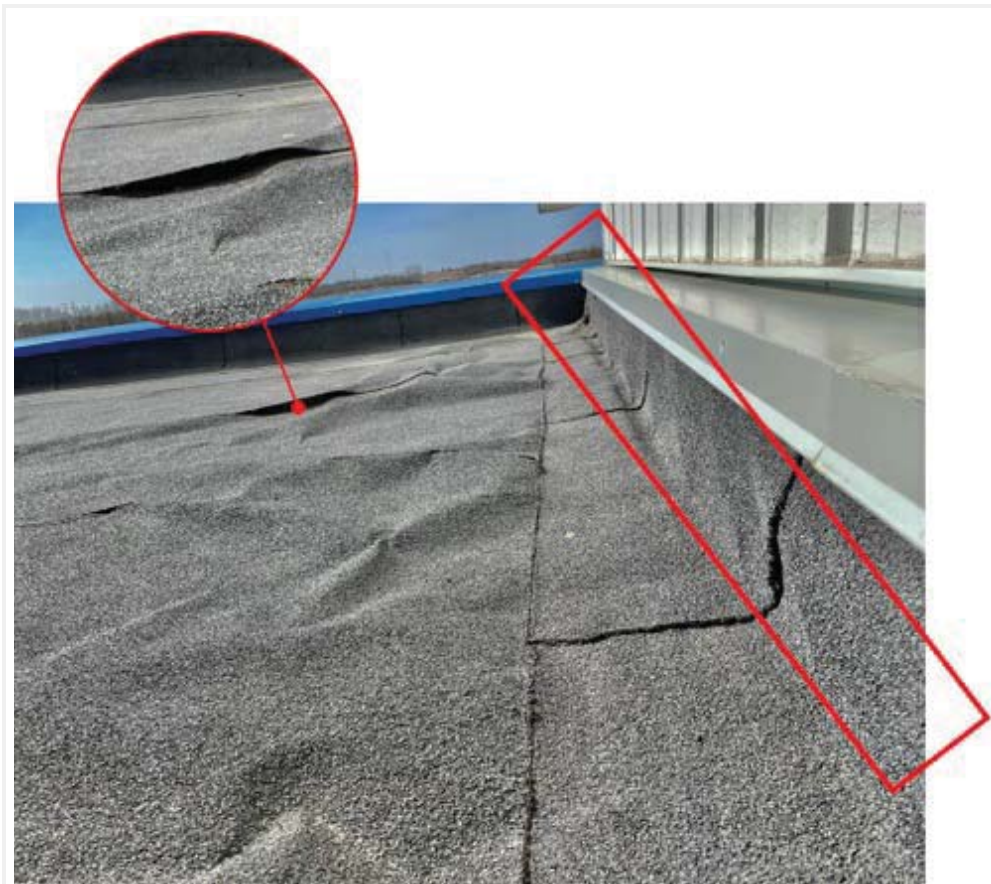
Photo 10

Blisters: Soft spongy pockets or swellings in the roofing material.

Perimeter Flashing Deterioration: Most roof failures start at perimeter and penetration locations.

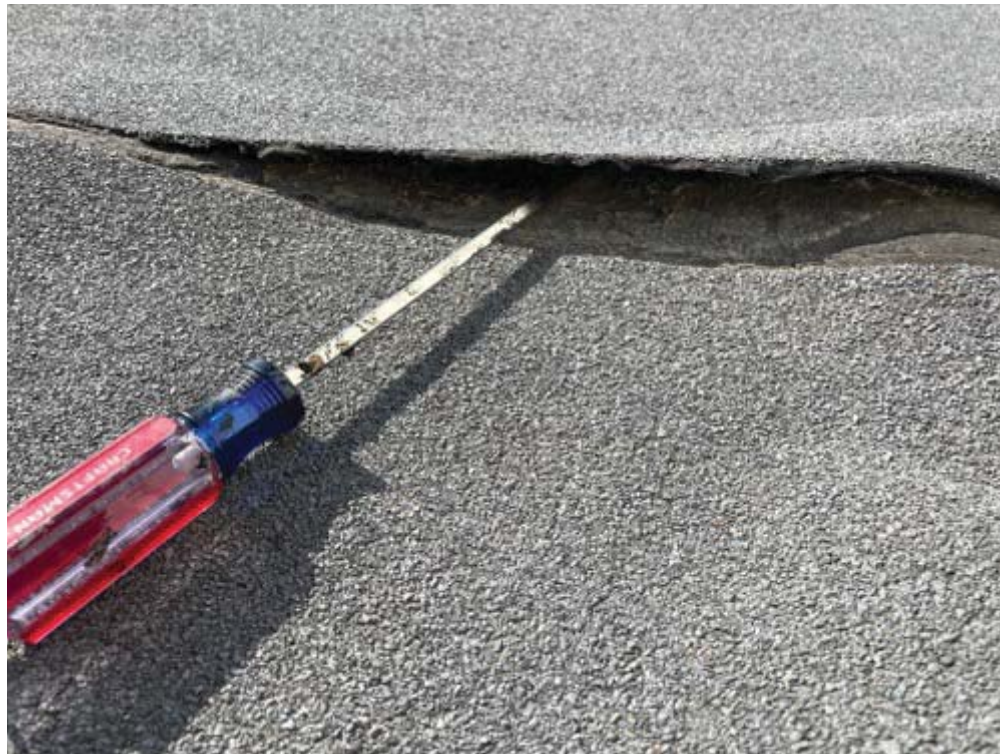
Photo 11

Seams: As the membrane blisters, this puts added stress on the seams. They are starting to split in many places allowing for moisture access into the building.

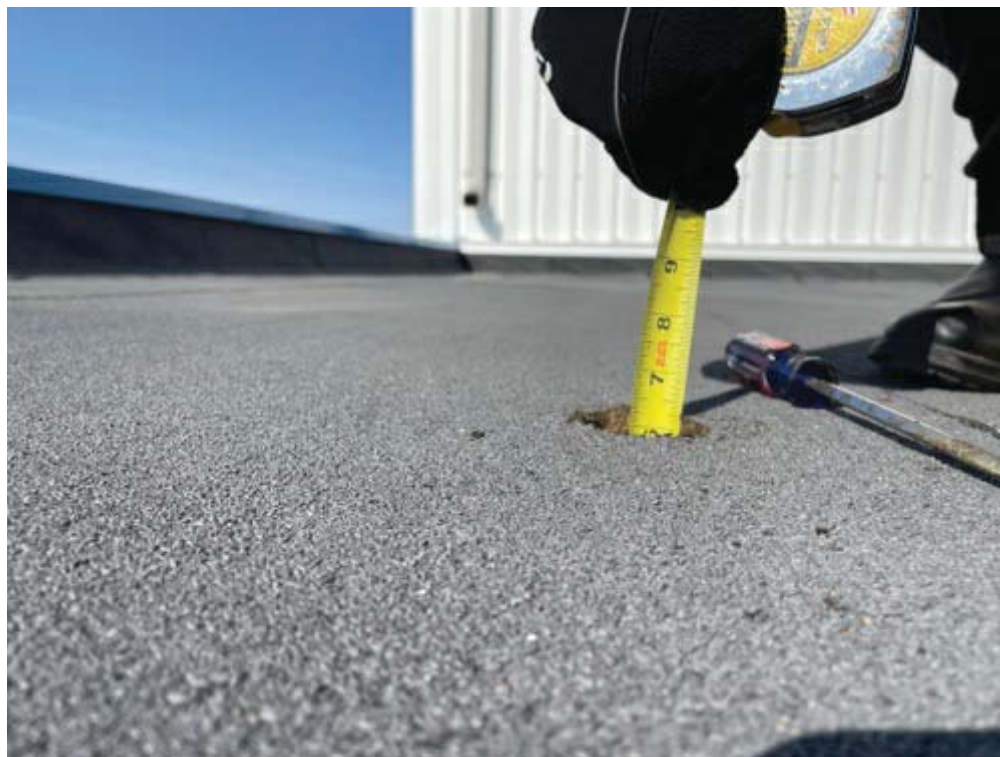
Photo 12

Core Cut:

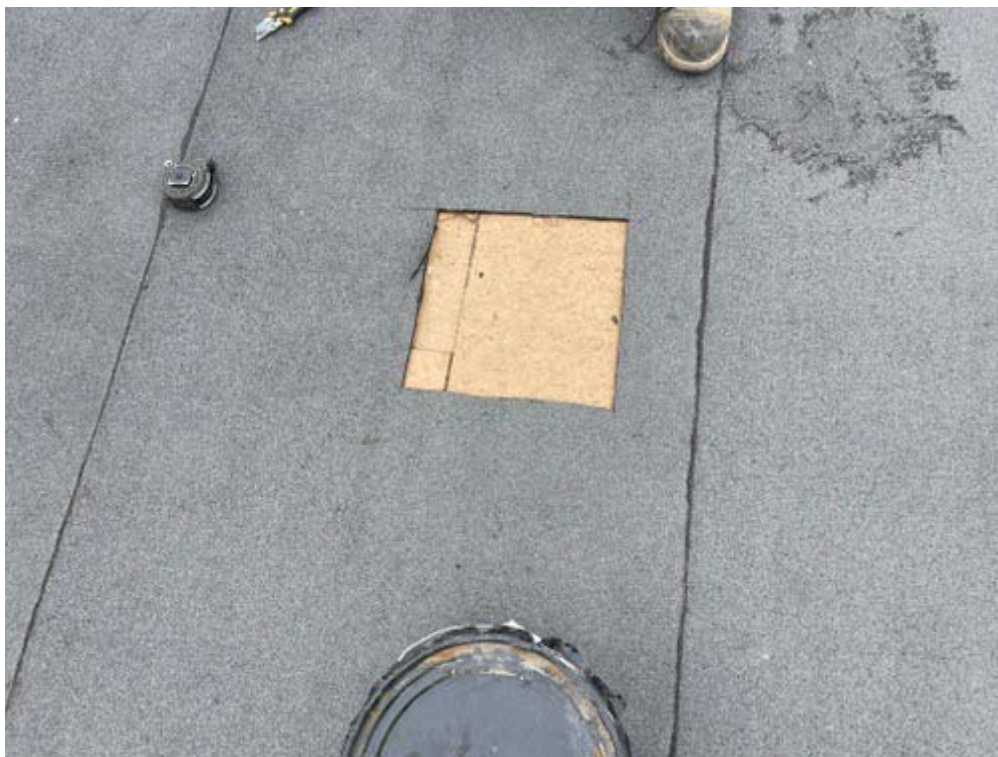
Photo 14

CLEAR Analysis: Removal of membrane sample.

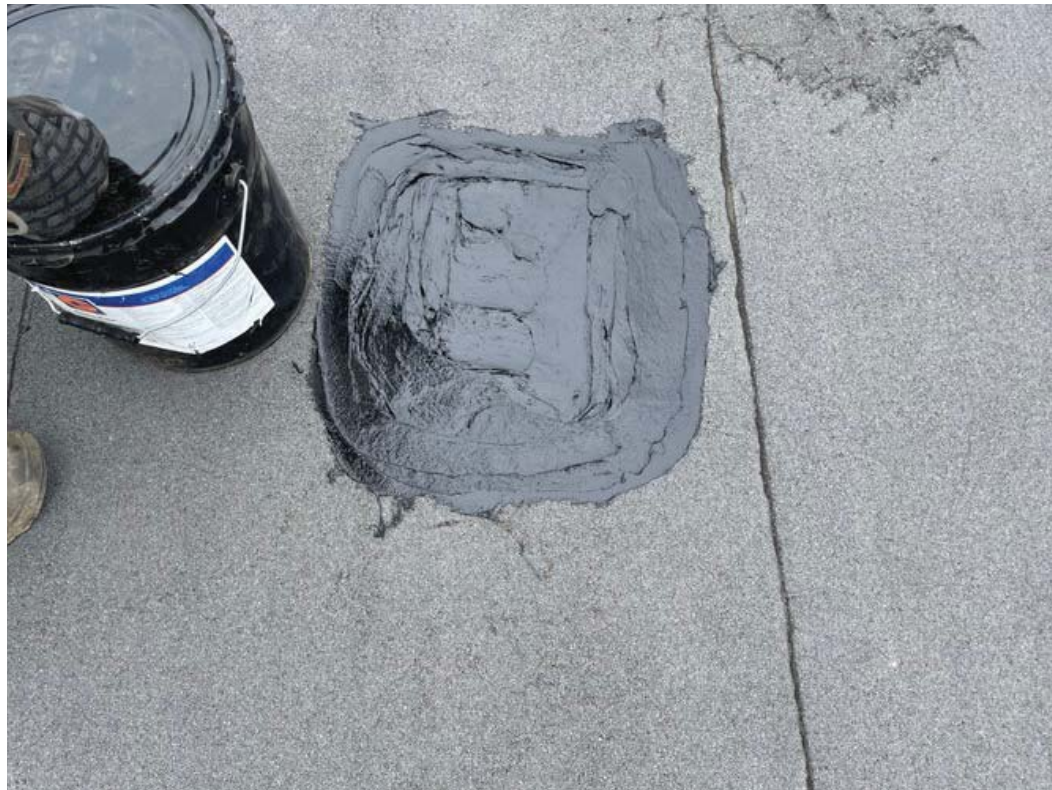
Photo 15

CLEAR Analysis: Repair of membrane sample.

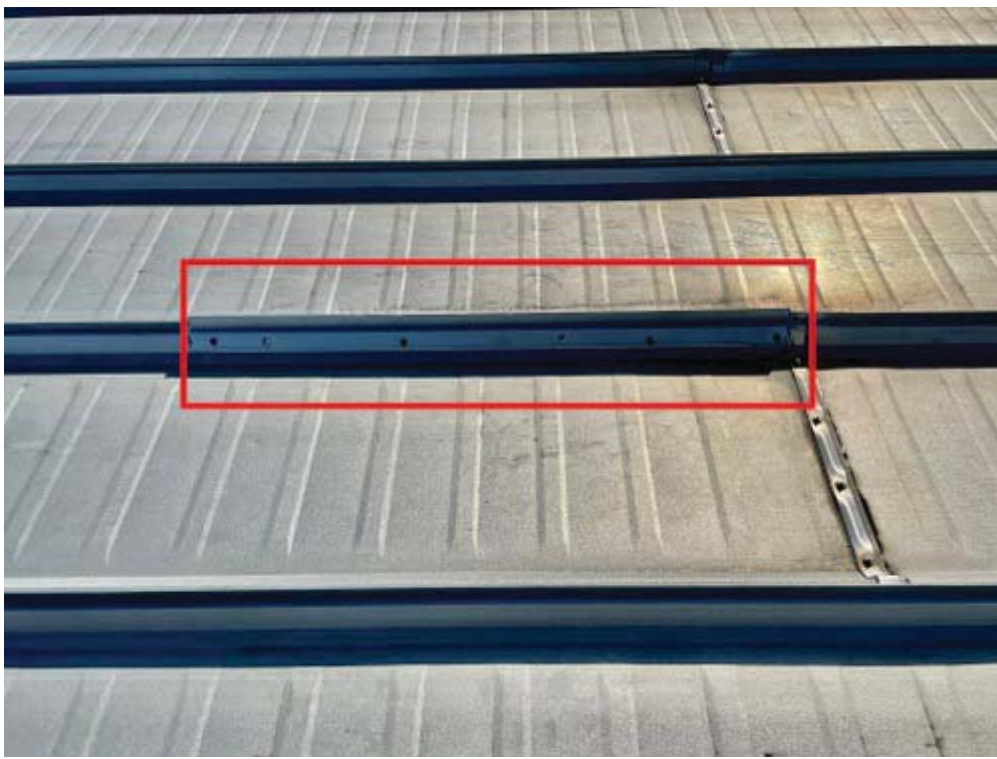
Photo 7

Previous Repair: Previous reinforcement of standing vertical seams found on several areas of the roof varying in length.

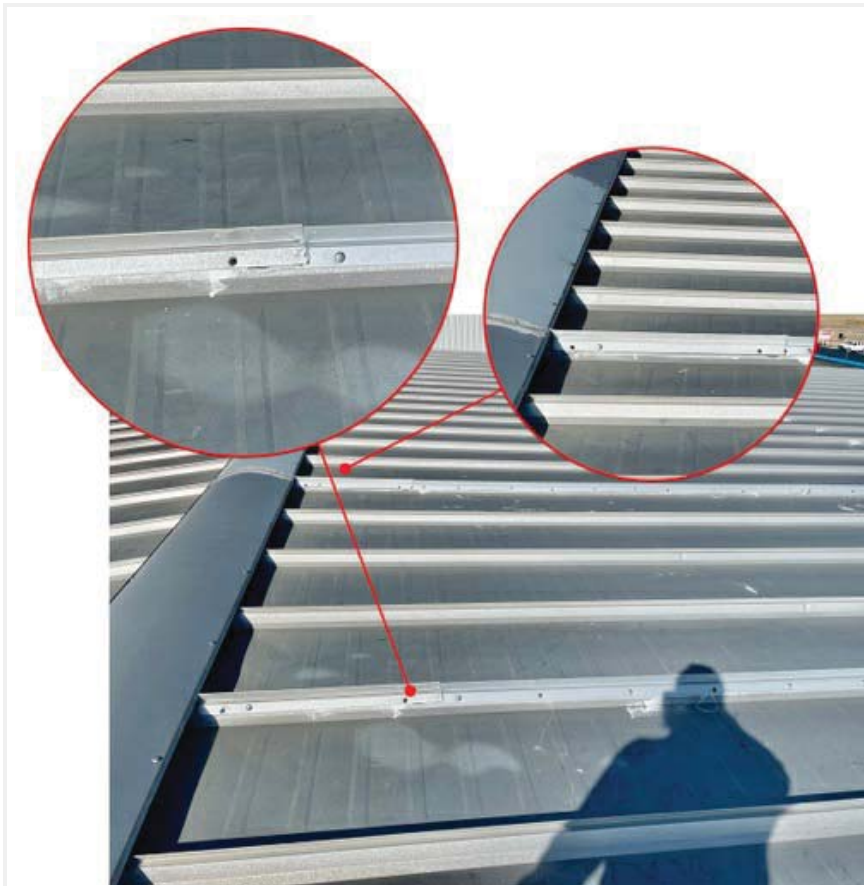
Photo 8

Previous Repair: Previous reinforcement of standing vertical seams found on several areas of the roof varying in length.

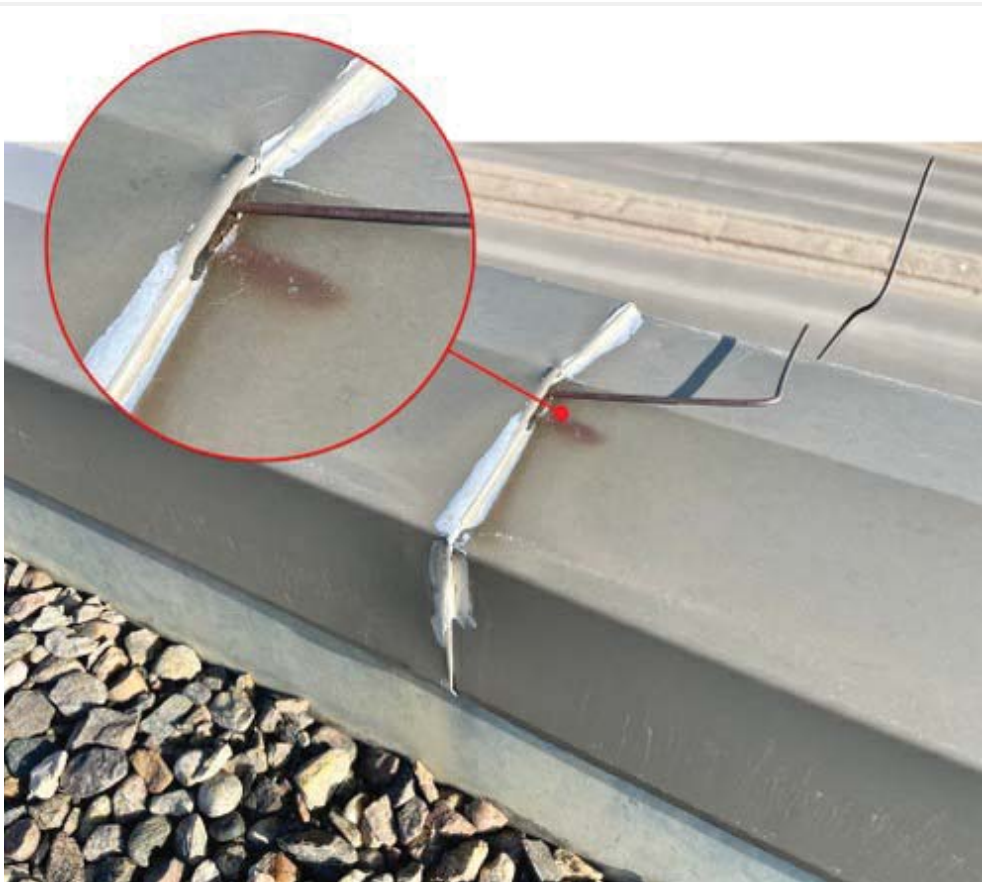
Photo 8

Caulking Deterioration: As caulking is exposed to UV rays and temperature fluctuations it loses its flexibility and develops cracks. Once this occurs splits develop allowing water to penetrate walls and buildings causing damage as well as leaks.

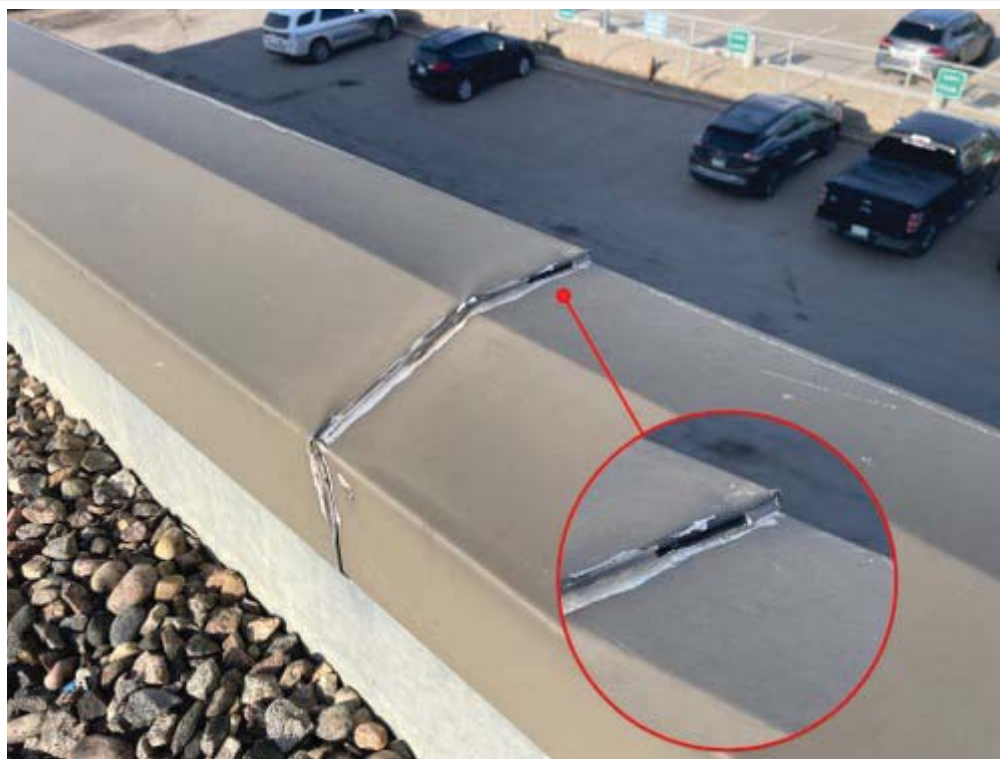
Photo 9

Caulking Deterioration: As caulking is exposed to UV rays and temperature fluctuations it loses its flexibility and develops cracks. Once this occurs splits develop allowing water to penetrate walls and buildings causing damage as well as leaks.

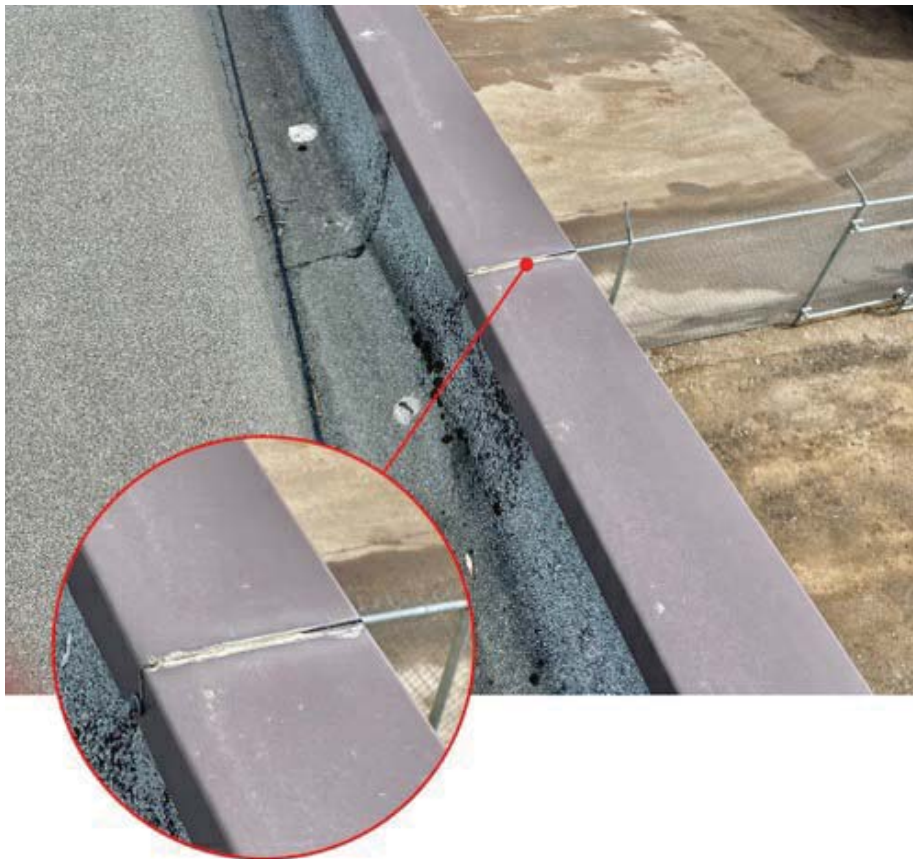
Photo 2

Caulking Deterioration: As caulking is exposed to UV rays and temperature fluctuations it loses its flexibility and develops cracks. Once this occurs splits develop allowing water to penetrate walls and buildings causing damage as well as leaks.

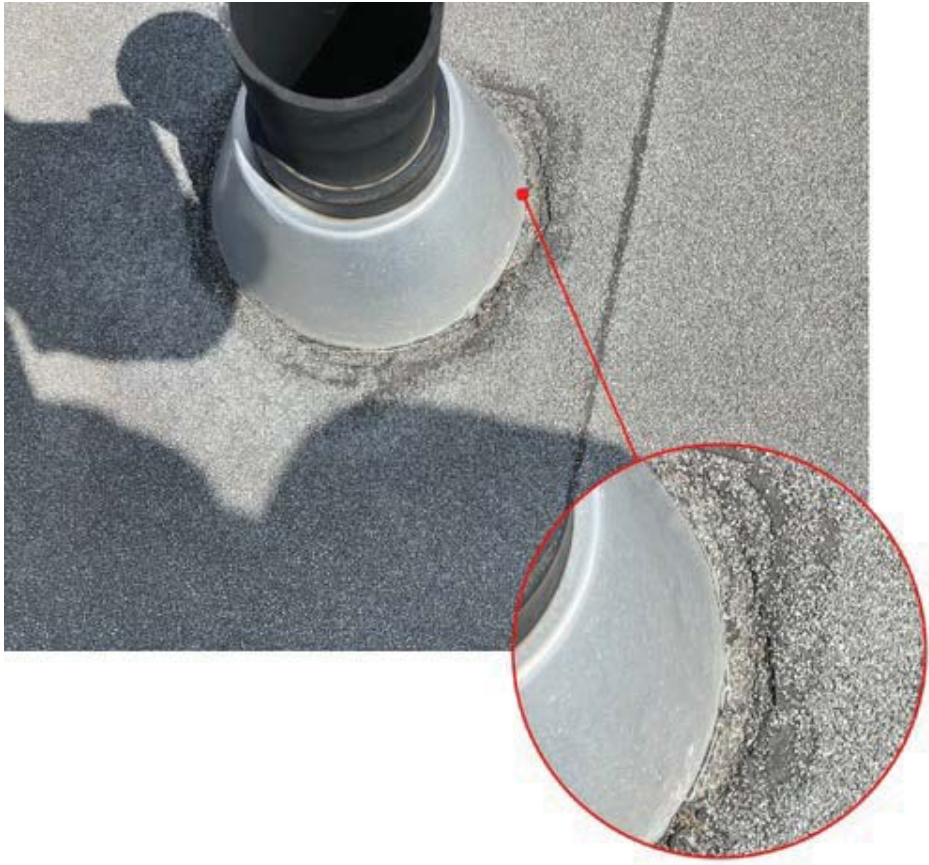
Photo 3

Penetration
Waterproofing: Beginning to deteriorate around the perimeter allowing for potential moisture access.

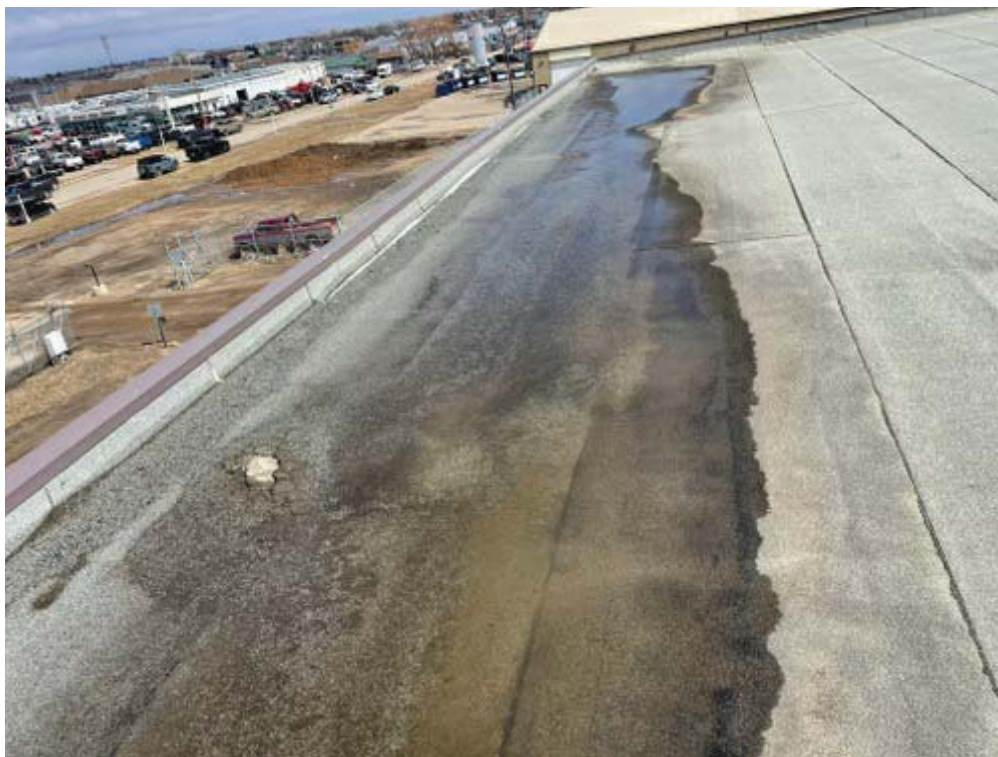
Photo 9

Ponding: Ponding water occurs when moisture collects in large pools on the surface of a roof system.
