FACILITY REVIEW 2025 – 2029

Parks, Recreation &
Culture Department

City of
Prince Albert

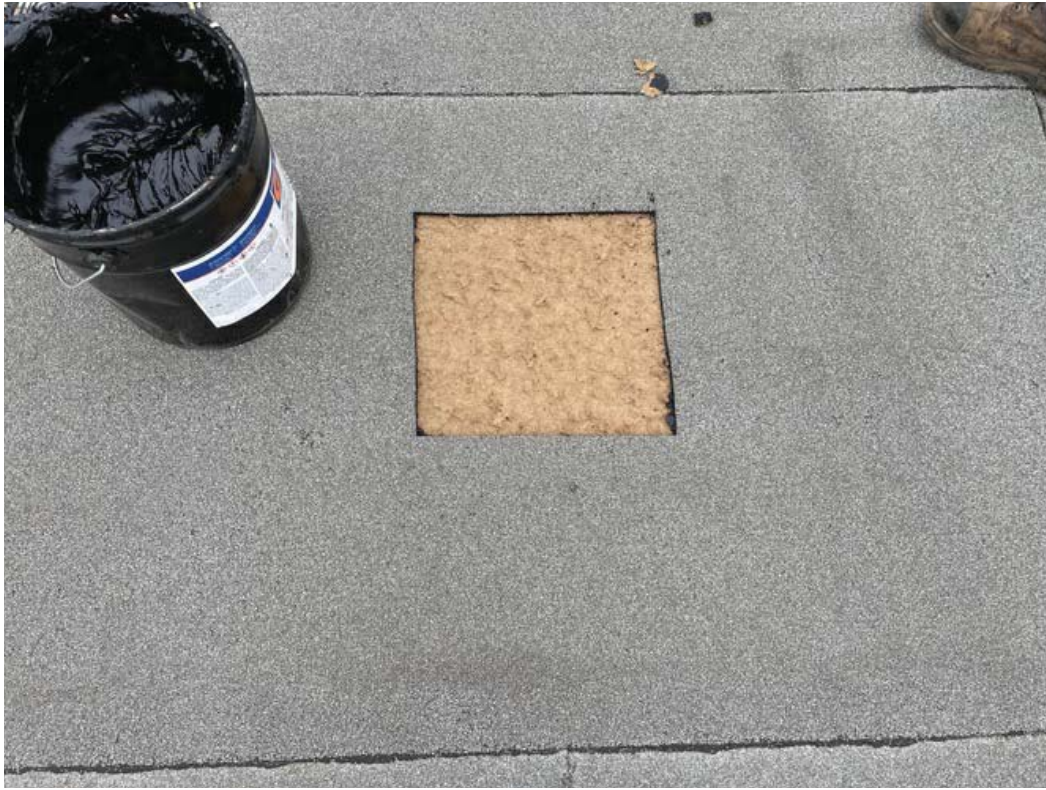
Photo 16

CLEAR Analysis: Repair of membrane cut.

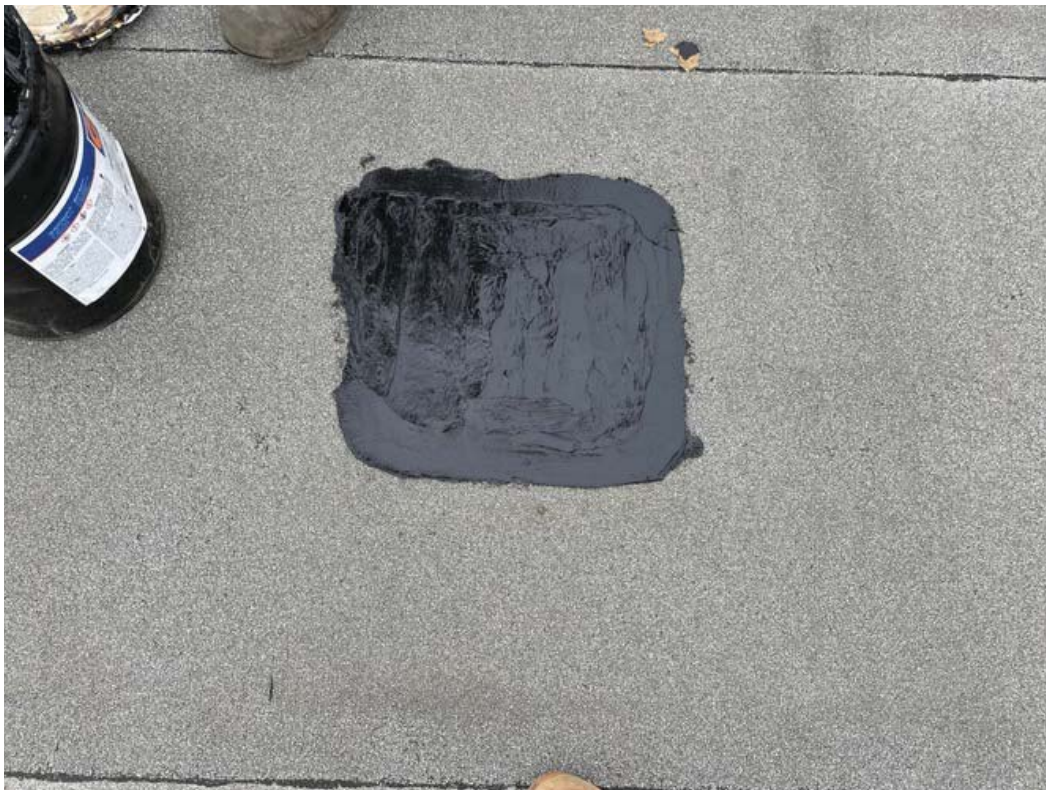
Photo 17

CLEAR Analysis:
Imbedded using granules from perimeter to reinforce mastic repair and protect from UV.

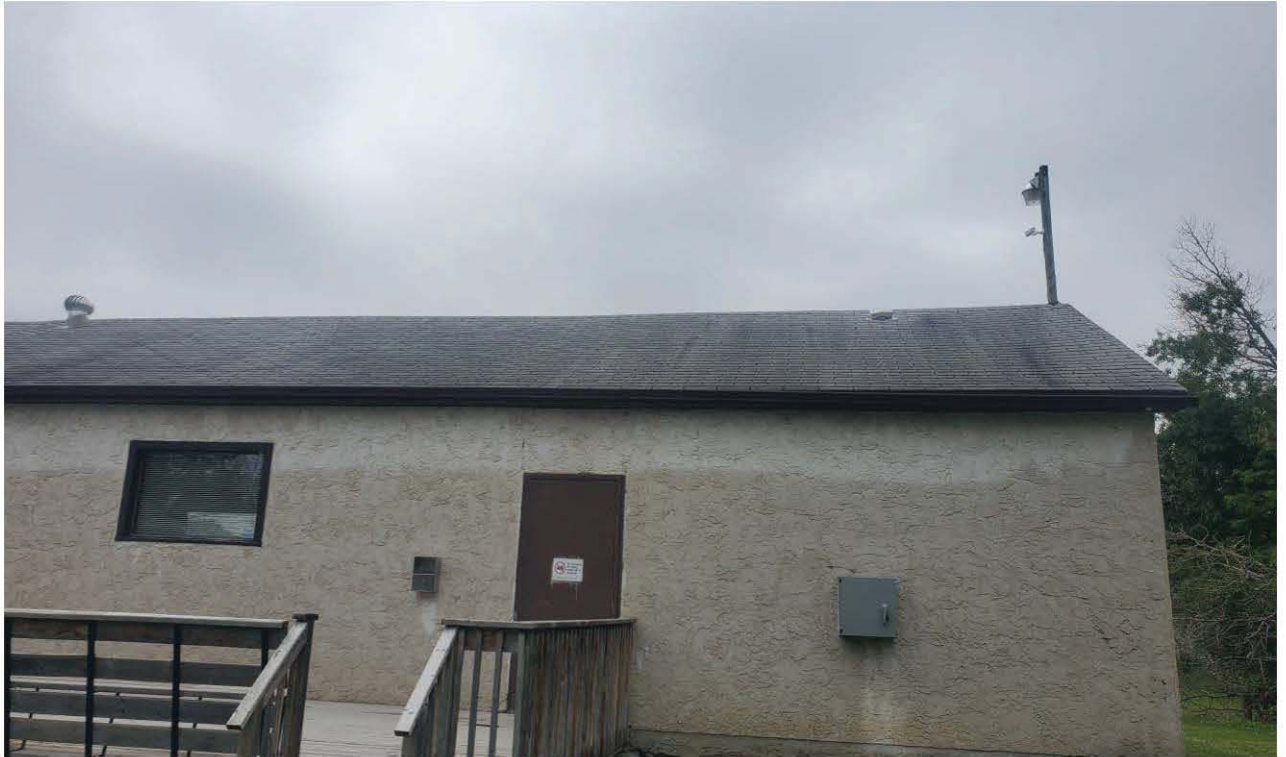
Observation Notes

- Roof is sagged where the building joined
- Fascia and gutter missing in this area

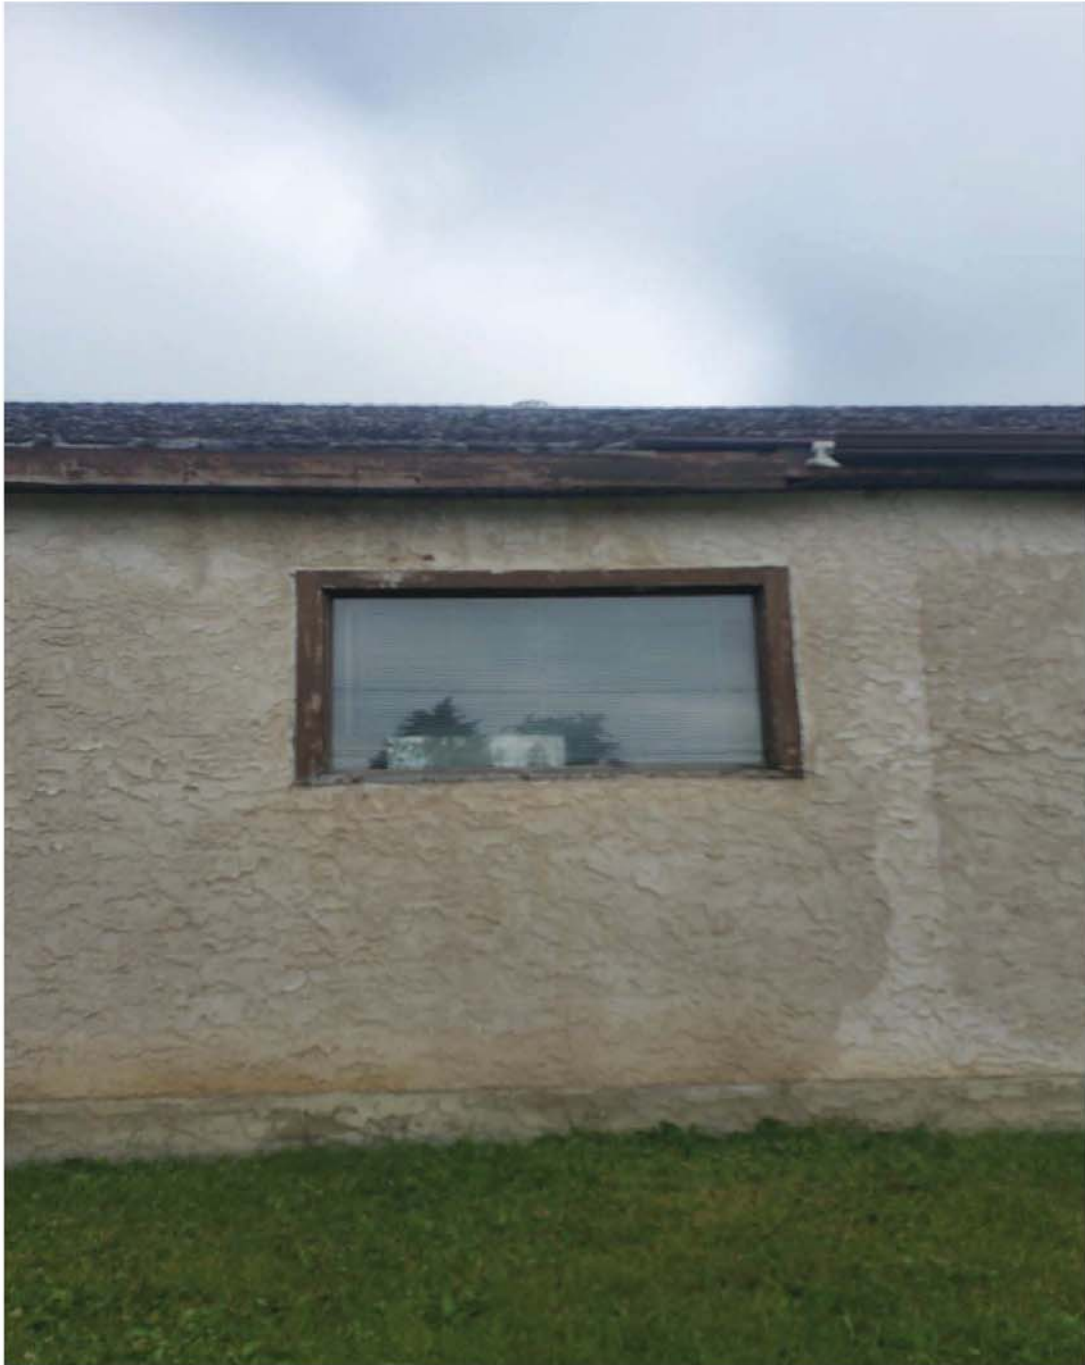
Observation Notes

- Missing fascia and gutter

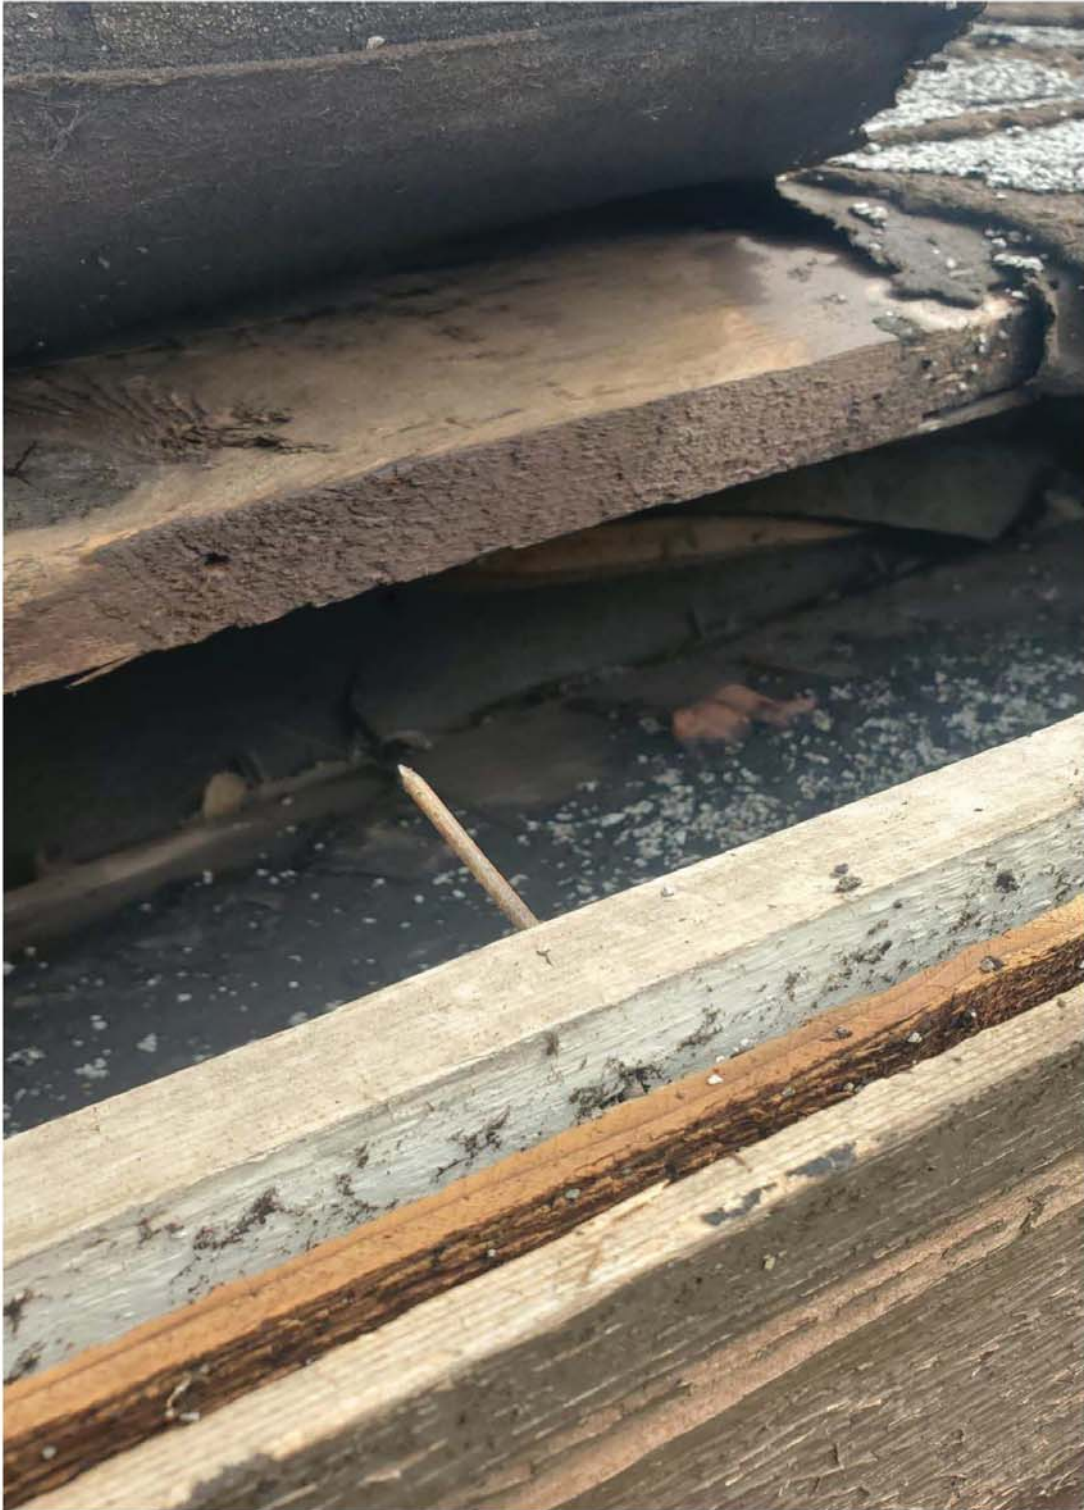
Observation Notes

- Leaks in the attic
- Lots of blown in insulation over wood shavings
