City of Prince Albert - Alfred Jenkins Initial Roof Inspection

Prepared By
Brett Foote

June 10, 2022

Facility: Alfred Jenkins Field House

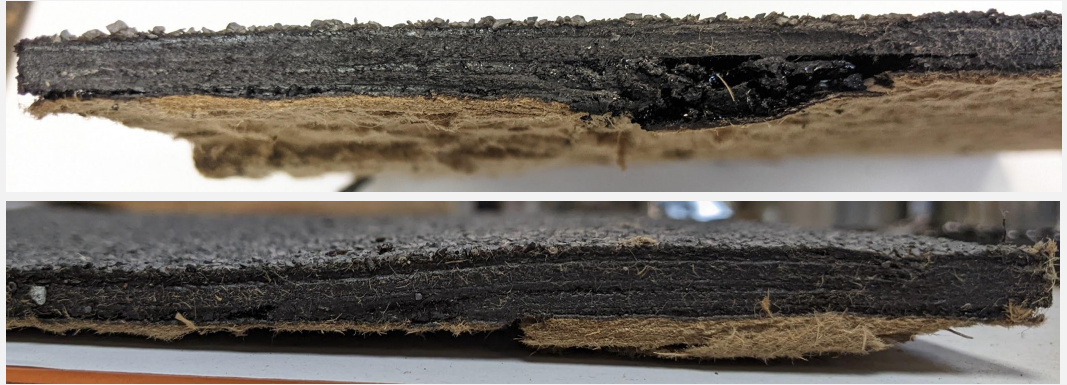
Figure 6: Alfred Jenkins side profile.

The 12 year old core sample is from a 2 ply modified roof system with fiberglass felt interplies in an asphalt adhesive. The lower interplies of the core are hard and brittle, and easily crumble by hand (Figure 6). The interplies could not be easily delaminated by hand. The mineral surfacing on this core has maintained good coverage. The softening point and pen tests show that the asphalt adhesive responsible for keeping the system intact has lost its oils over time, causing the system to become more brittle. The cores tested below the recommended tensile strength and elongation recommendations. The sample performed well when undergoing puncture testing, implying that the system can withstand foot traffic and most weather phenomena.

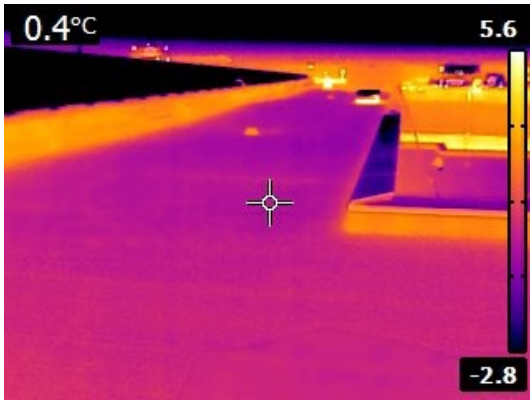
Photo 1

General view of section A2 (upper section)

No thermal anomaly was found on this section.

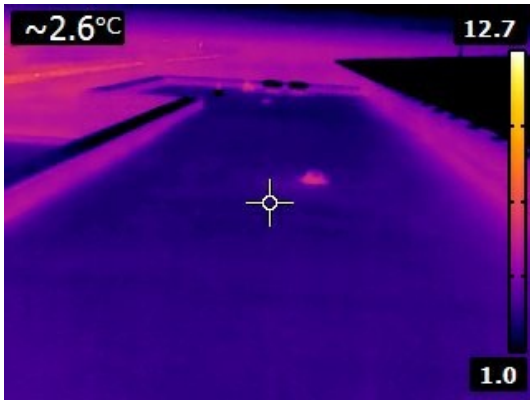
Photo 2

General view of section A2 (upper section)

No thermal anomaly was found on this section.

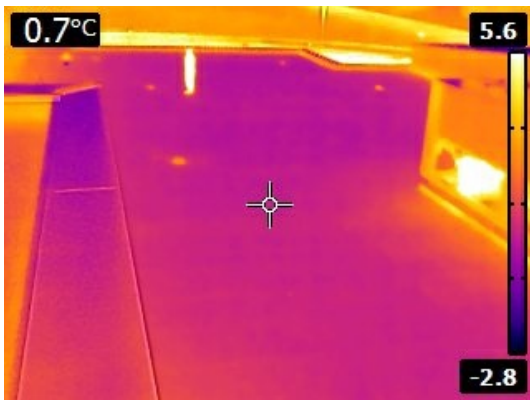
Photo 3

General view of section B1 (lower section) - from above

No thermal anomaly related to wet areas was found on this section.

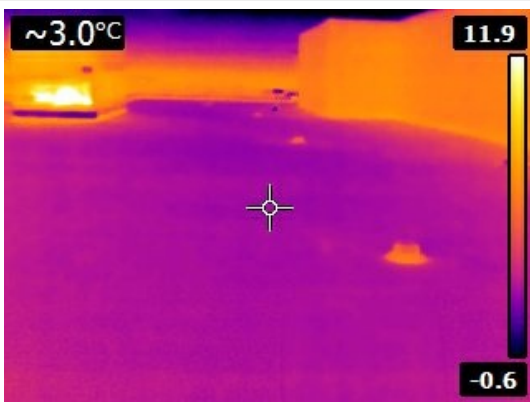
Photo 4

General view of section B1 (lower section) - from the roof surface

No thermal anomaly related to wet areas was found on this section.

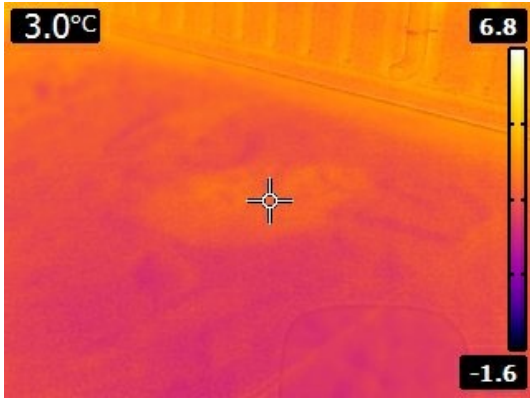
Photo 5

General view of a blister on the membrane with the infrared camera.

A humidity meter was used to confirm that the roofing assembly around the blister is still dry.

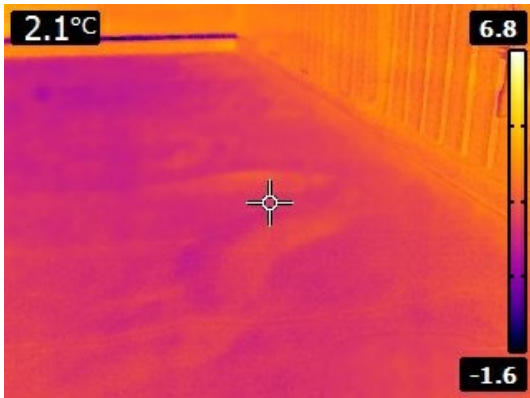
Photo 6

General view of ridges on the membrane with the infrared camera.

A humidity meter was used to confirm that the roofing assembly around the ridges is still dry.

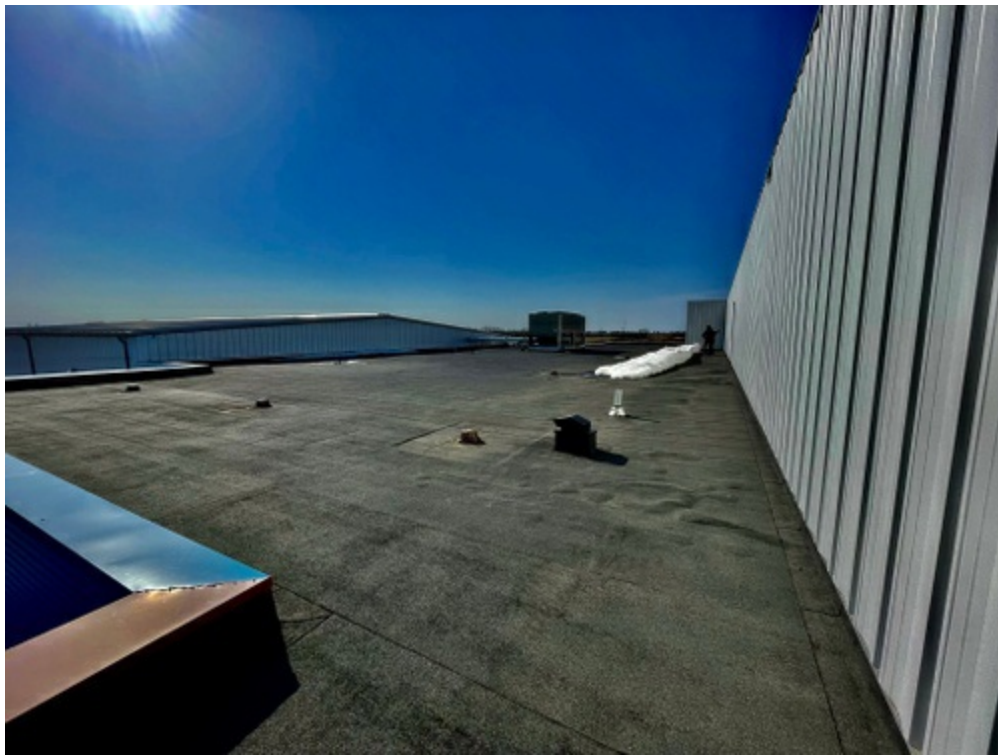
Photo 1

Section 1 - 2 ply Modified Bitumen

Overall Condition: Failed

CLEAR Analysis: The 12 year old core sample is from a 2 ply modified roof system with fiberglass felt interplies in an asphalt adhesive. The lower interplies of the core are hard and brittle, and easily crumble by hand (Figure 6). The interplies could not be easily delaminated by hand. The mineral surfacing on this core has maintained good coverage. The softening point and pen tests show that the asphalt adhesive responsible for keeping the system intact has lost its oils over time, causing the system to become more brittle. The cores tested below the recommended tensile strength and elongation recommendations. The sample performed well when undergoing puncture testing, implying that the system can withstand foot traffic and most weather phenomena.

IR Scan: 0% Wet

1. Remove all roof components down to dry insulation;
2. Install new recovery board in damaged areas;
3. Install new SBS modified bitumen base sheet
4. Install new SBS modified bitumen cap sheet

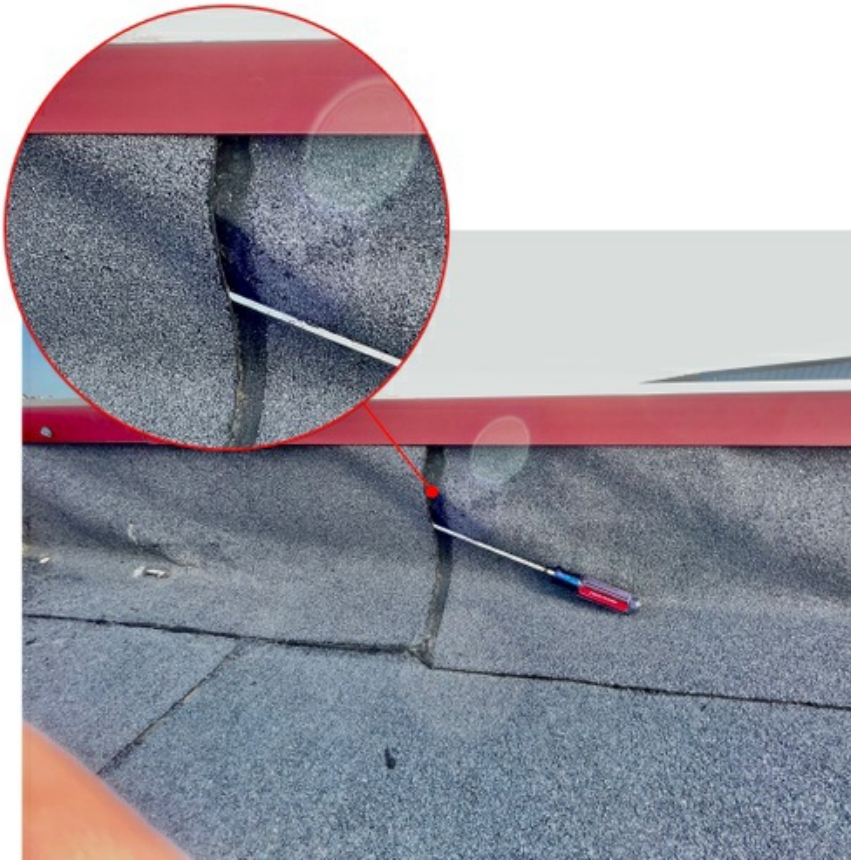
Photo 2

Fish mouths: Wrinkles or openings at the edge of the membrane caused by poor adhesion or installation. Fish mouths are a common cause of early failure on 2-ply torch down and single ply roof systems. These systems are prone to workmanship error due to two factors (1) the manual heating/welding of the adhesive, which is very unpredictable for constant heat, and (2) the roof system only consists of 1 to 2 plies, which translates in to a very thin layer of water protection.

Perimeter Flashing Deterioration: Most roof failures start at perimeter and penetration locations. Metal edge conditions that are poorly designed and improperly installed fail due to the extreme expansion and contraction that is typical with metal. Perimeter wall flashings can also be damaged due to normal seasonal building movement and thermal shock. Additional damage can also be see from UV degradation as well. At all of these deteriorated or failed points, moisture can gain direct access to the roof system insulation and the buildings interior.

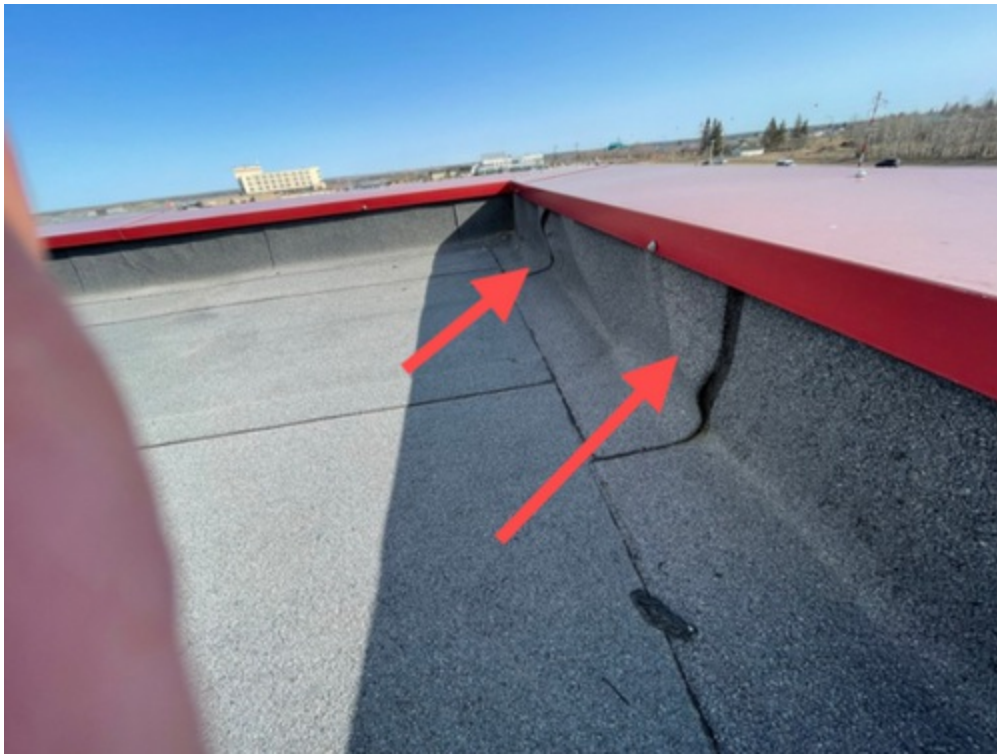
Photo 4

Blisters: Soft spongy pockets or swellings in the roofing material. They occur between layers of felt or between the roof membrane and substrate. Air or moisture vapor entrapped within a blister expands as the roof and outside air temperatures rise. This results in sufficient pressure to push the roofing felts upwards and apart. Blisters may be ruptured by roof traffic, expanding frozen water, or hail (especially during colder weather). Some blisters may become so large as to affect drainage, which may then cause ponding water. Laps could also be pulled apart, resulting in leakage. A ruptured blister will immediately allow water to penetrate and damage the roof system.

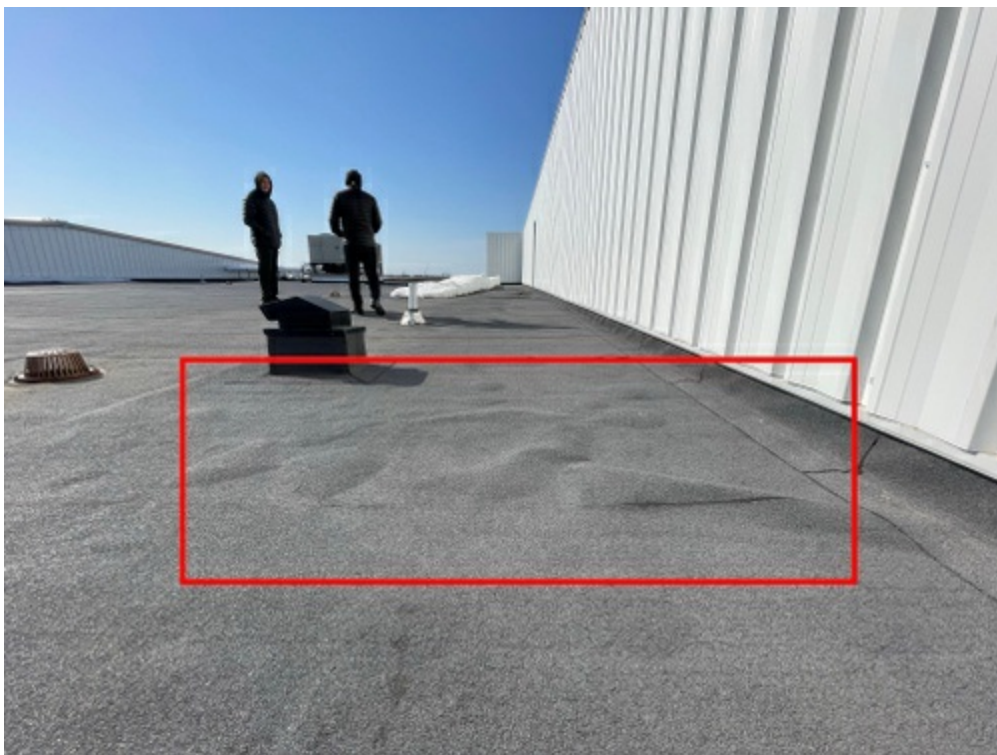
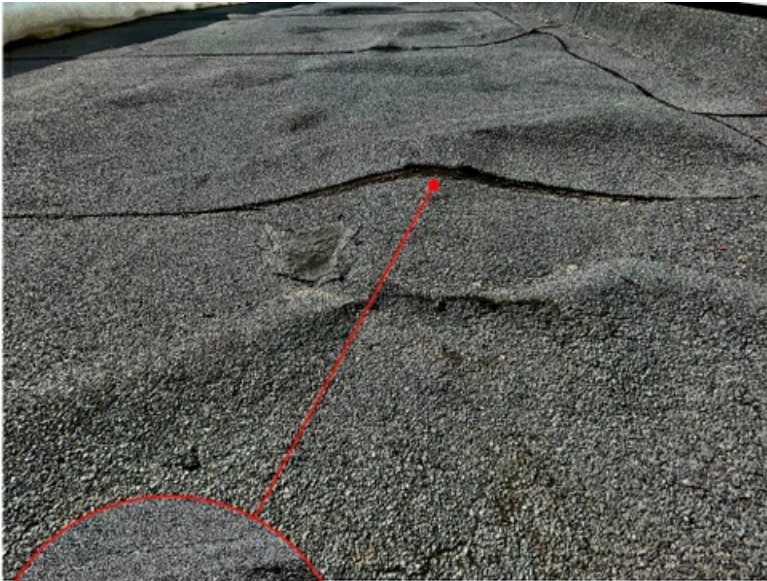
Photo 5

Blisters: Soft spongy pockets or swellings in the roofing material. They occur between layers of felt or between the roof membrane and substrate. Air or moisture vapor entrapped within a blister expands as the roof and outside air temperatures rise.

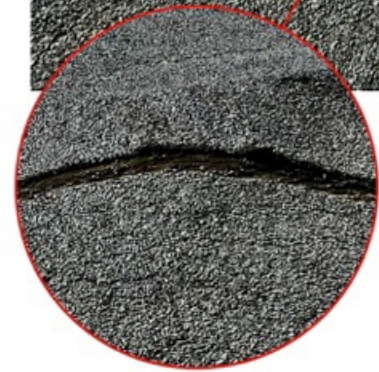
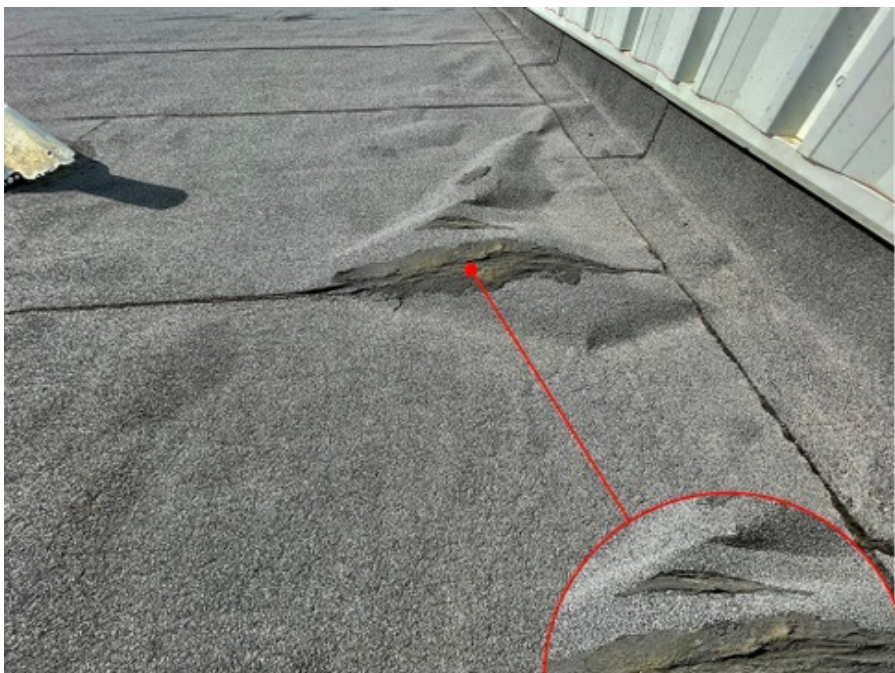
Photo 6

Blisters: Soft spongy pockets or swellings in the roofing material. They occur between layers of felt or between the roof membrane and substrate. Air or moisture vapor entrapped within a blister expands as the roof and outside air temperatures rise.

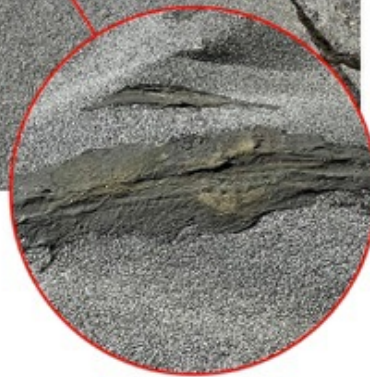
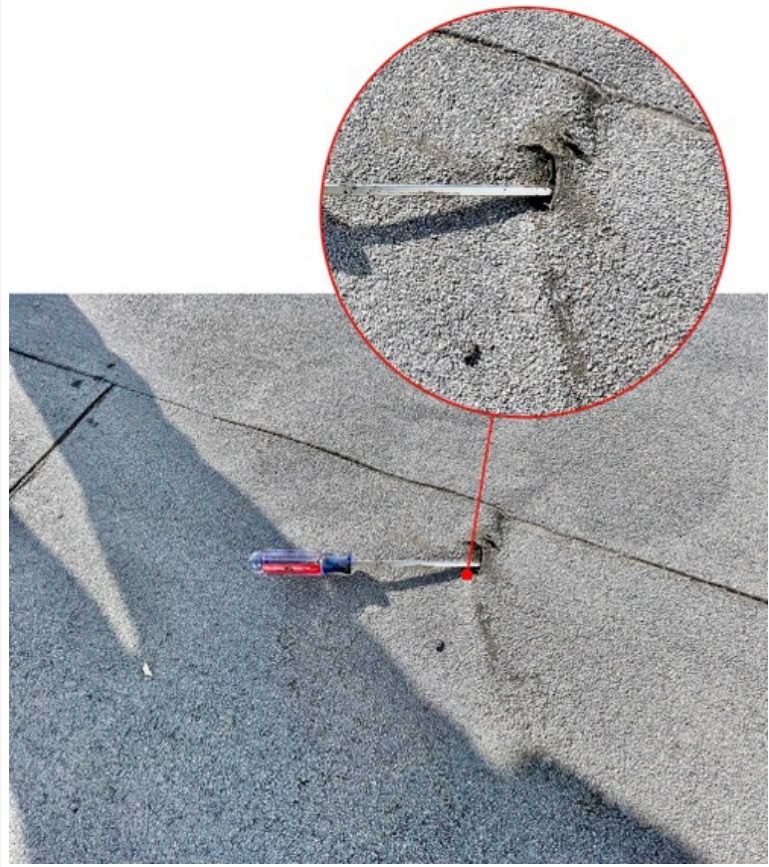
Photo 7

Membrane Puncture: Large puncture hole in waterproofing membrane allowing for moisture access the building.

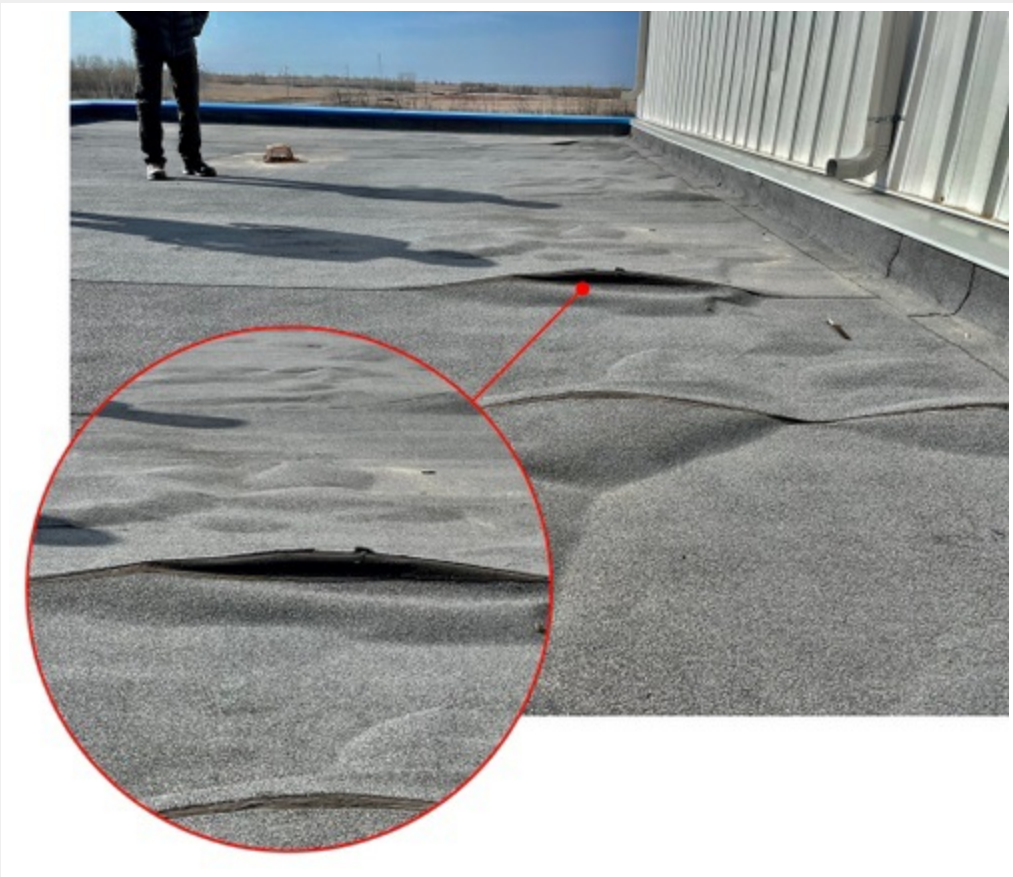
Photo 8

Seams: As the membrane blisters, this puts added stress on the seams. They are starting to split in many places allowing for moisture access into the building.

Blisters: Soft spongy pockets or swellings in the roofing material.

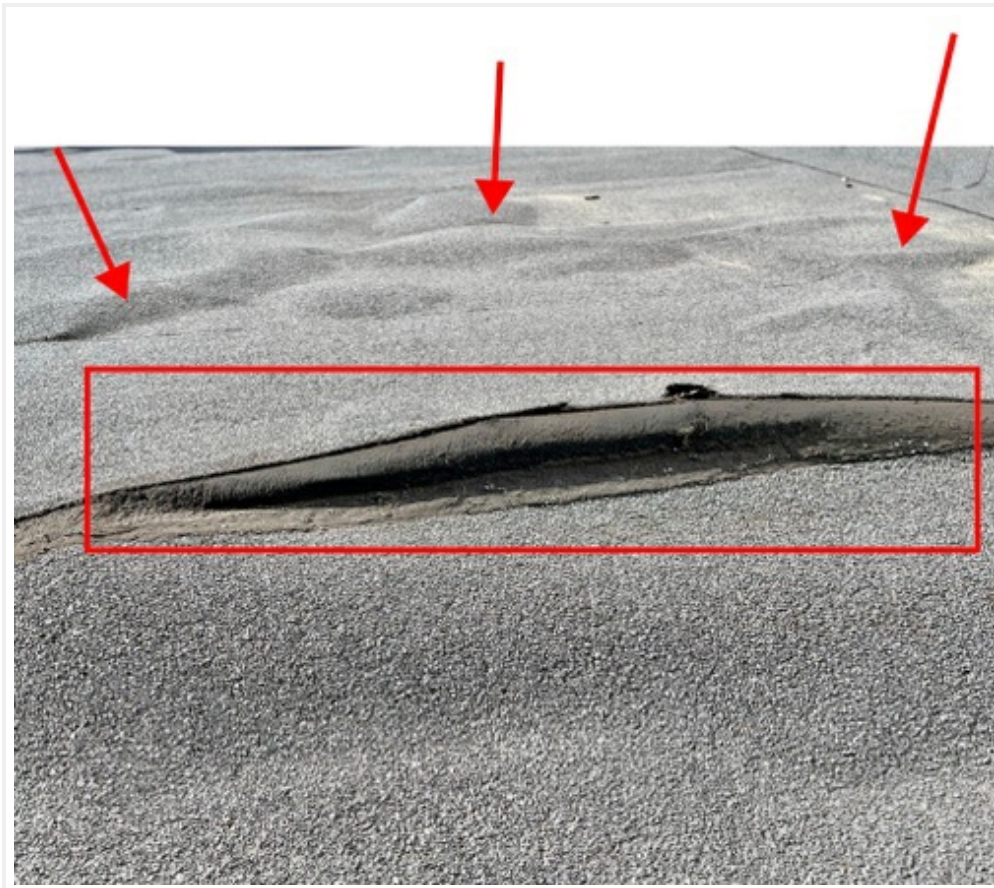
Photo 9

Seams: As the membrane blisters, this puts added stress on the seams. They are starting to split in many places allowing for moisture access into the building.

Blisters: Soft spongy pockets or swellings in the roofing material.

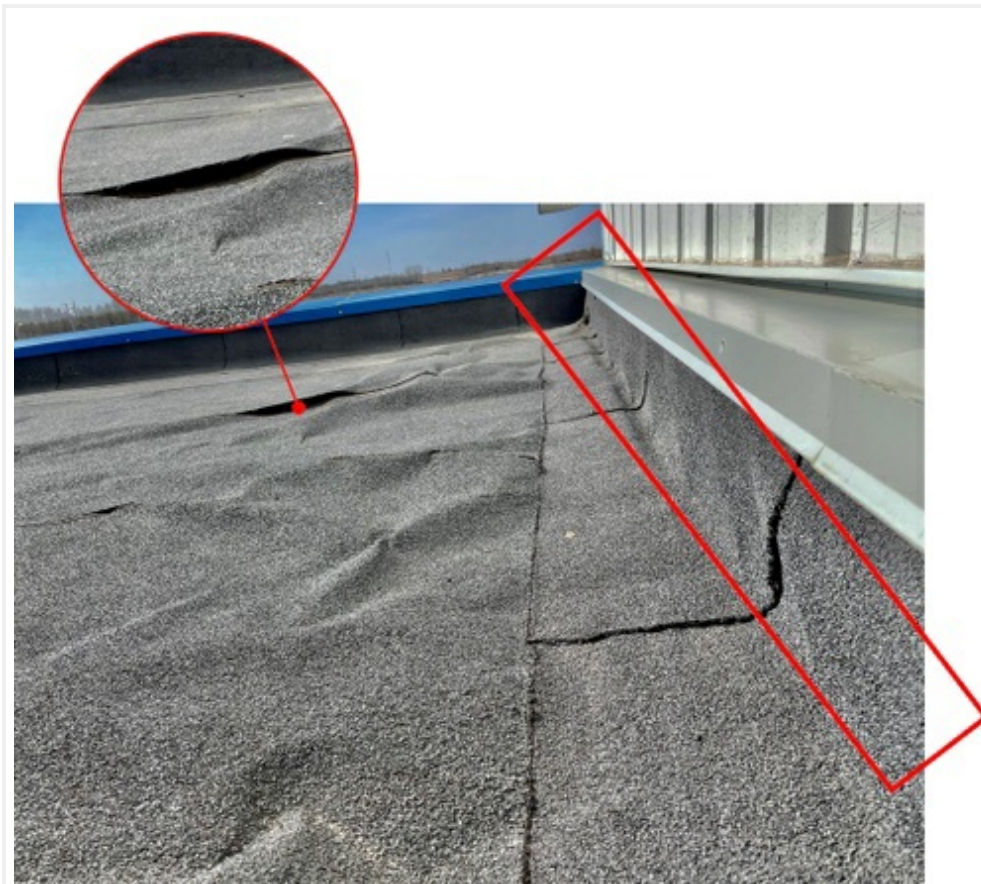
Photo 10

Blisters: Soft spongy pockets or swellings in the roofing material.

Perimeter Flashing

Deterioration: Most roof failures start at perimeter and penetration locations.

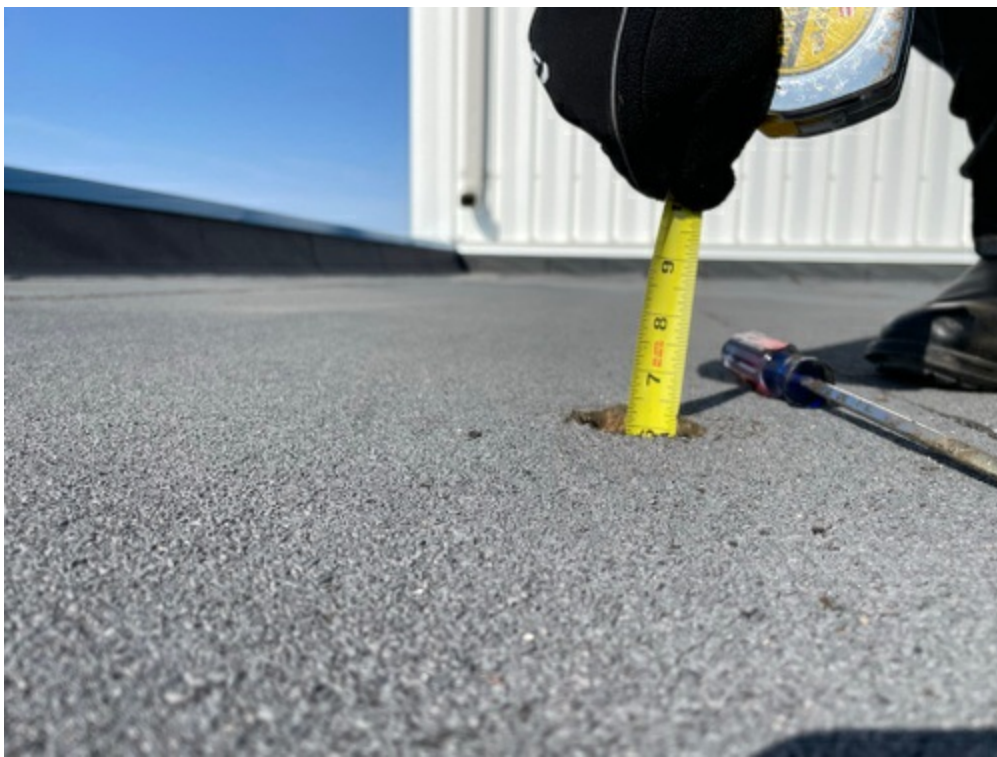
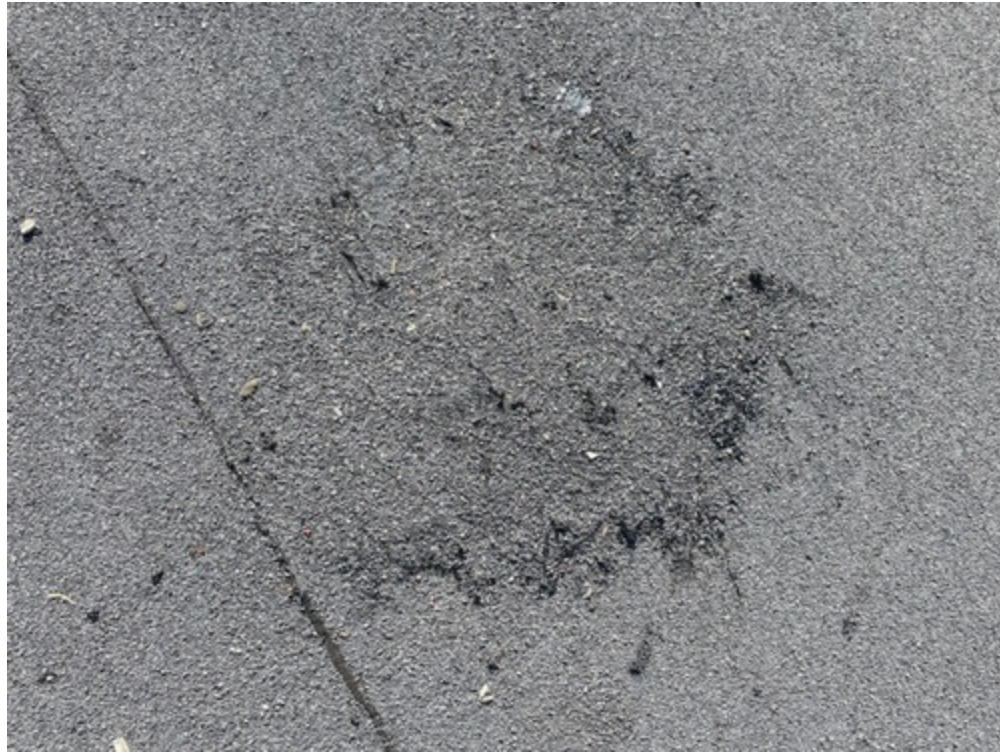
Photo 13

Core Cut: Repaired core cut using high-grade roof mastic imbedded with mesh to increase tensile strength of repair. Imbedded with gravel worn off of the membrane to help against UV.

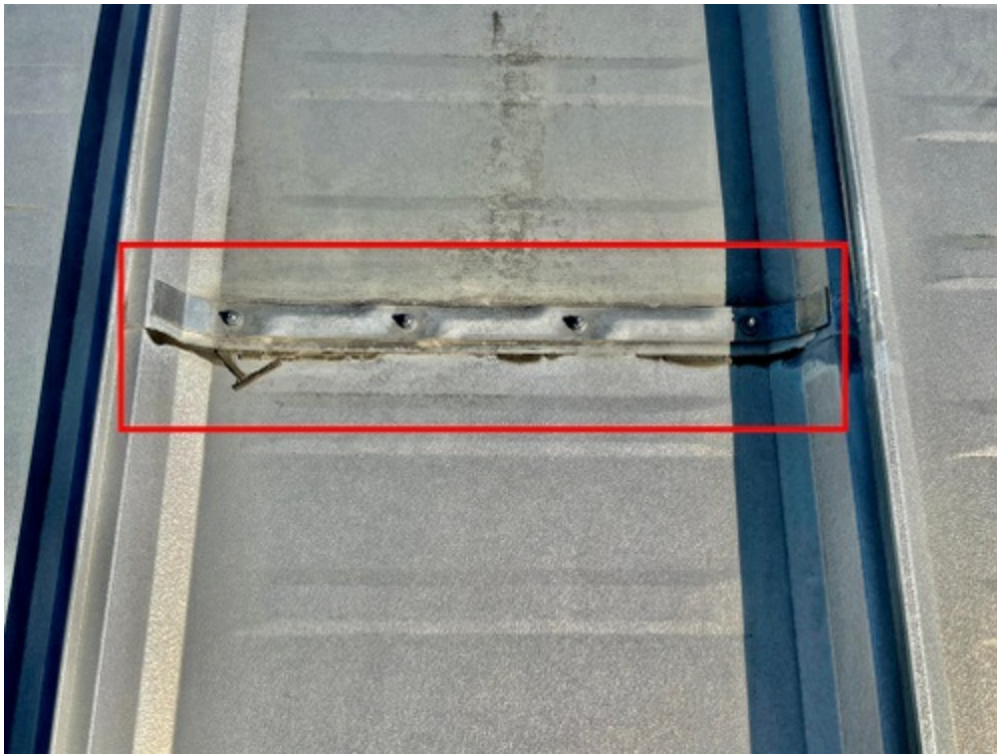
Photo 3

Ridge Cap Vent: Sealant around Ridge Cap Vent deteriorating allowing for potential moisture access.

1. Seal all vertical seams using a high performance polyester-faced adhesive tape followed by a coat of a fluid applied waterproofing system to insure the seams stay water tight
2. Seal all horizontal seams using a high performance polyester-faced adhesive tape followed by a coat of a fluid applied waterproofing system to insure the seams stay water tight
3. Seal all ridge cap seams using a high performance polyester-faced adhesive tape followed by a coat of a fluid applied waterproofing system to insure the seams stay water tight
4. Reinforce all previous seam repairs seams using a high performance polyester-faced adhesive tape followed by a coat of a fluid applied waterproofing system to insure the seams stay water tight
5. Reinforce all penetrations using a high performance polyester-faced adhesive tape followed by a coat of a fluid applied waterproofing system

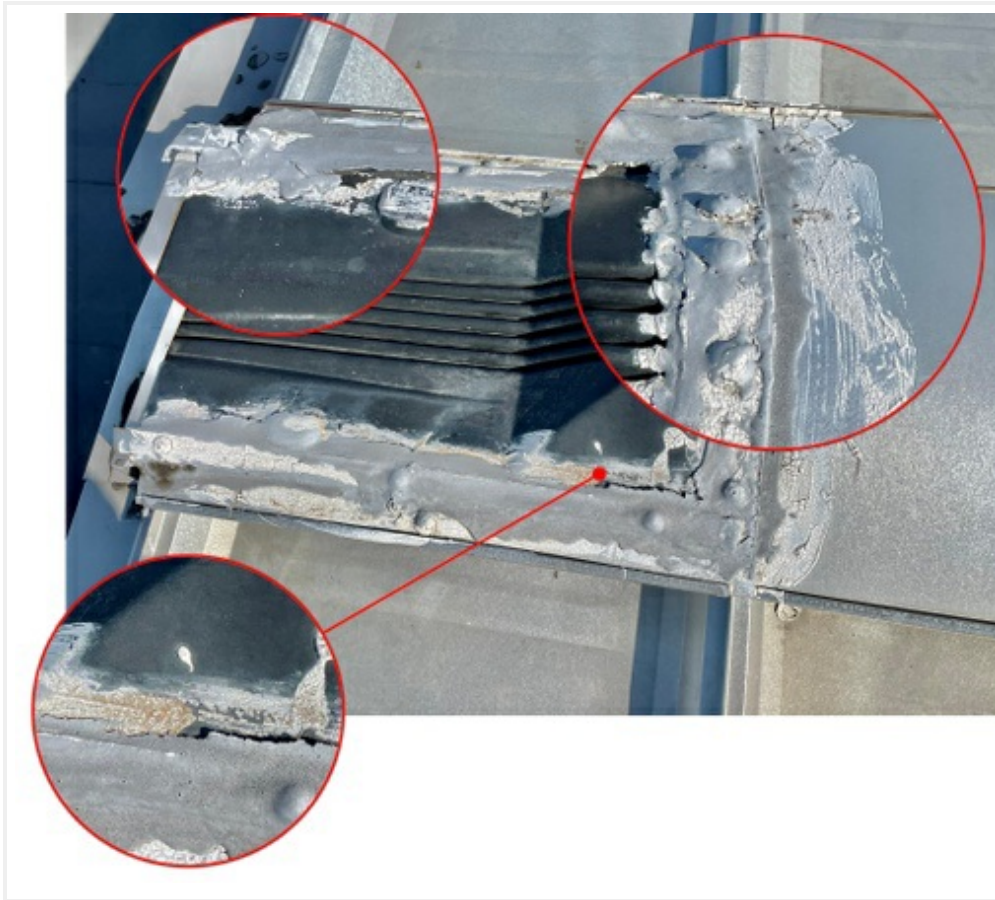
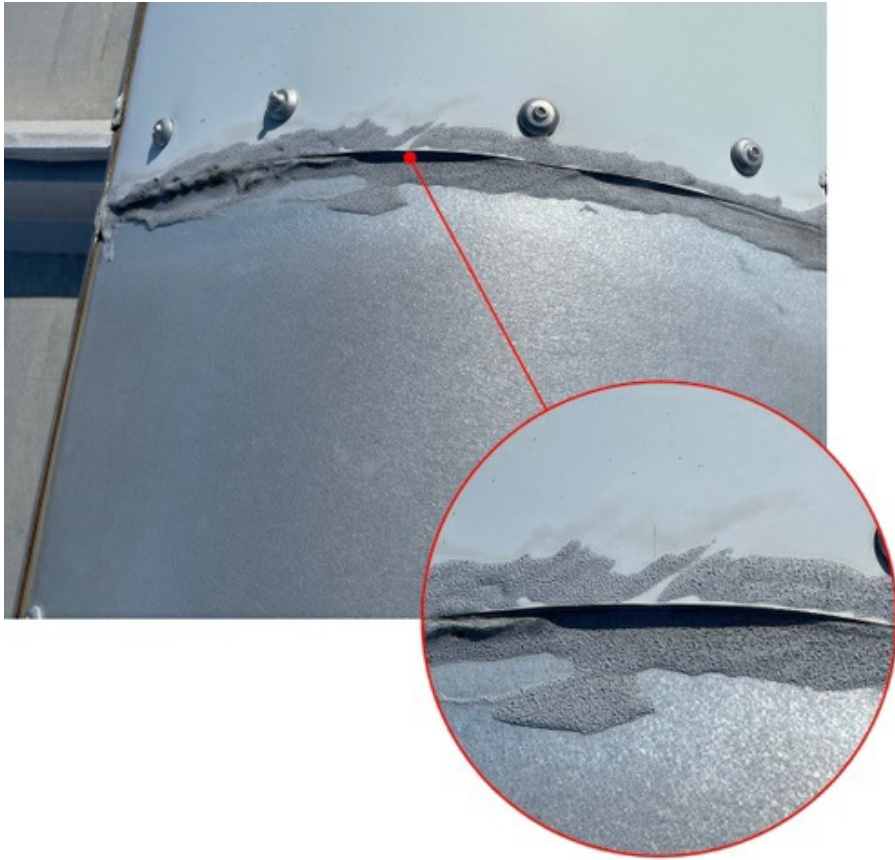
Photo 4

Ridge Cap Seam Caulking

Deterioration: As caulking is exposed to UV rays and temperature fluctuations it loses its flexibility and develops cracks. Once this occurs splits develop allowing water to penetrate walls and buildings causing damage as well as leaks.

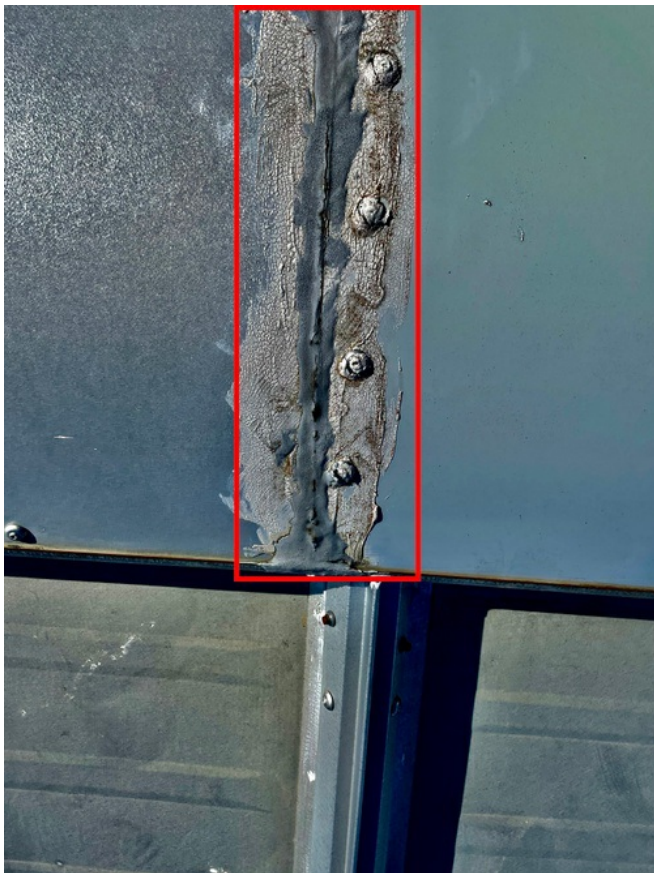
Photo 5

Ridge Cap Seam Caulking Deterioration: As caulking is exposed to UV rays and temperature fluctuations it loses its flexibility and develops cracks. Once this occurs splits develop allowing water to penetrate walls and buildings causing damage as well as leaks.

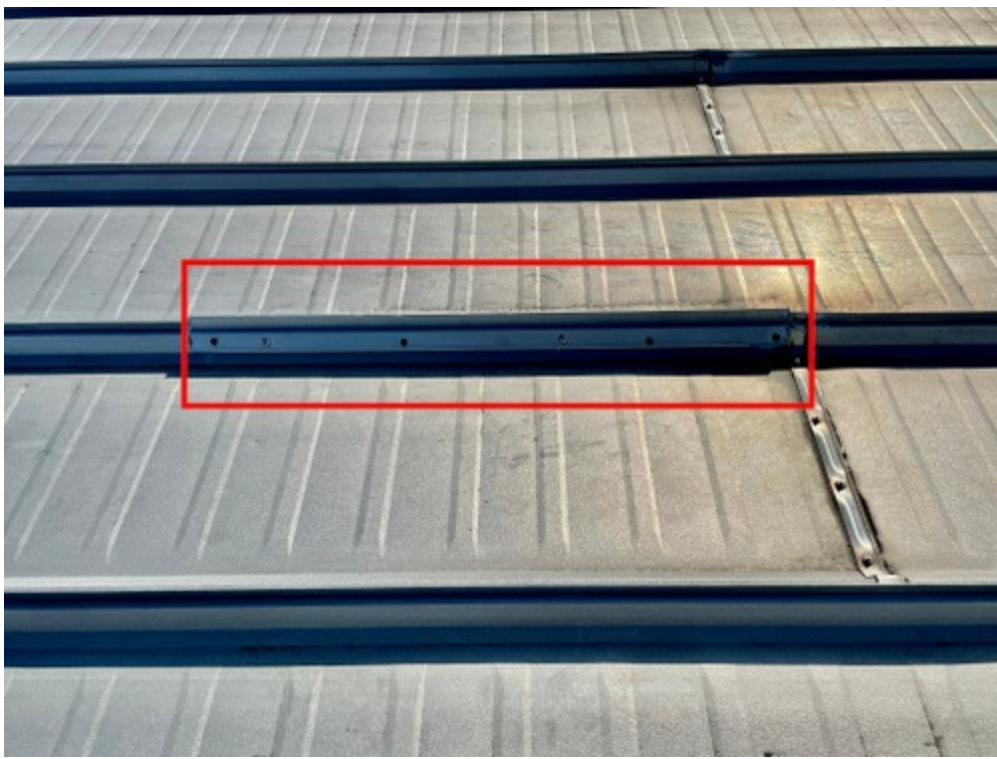
Photo 7

Previous Repair: Previous reinforcement of standing vertical seams found on several areas of the roof varying in length.

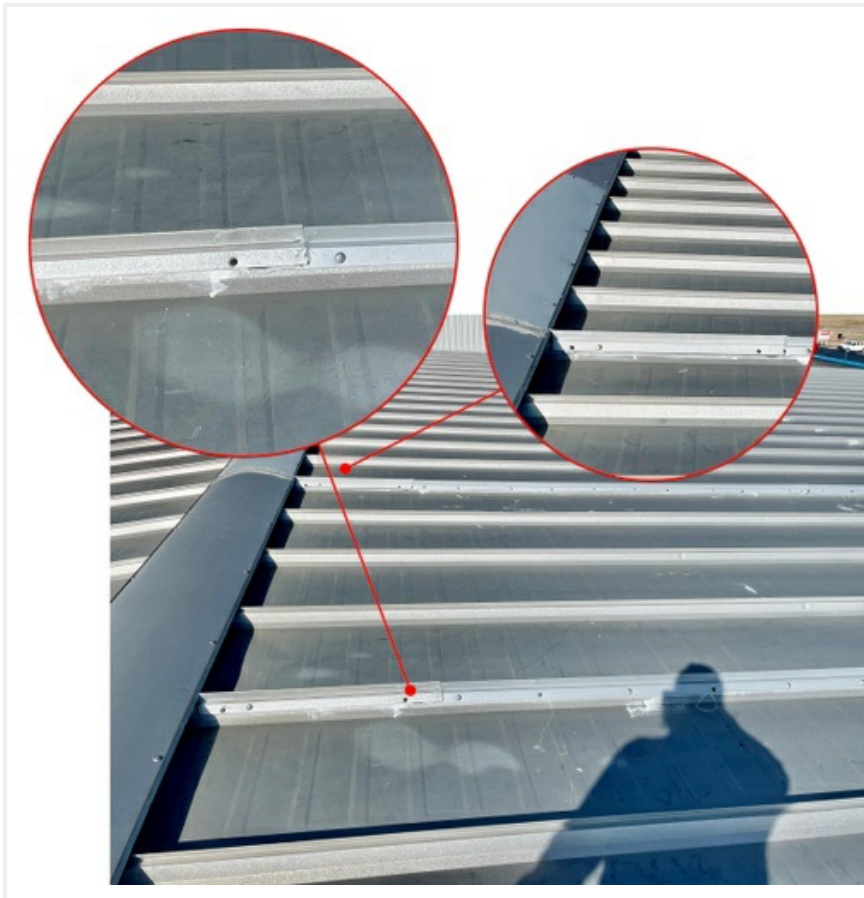
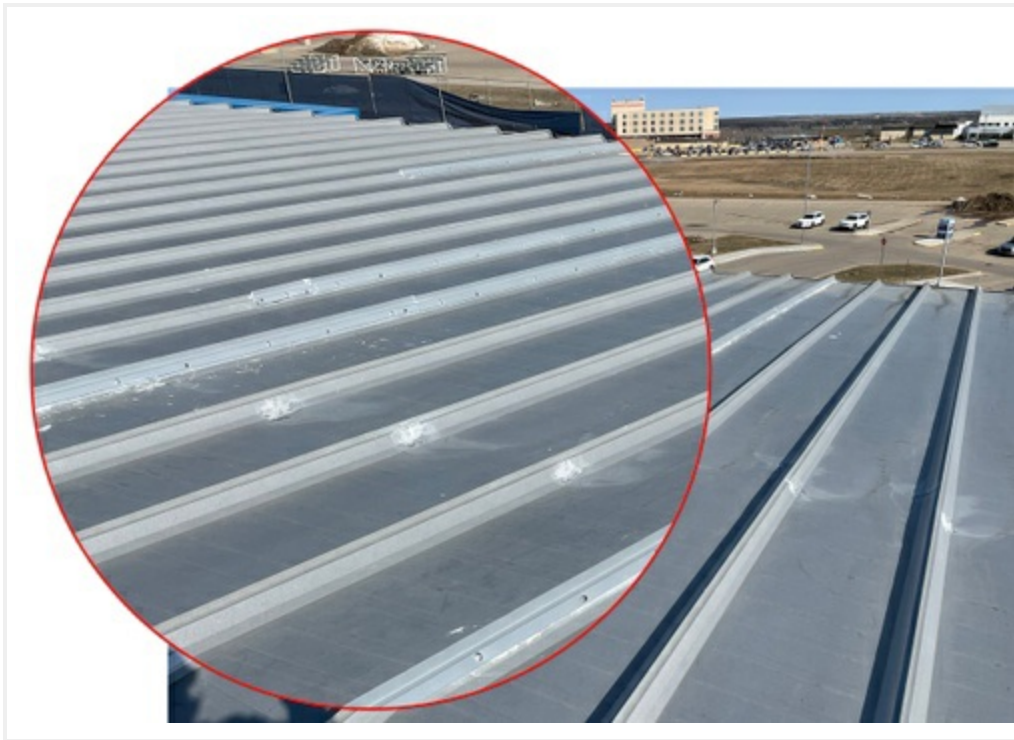
Photo 8

Previous Repair: Previous reinforcement of standing vertical seams found on several areas of the roof varying in length.

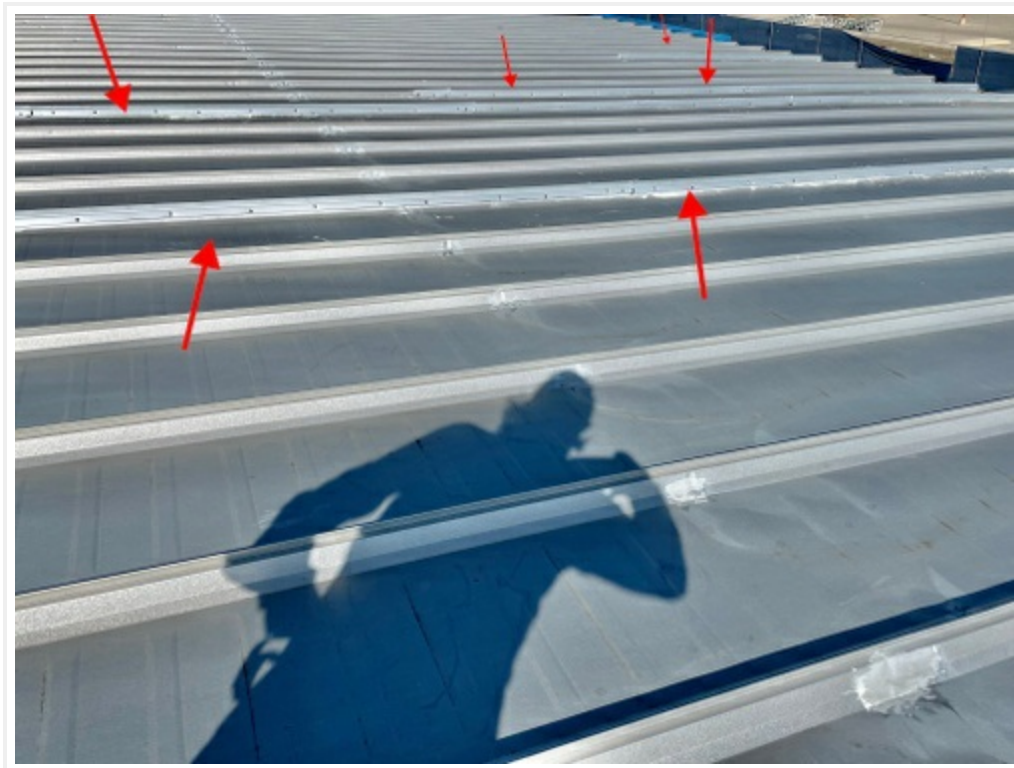
Photo 9

Previous Repair: Previous reinforcement of standing vertical seams found on several areas of the roof varying in length.
