Roof Asset Management Program

City of Prince Albert Library Roof Inspection

May 26, 2022

Title: Initial Inspection

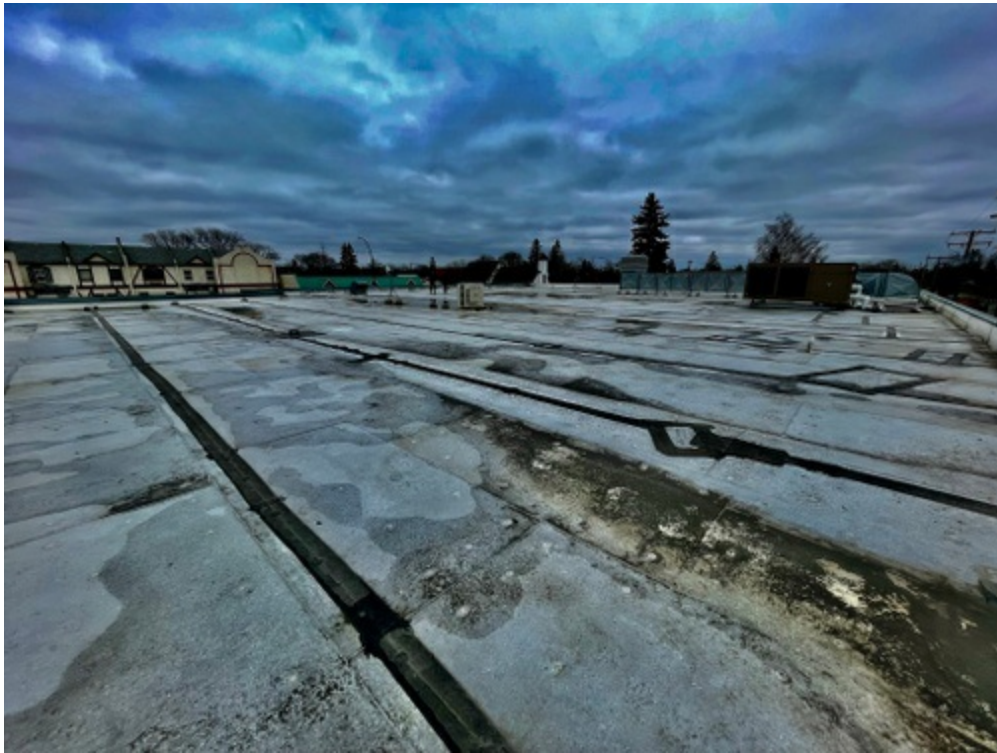
Photo 1

Library Roof - TPO

Overall Condition: Poor

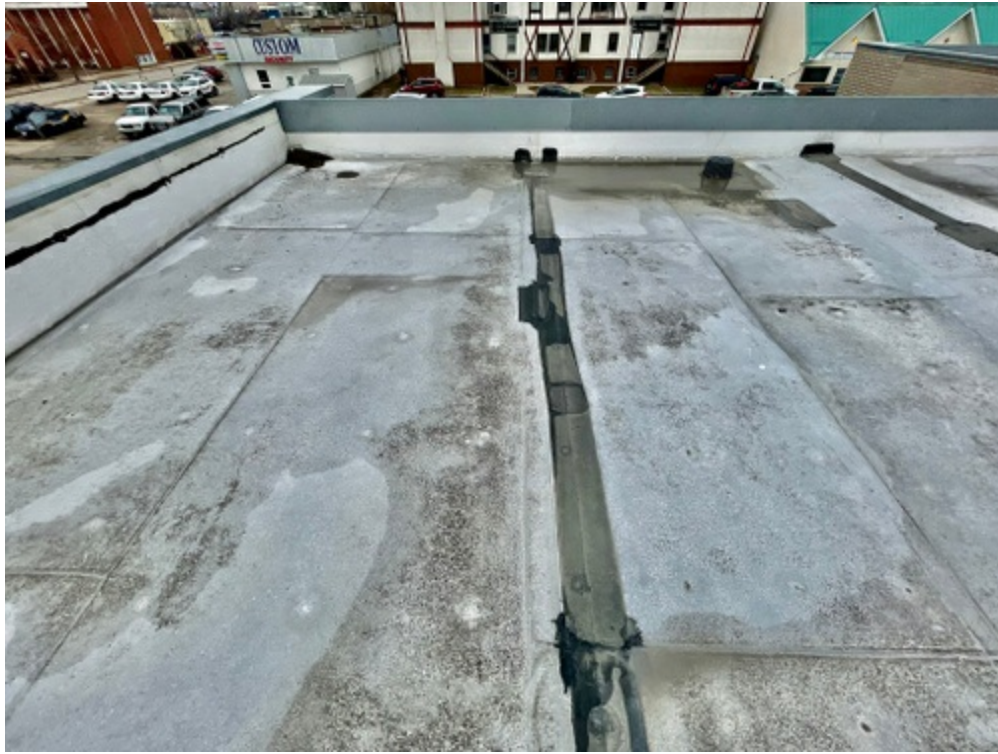
Photo 2

Previously reinforced seams,
approximately 10 years old.

- Powerwash/clean all applicable areas
- Apply White Stallion Base Coat over all previously reinforced seams at 32 wet mils
- Allow to dry for 24-48 hours
- Apply White Stallion Top Coat over seams at 32 wet mils
- Reinforce around plumbing stacks using same process
- Reinforce all previous patch repairs using same process
- Fill all pitch pockets using Garla-Flex mastic
- Remove all backed out fasteners from top of coping cap, fill holes with Tuff-Stuff caulking
- Re-fasten coping cap from side, rather than top
- Coat any fasteners starting to back out through the TPO using the same White Stallion Process.
- Ensure all drains are free of debris and allowed to drain properly

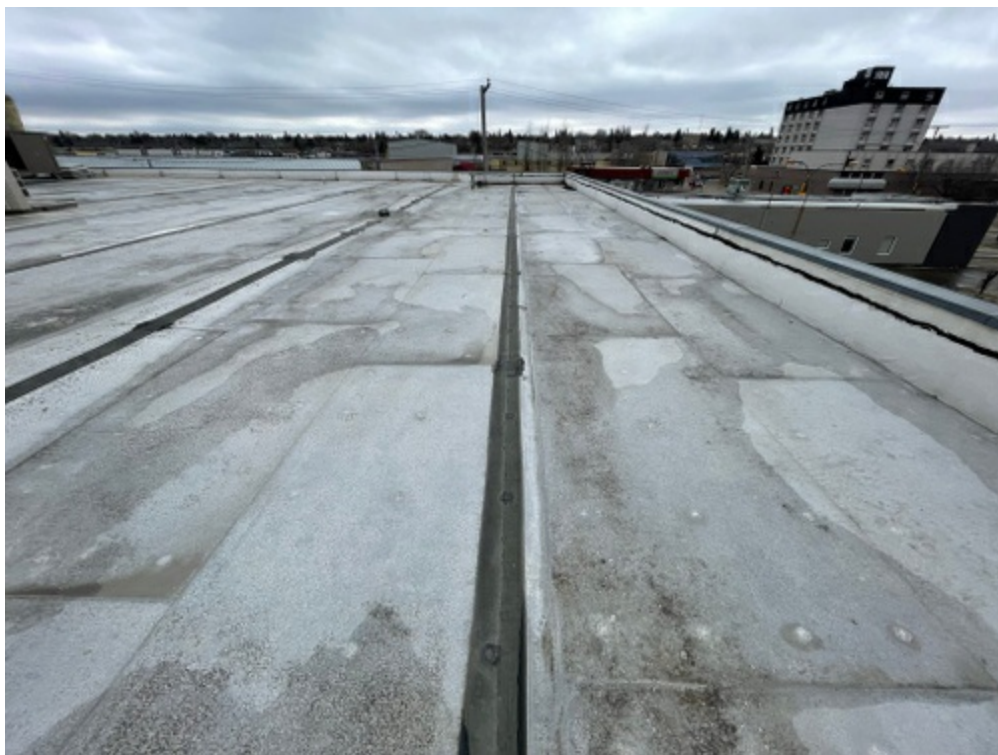
Photo 3

Previously reinforced seams,
approximately 10 years old.

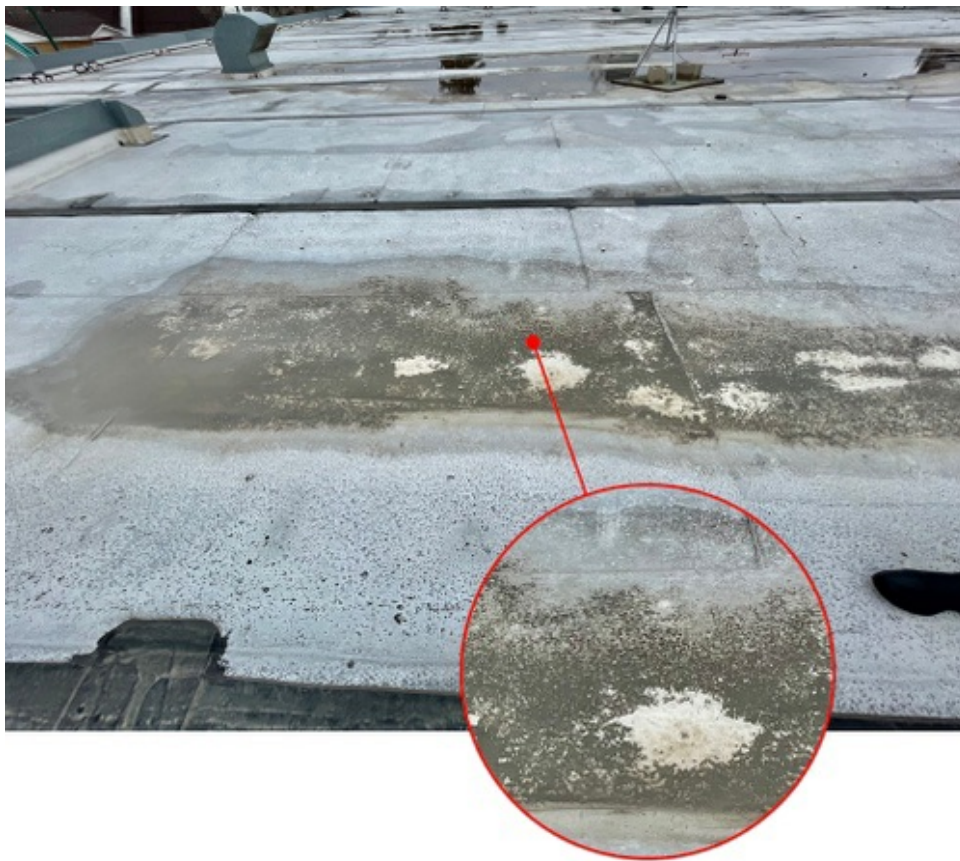
Photo 4

Fastener Back-Out: This condition can occur on mechanically fastened roof systems depending upon the location of the fastener. Typically this condition is found where the system configuration has the fastener immediately below the surface membrane. In these conditions thermal bridging and condensation from the thermal bridge creates a situation whereby the fastener begins to back out. Additionally, wind loads, incorrect fastener type for the substrate and dimensional instability of the insulation also contributes to this condition. In some cases, what appears to be fastener back out is actually insulation dimension loss typically due to the use of low density insulation and/or moisture contamination. Roof traffic can also create conditions that appear to be fastener back out as well. With fastener back out comes the high probability of the fastener puncturing the waterproofing surface membrane and eventually causing a leak. Proper design reduces or eliminates fasteners having direct contact with the surface membrane.

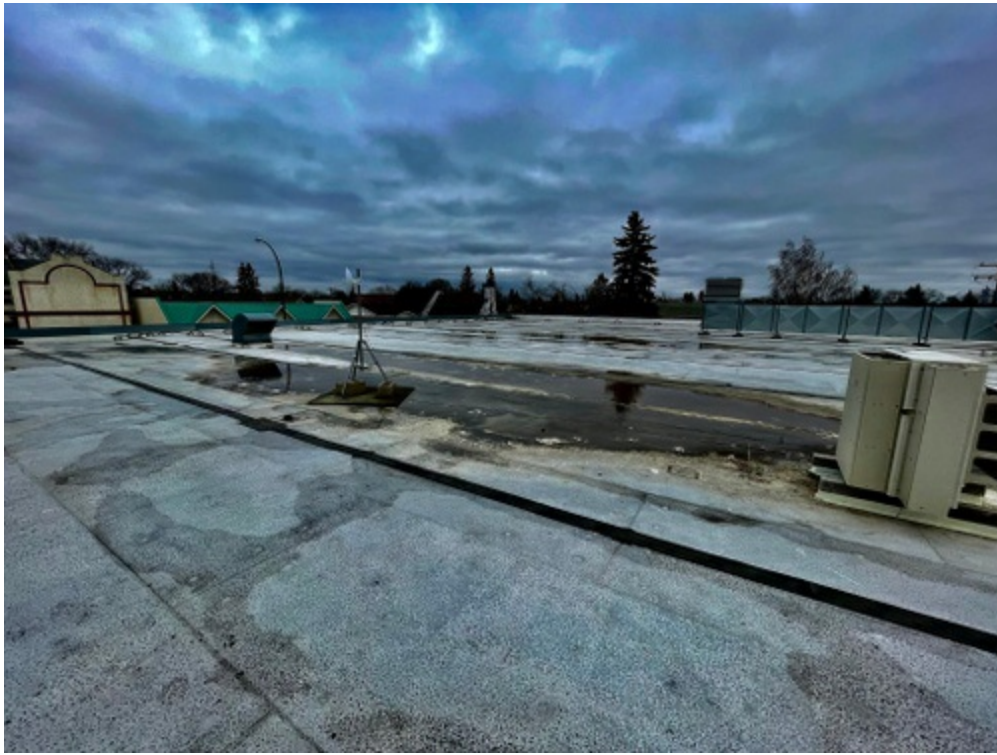
Photo 5

Ponding: Ponding water occurs when moisture collects in large pools on the surface of a roof system. These pools begin to form due to the following: 1) roof drains are blocked or clogged with debris, 2) the insulation package has lost dimensional stability and has reduced in thickness, 3) poor slope to drain design via overbuilt crickets or tapered insulation system, 4) roof drains are

built along side building support columns which maintain a consistent height under load while the balance of the roof system is applied over a live deck which tends to move and deflect under normal seasonal load. In all cases, roof depressions that collect and hold water will tend to grow in size as the added weight of the ponding water will continue to deflect the roof deck even further.

This condition can damage the roof in a number of ways. Additional structural loads create more movement of the roof assembly creating more tear stress and of course a potential for structural failure. UV intensity also increases under ponding conditions as the sun's rays are increased to the point where it accelerates deterioration in most all roof systems. In asphalt based assemblies the natural waterproofing oils in the asphalt will separate from the membrane if the system remains submerged under water for sustained periods. Single ply roof system rot and burn out when the ponding area is exposed to sunlight. The added weight can crush insulation increasing the ponding condition and creating a condition where the insulation becomes a useless thermal barrier. This condition then affects the mechanical system and the cost of heating and cooling the building. In the winter ponding water will expand as it freezes. This expansion will weaken small imperfections in the roof system. Small cracks and tears will widen until they rupture to allow

water into the building. And finally, a negatively deflected deck becomes a structural concern.

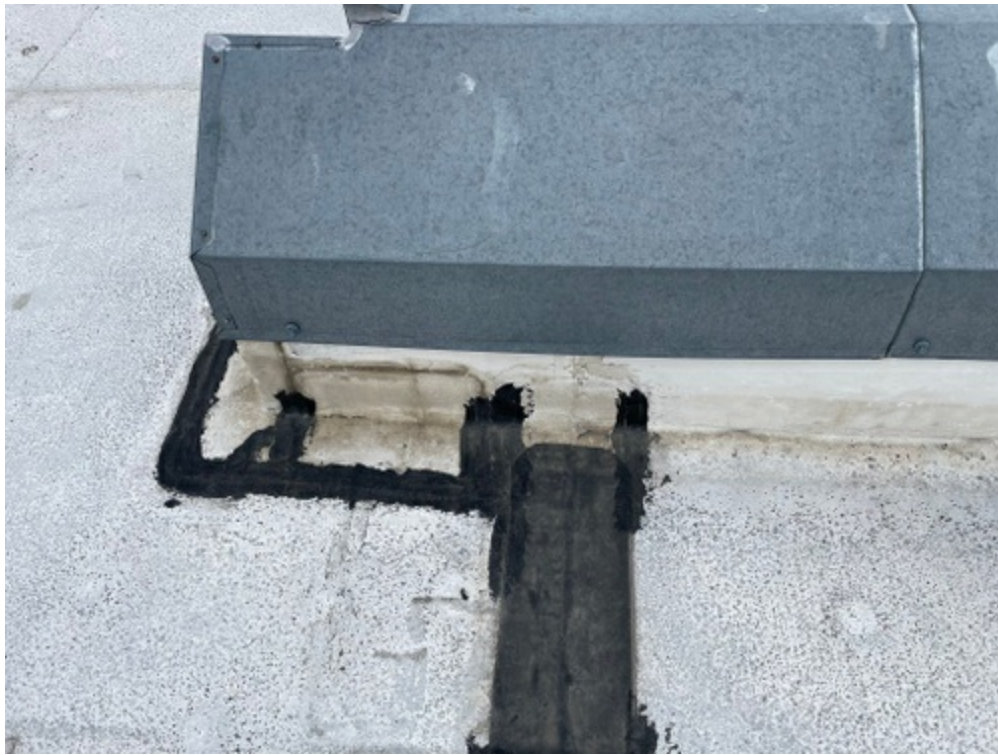
Photo 6

Previously reinforced seams, approximately 10 years old.

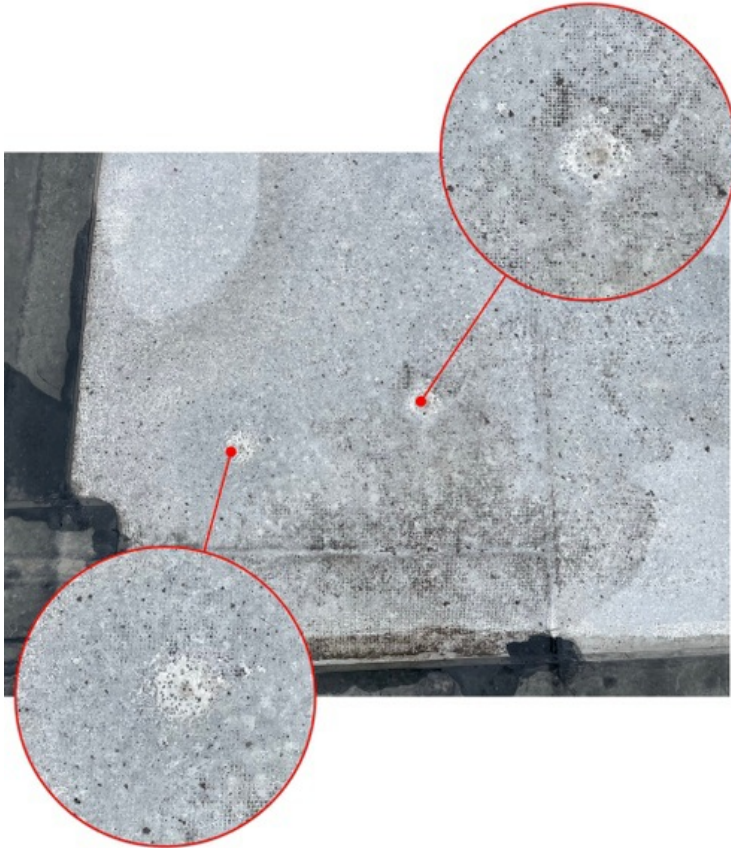
Photo 7

Fastener Back-Out: This condition can occur on mechanically fastened roof systems depending upon the location of the fastener.

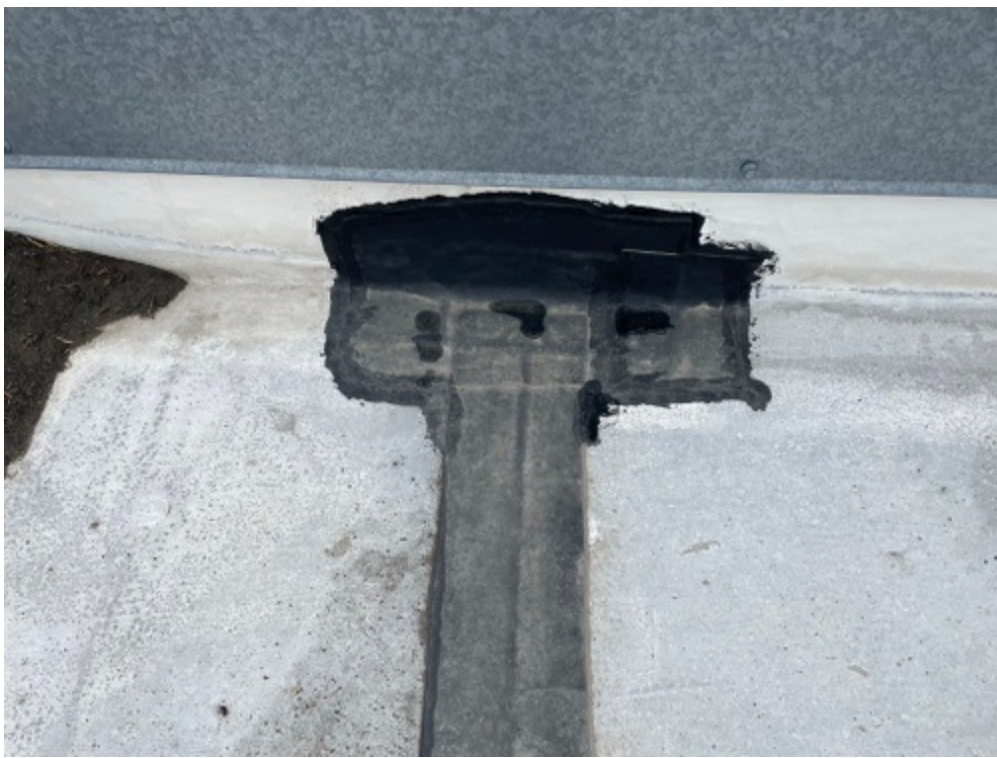
Photo 8

Previously reinforced seams, approximately 10 years old.

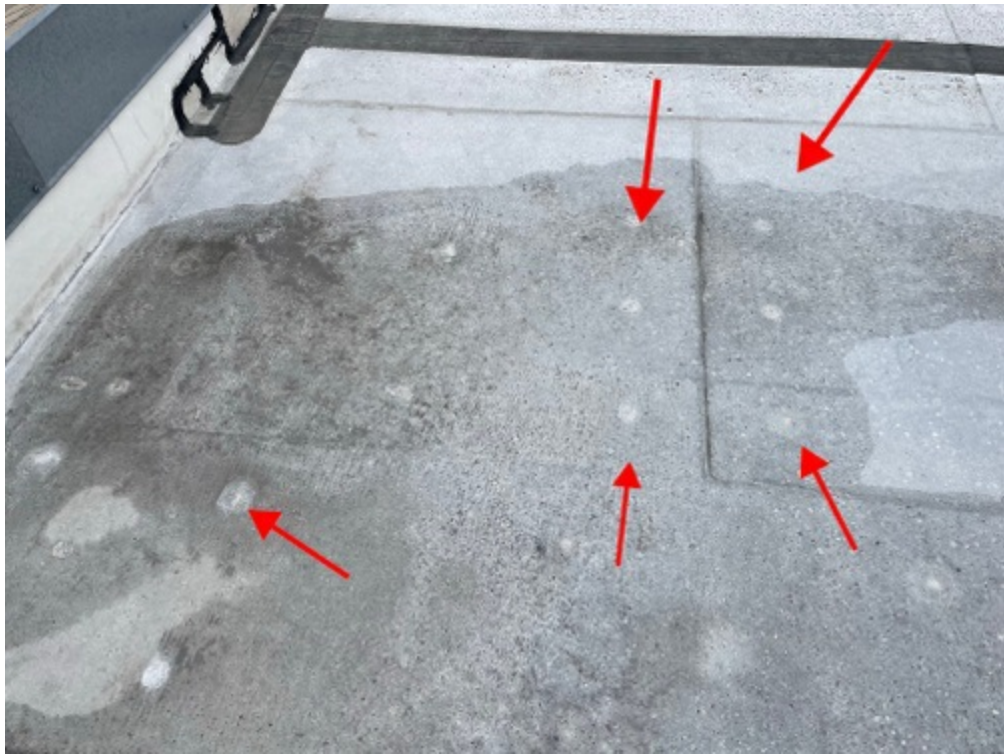
Photo 9

Fastener Back-Out: This condition can occur on mechanically fastened roof systems depending upon the location of the fastener.

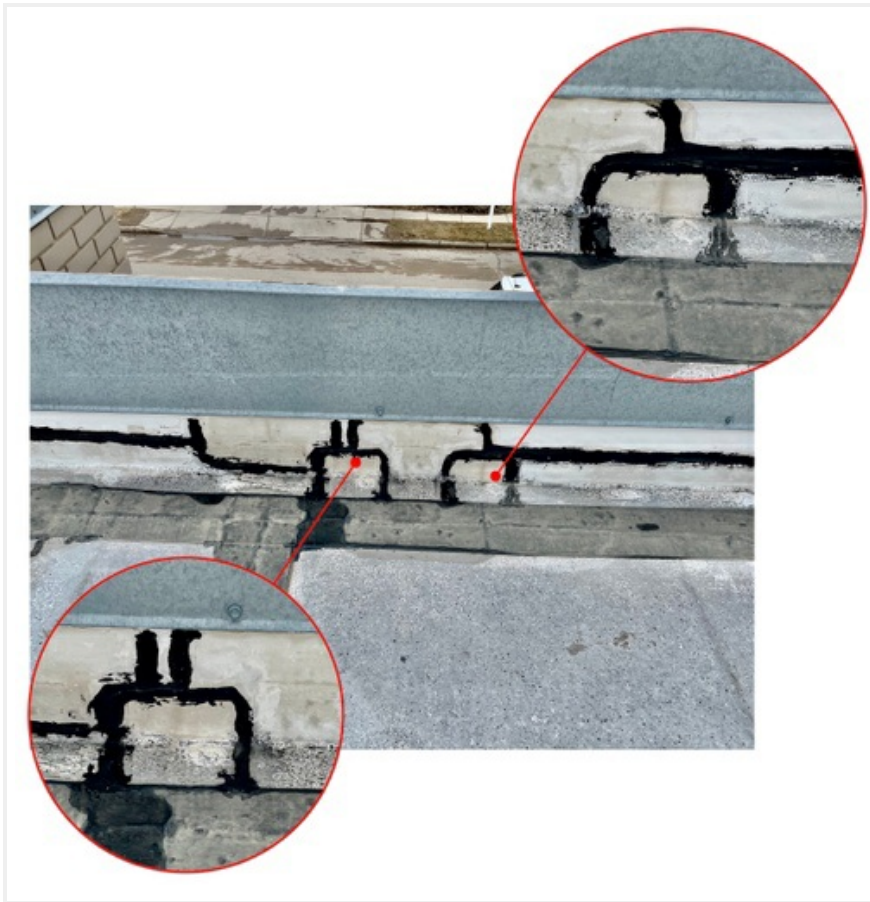
Photo 10

Previously reinforced seams, approximately 10 years old.

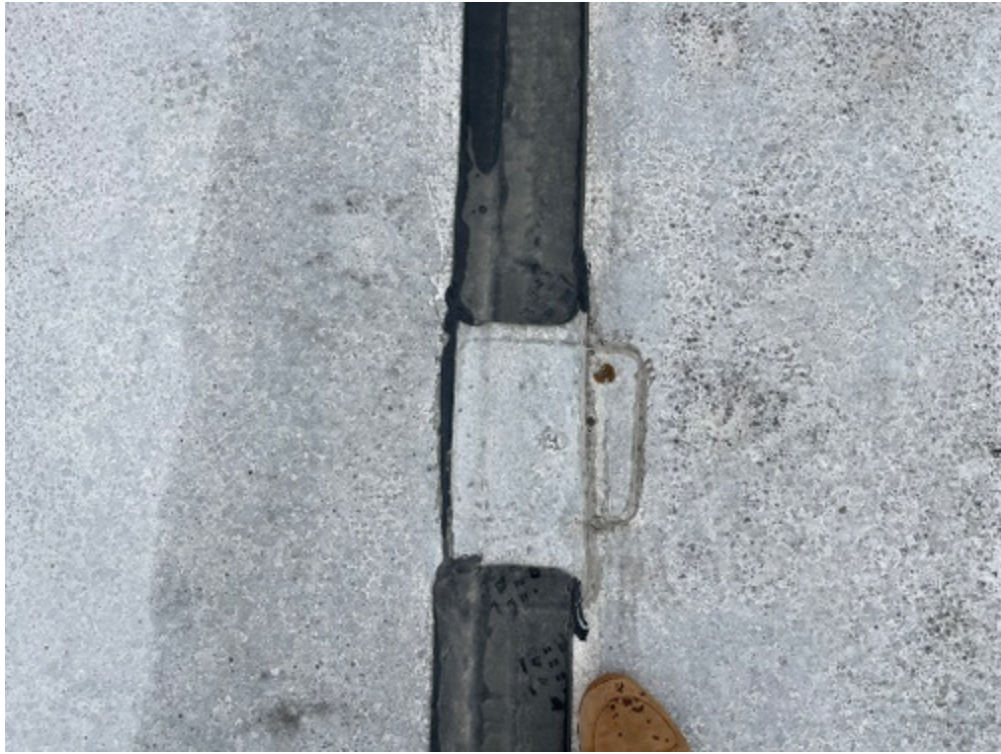
Photo 11

Previously reinforced seams, beginning to fail in spots.

- Powerwash/clean most deteriorated seams
- Apply Base Coat over identified seams at 32 wet mils
- Allow to dry for 24-48 hours
- Apply Top Coat over most deteriorated seams at 32 wet mils
- Reinforce around most effected plumbing stacks using same process
- Reinforce around any deteriorated previous repairs using same process
- Fill deteriorated pitch pockets using Garla-Flex mastic
- Ensure all drains are free of debris and allowed to drain properly

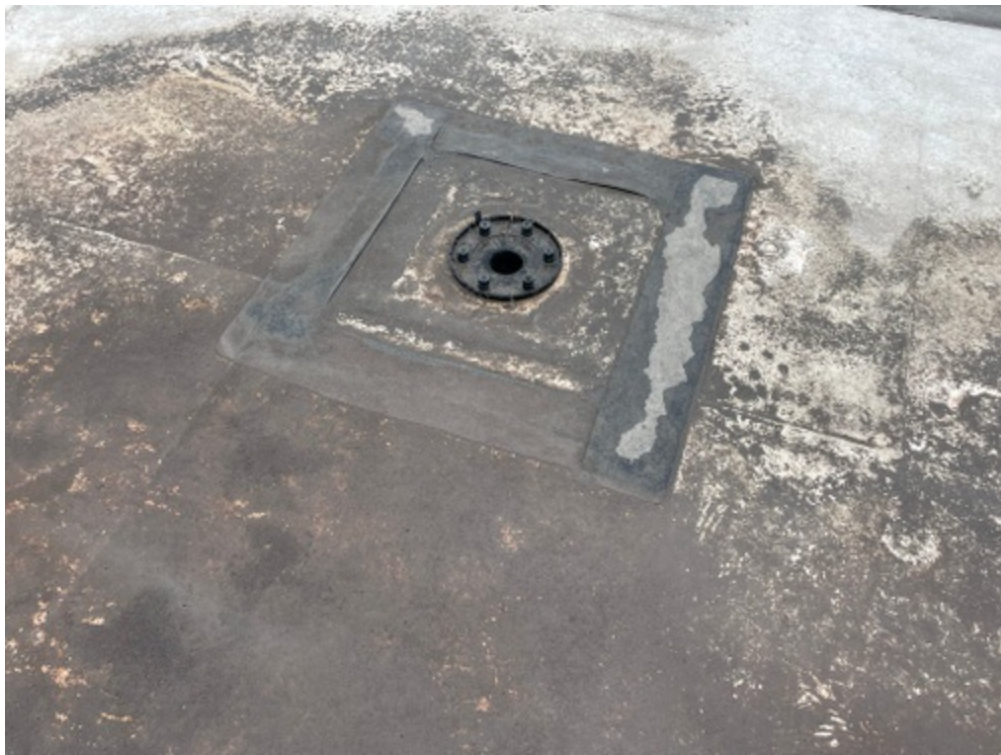
Photo 12

Drain Screen: Missing

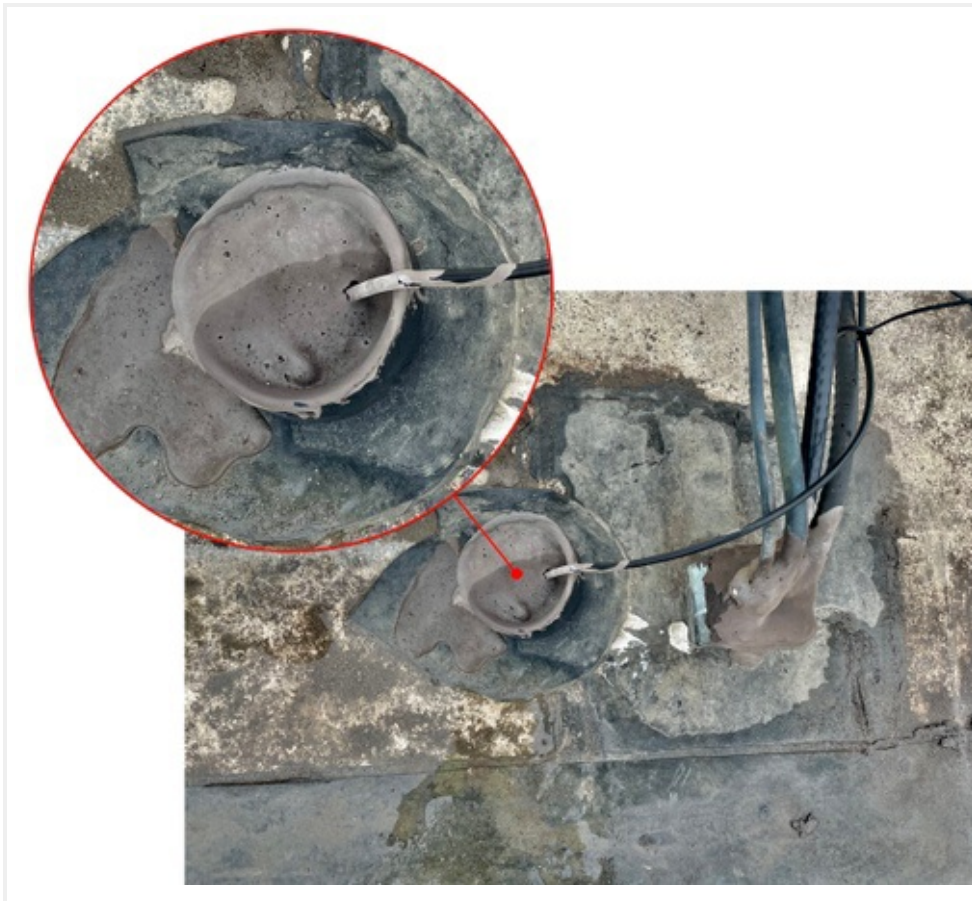
Photo 13

Pitch Pocket Deterioration:

Metal protrusions that penetrate the roof system to allow conduits to run from the rooftop into the building. Movement from the protrusion can break the waterproofing compound, creating cracks. Over time, the release of solvents from the compound can cause the material to shrink, leaving gaps along the edges of the pan and around structural support. Water can enter through a defective pitch pan and find its way into the interior of the building. Moisture can also penetrate into the roof system leading to premature failure.

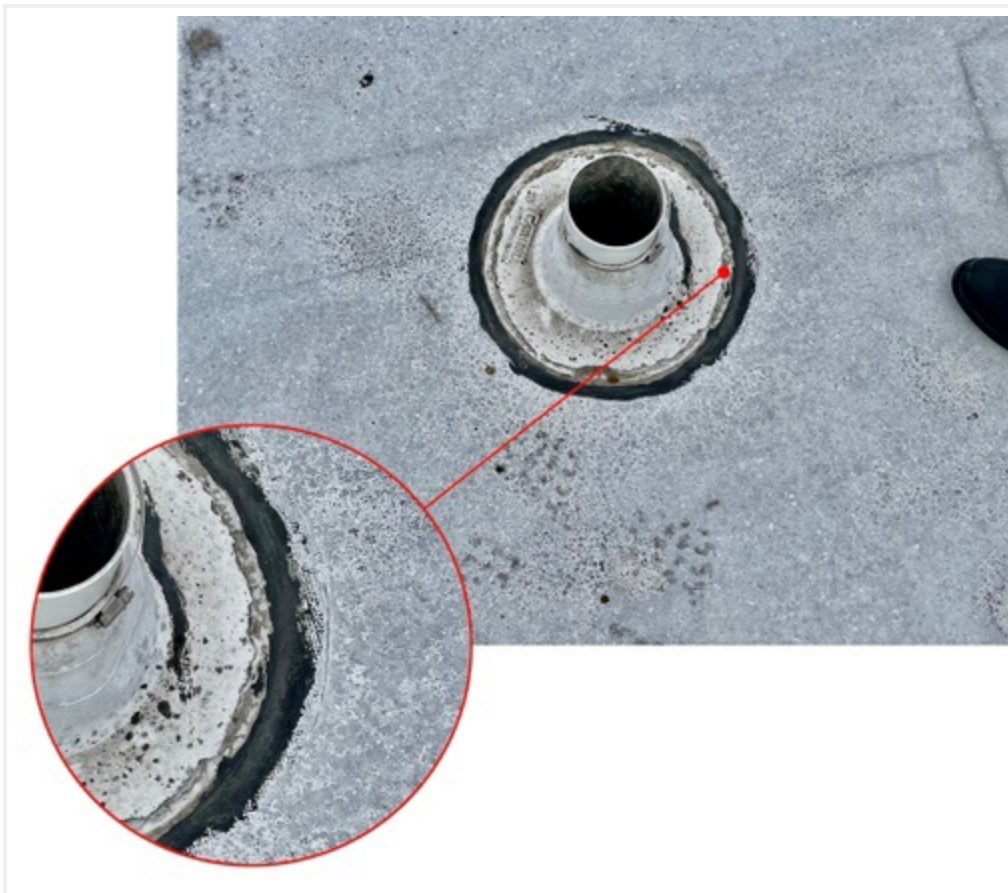
Photo 14

Penetrations:

Waterproofing around some penetrations beginning to deteriorate.

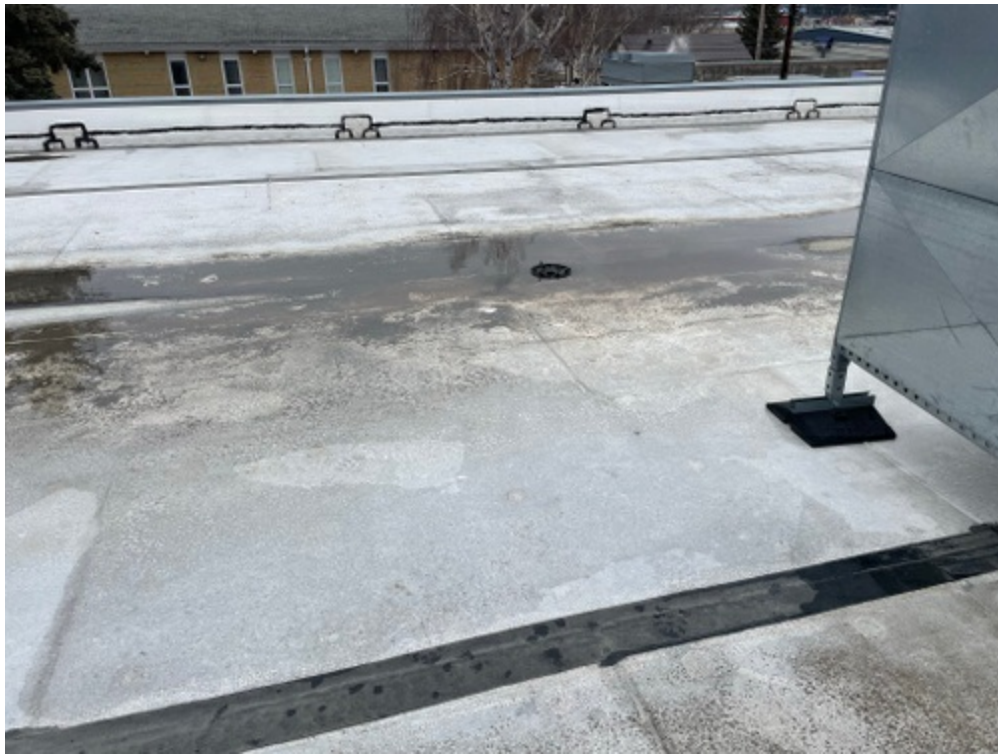
Photo 15

Ponding: Ponding water occurs when moisture collects in large pools on the surface of a roof system

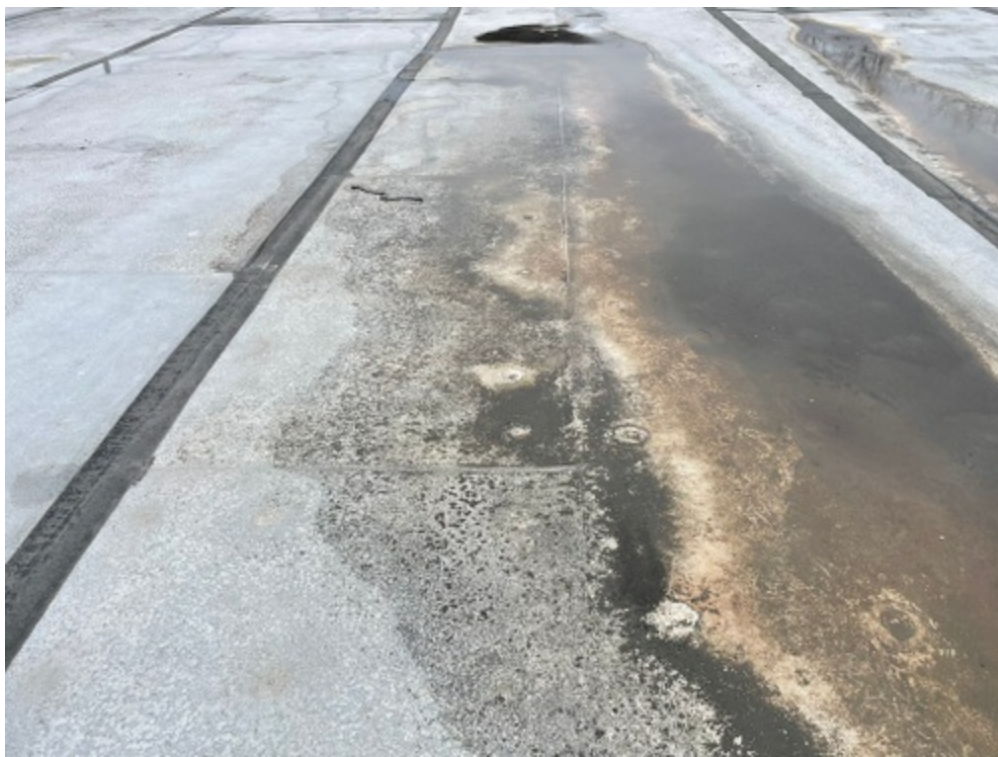
Photo 16

Ponding: Ponding water occurs when moisture collects in large pools on the surface of a roof system

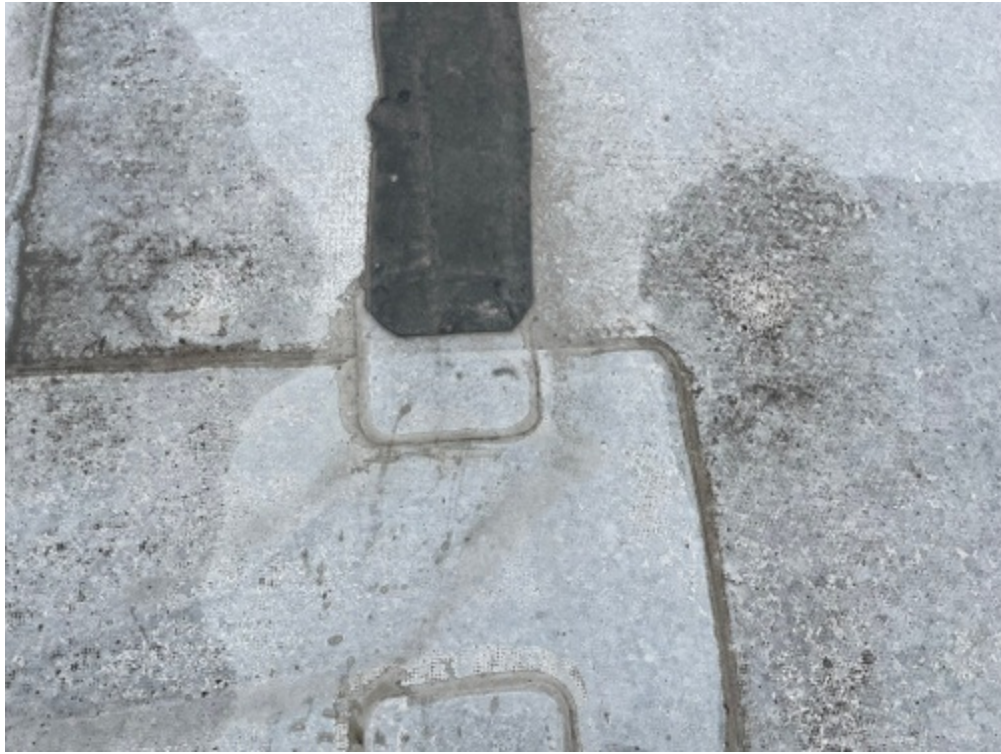
Photo 17

Previously reinforced seams, approximately 10 years old.

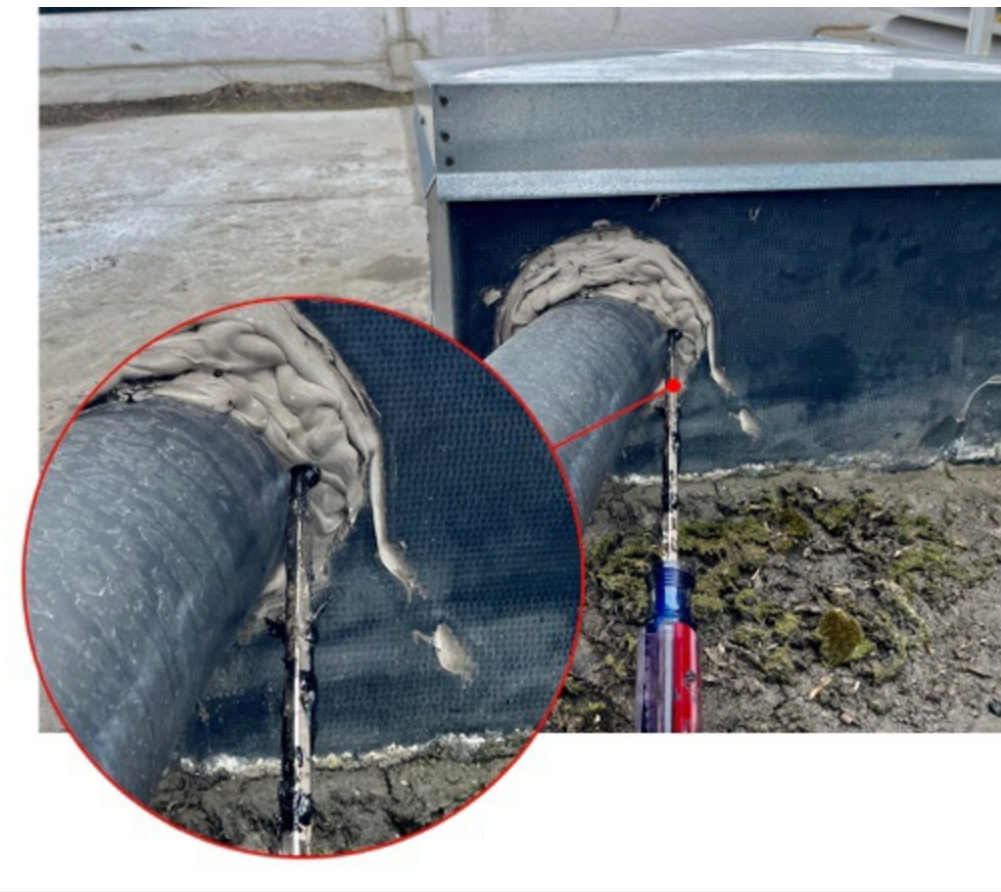
Photo 18

Caulking Deterioration: As caulking is exposed to UV rays and temperature fluctuations it loses its flexibility and develops cracks. Once this occurs splits develop allowing water to penetrate walls and buildings causing damage as well as leaks.

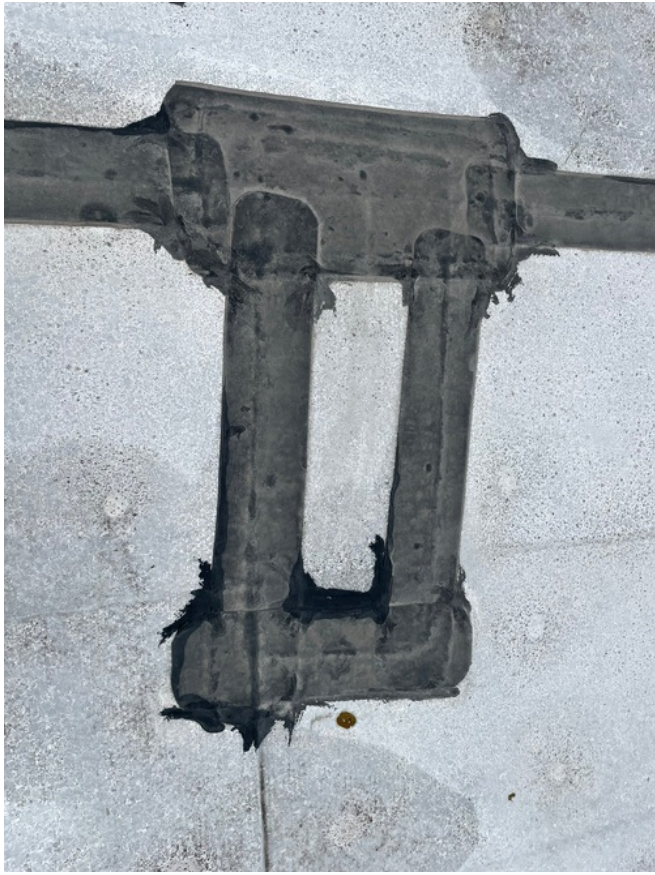
Photo 19

Previously reinforced seams, approximately 10 years old.

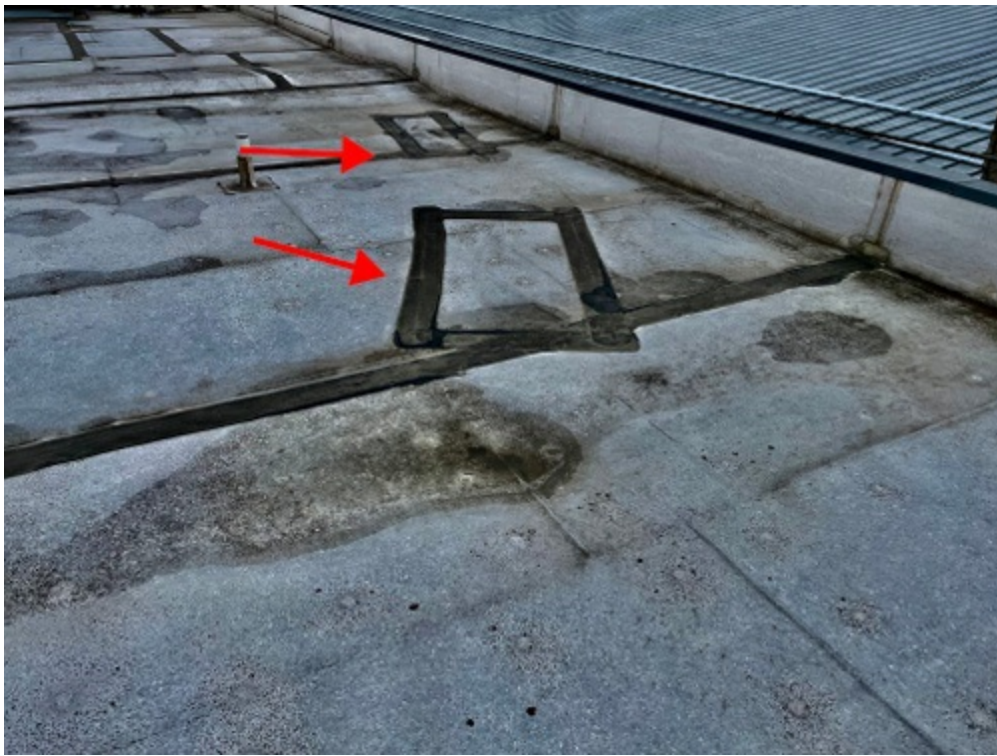
Photo 20

Previous patches.

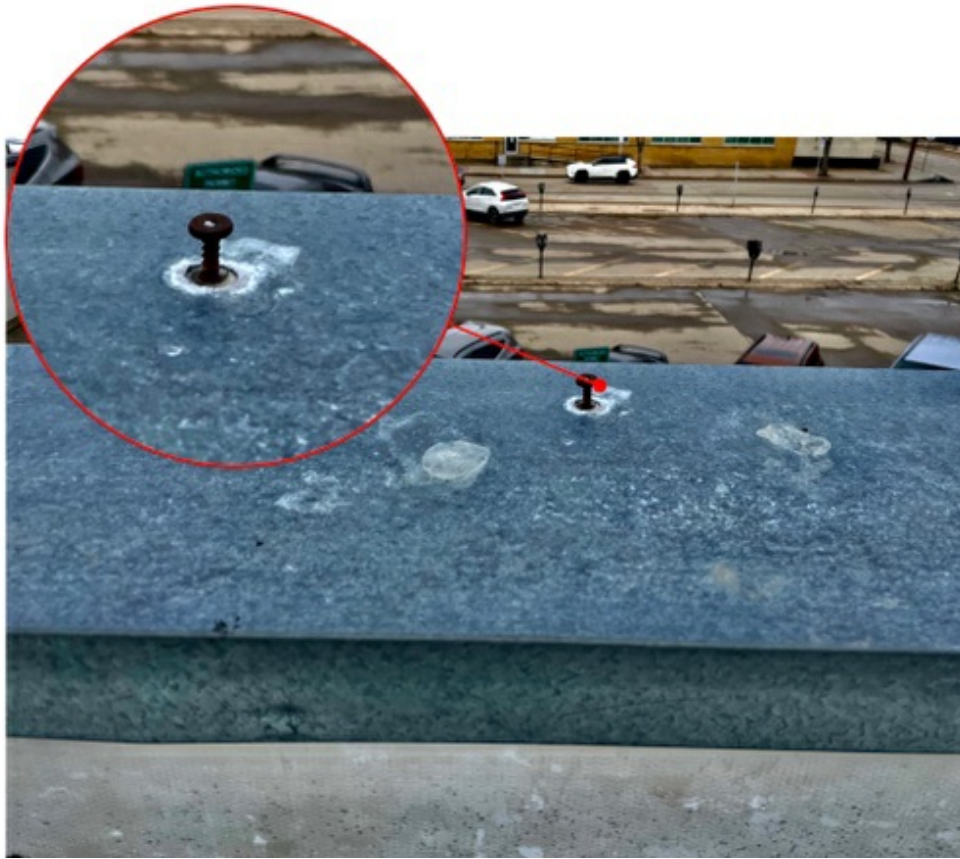
Photo 21

Fastener Back-Out: This is a common condition with through fastened metal roof systems. Metal expands and contracts at a higher rate than other building components. Seasonal expansion on a one foot section of metal typically exceeds 1,000 lb per foot. As most of the fasteners used with this system have about 300 lbs per foot shear resistance you would need more than three of these fasteners per foot to control the movement. Spacing typically is 8" – 12" on center in this application. This extra stress leads to two conditions 1) fastener back-out and 2) fastener shear or panel damage. The fasteners used are called cap screws and feature a neoprene grommet as the primary seal at the fastener penetration through the panel. Unfortunately these grommets typically dry out after 5-7 years creating a leak source at the fastener. Additionally there is an element of thermal bridging with the fastener that helps to exacerbate the condition. In this case water can then enter the building and walls leading to structural element damage.
