Roof Asset Management Program

City of Prince Albert - Police Station Roof Inspection

Report Date: 05/26/2022

Title: Police Station Initial Inspection

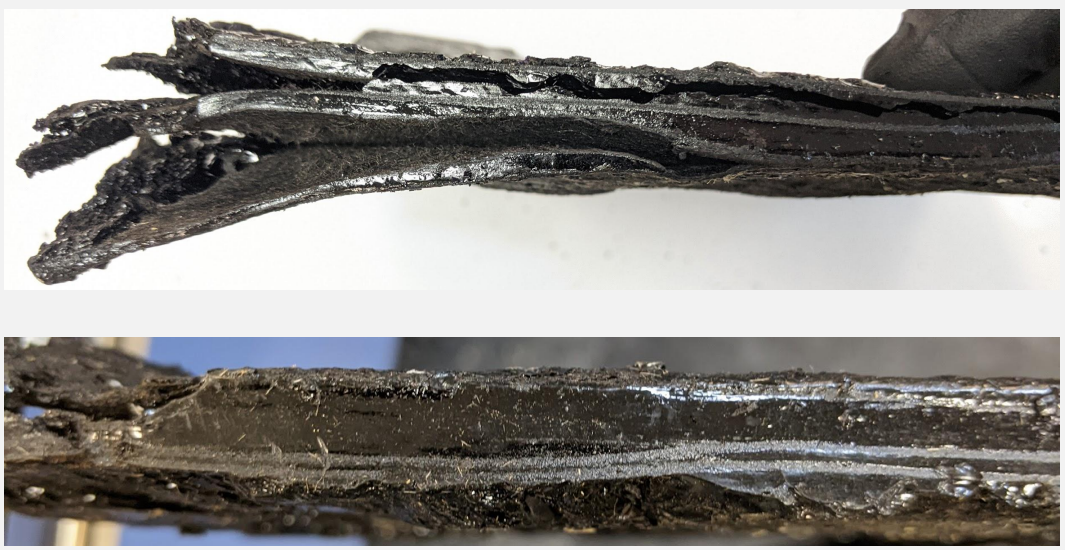
Figure 9: Police Station side profile.

The 30 year old core sample is from a 4 ply inverted roofing membrane assembly (IRMA) with felt paper interplies in an asphalt adhesive. The interplies were very easily delaminated by hand as shown in Figure 9. The interplies and overall thickness of the core imply that the system was installed at a lower than specified temperature resulting in thick, viscous layers. The thickest point of adhesive was measured at 125 mils. A typical interply thickness when installed correctly is between 32-40 mils. Due to the overall thickness of the core, specimens could not be cut for tensile, elongation, and flexural strength. A surface coating was used on the membrane, which is unusual for an IRMA system. Instead, a final layer such as paving stones typically protect the membrane from the elements. The softening point and pen tests show that the asphalt adhesive and flood coat responsible for keeping the system intact has lost its oils over time, causing the system to become more brittle. The sample performed well when undergoing puncture testing, implying that the system can withstand foot traffic and most weather phenomena.

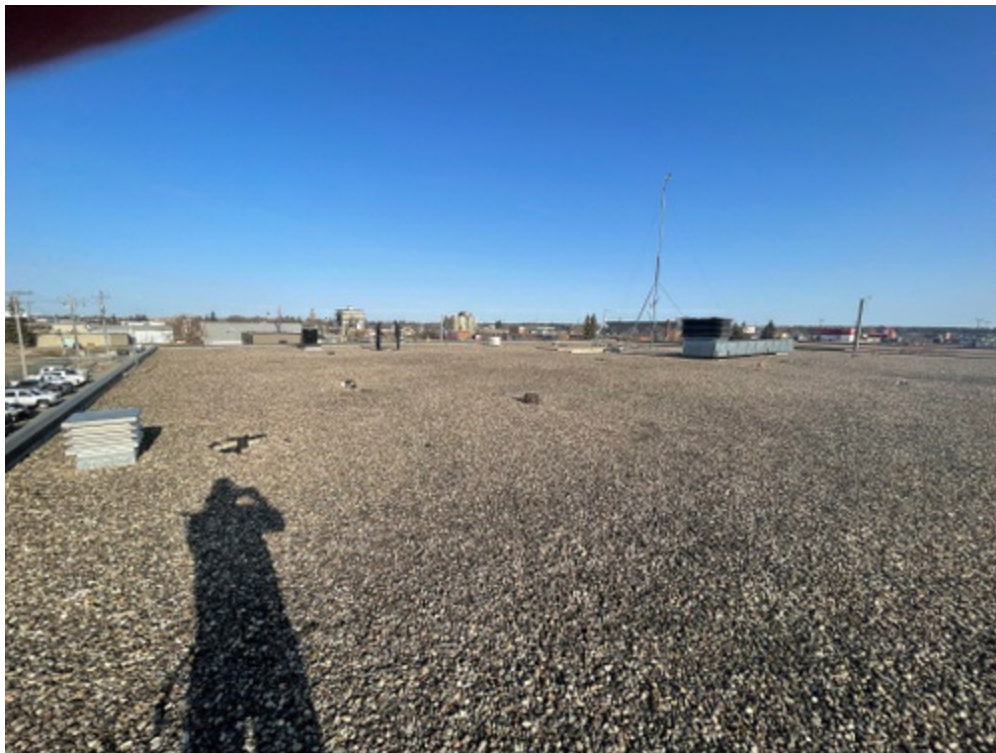
Photo 1

Roof Section - I.R.M.A.

CLEAR Analysis: The 30 year old core sample is from a 4 ply inverted roofing membrane assembly (IRMA) with

felt paper interplies in an asphalt adhesive. The interplies were very easily delaminated by hand as shown in Figure 9. The interplies and overall thickness of the core imply that the system was installed at a lower than specified temperature resulting in thick, viscous layers. The thickest point of adhesive was measured at 125 mils. A typical interply thickness when installed correctly is between 32-40 mils.

Due to the overall thickness of the core, specimens could not be cut for tensile, elongation, and flexural strength. A surface coating was used on the membrane, which is unusual for an IRMA system. Instead, a final layer such as paving stones typically protect the membrane from

the elements. The softening point and pen tests show that the asphalt adhesive and flood coat responsible for keeping the system intact has lost its oils over time, causing the system to become more brittle. The sample performed well when undergoing puncture testing, implying that the system can withstand foot traffic and most weather phenomena.

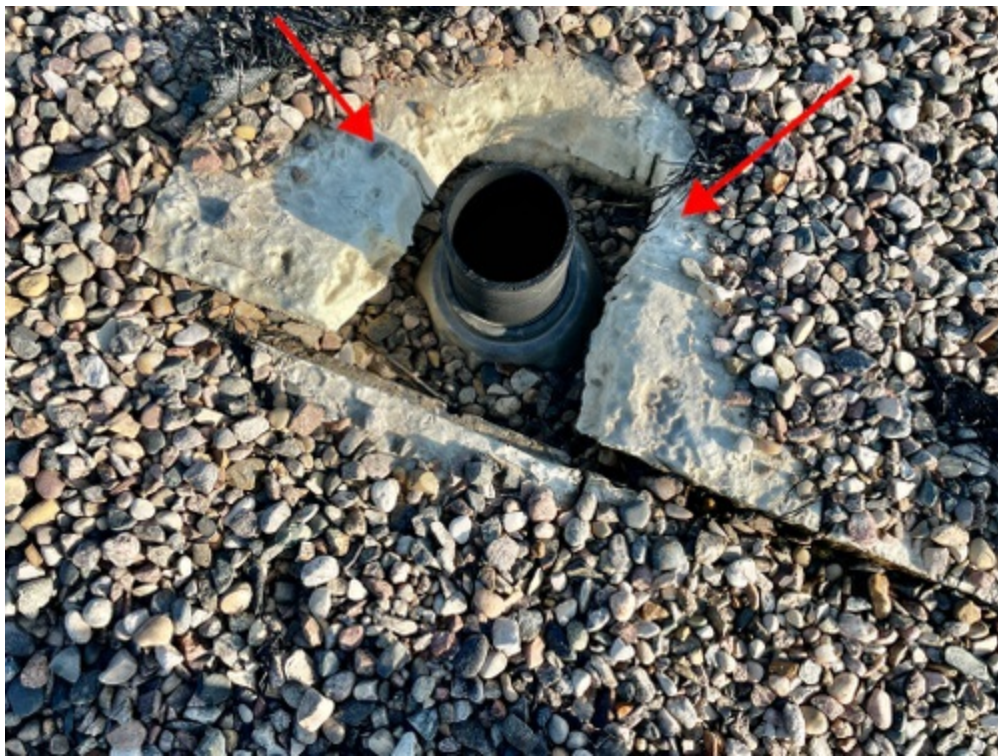
Photo 2

Insulation: Extruded polystyrene insulation beginning to shrink from exposure to UV and other elements. EPS also experiences post-molding shrinkage; it shrinks dimensionally from its molded size after processing.

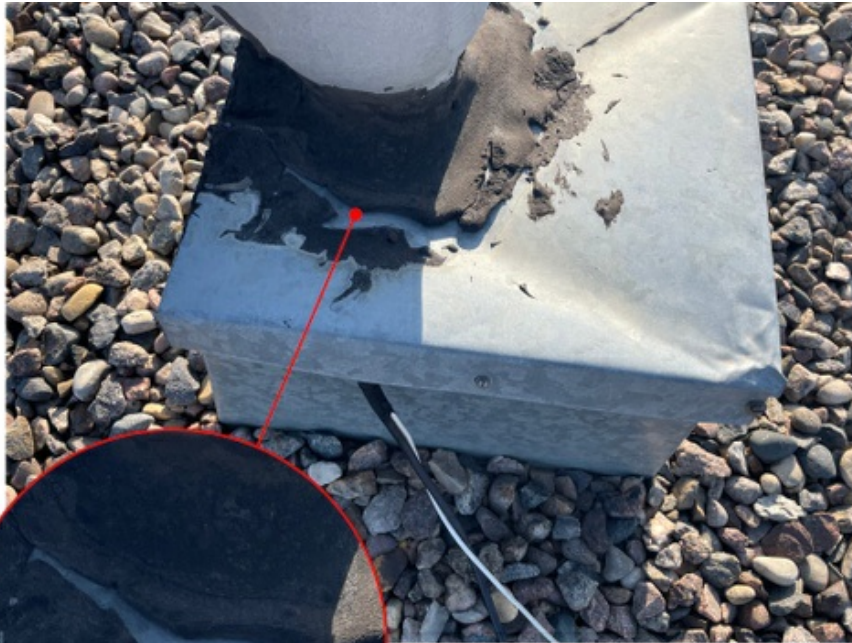
Photo 3

Caulking Deterioration: As caulking is exposed to UV rays and temperature fluctuations it loses its flexibility and develops cracks. Once this occurs splits develop allowing water to penetrate walls and buildings causing damage as well as leaks.

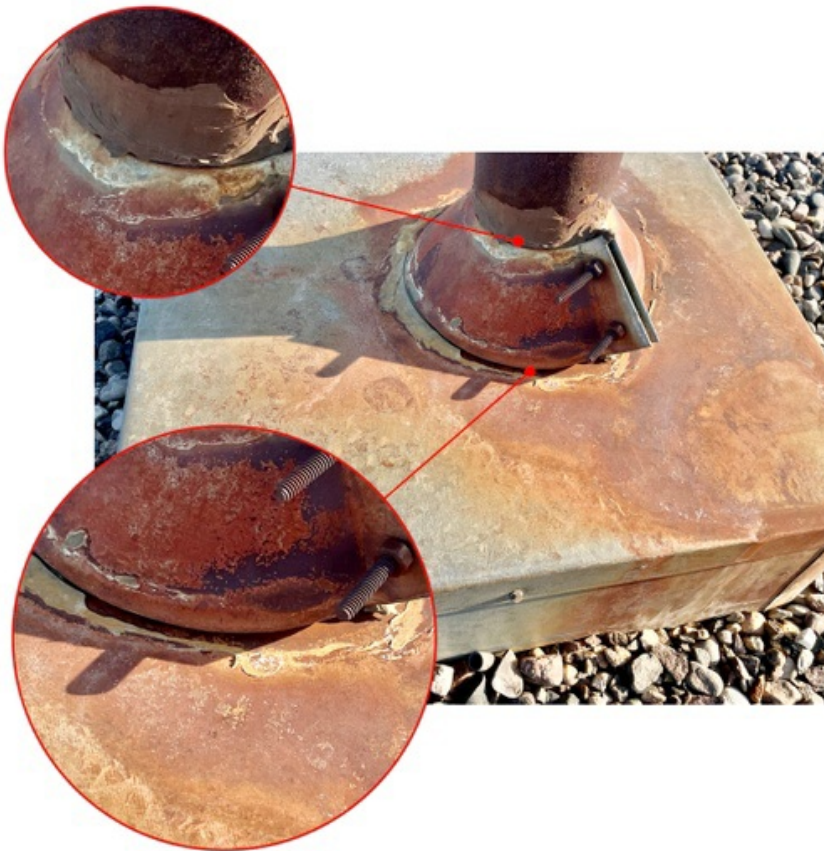
Photo 4

Caulking Deterioration: As caulking is exposed to UV rays and temperature fluctuations it loses its flexibility and develops cracks. Once this occurs splits develop allowing water to penetrate walls and buildings causing damage as well as leaks.

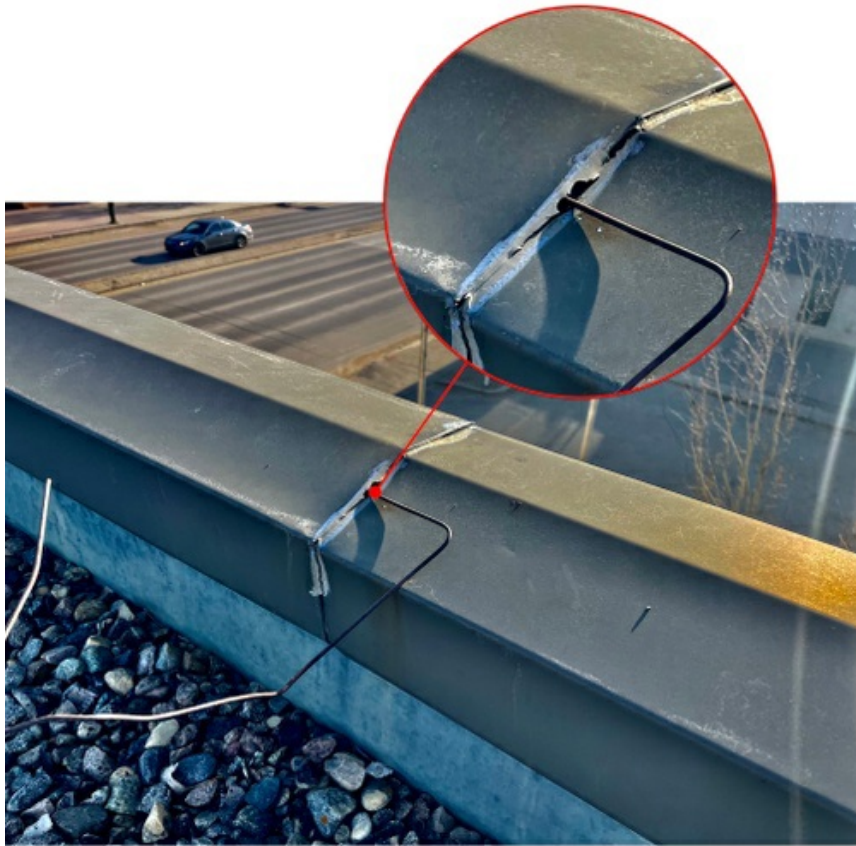
Photo 5

Caulking Deterioration: As caulking is exposed to UV rays and temperature fluctuations it loses its flexibility and develops cracks. Once this occurs splits develop allowing water to penetrate walls and buildings causing damage as well as leaks.

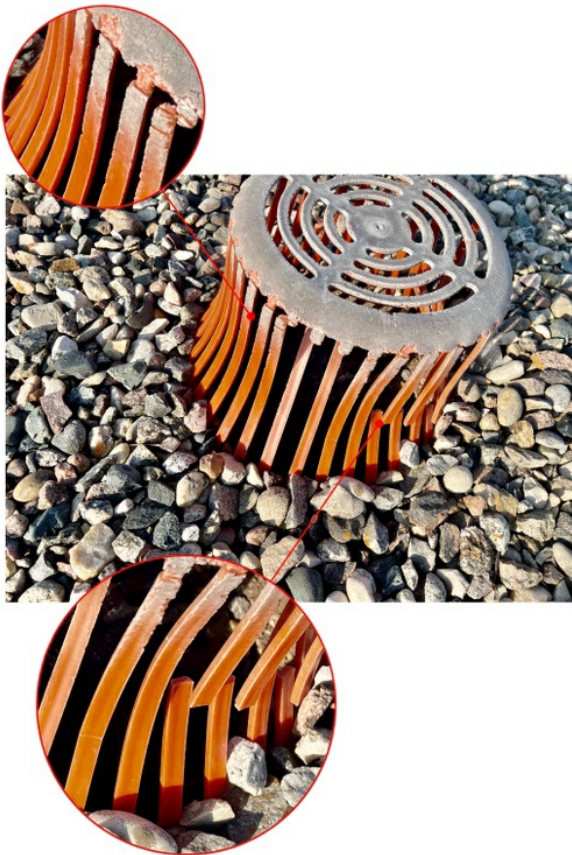
Photo 6

Drain Screen: Cracked

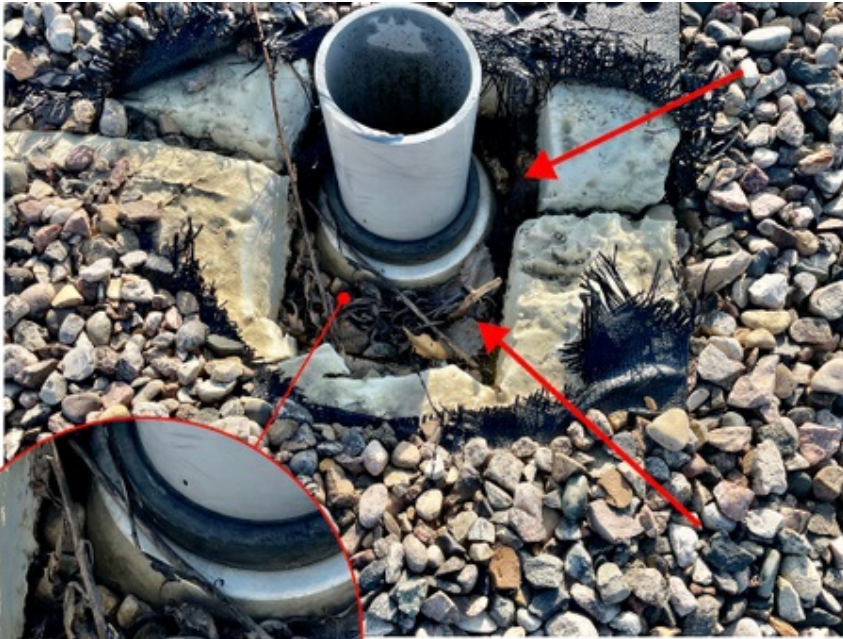
Photo 7

Insulation: Extruded polystyrene insulation beginning to shrink from exposure to UV and other elements. EPS also experiences post- molding shrinkage; it shrinks dimensionally from its molded size after processin

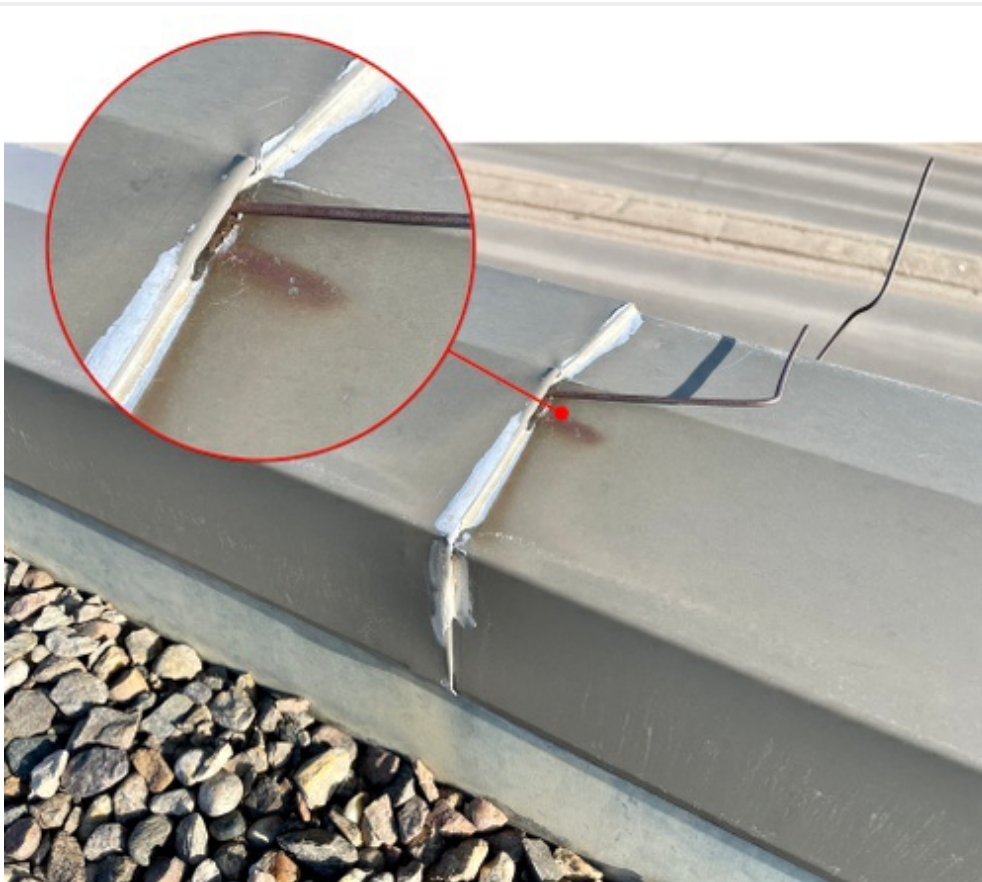
Photo 8

Caulking Deterioration: As caulking is exposed to UV rays and temperature fluctuations it loses its flexibility and develops cracks. Once this occurs splits develop allowing water to penetrate walls and buildings causing damage as well as leaks.

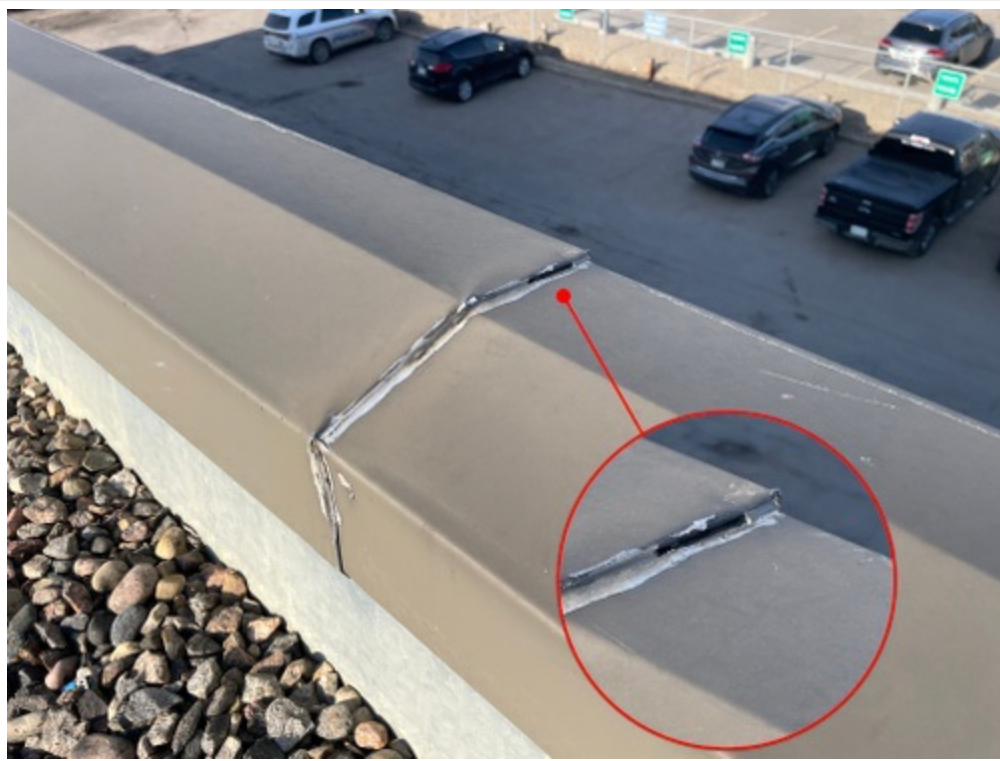
Photo 9

Caulking Deterioration: As caulking is exposed to UV rays and temperature fluctuations it loses its flexibility and develops cracks. Once this occurs splits develop allowing water to penetrate walls and buildings causing damage as well as leaks.

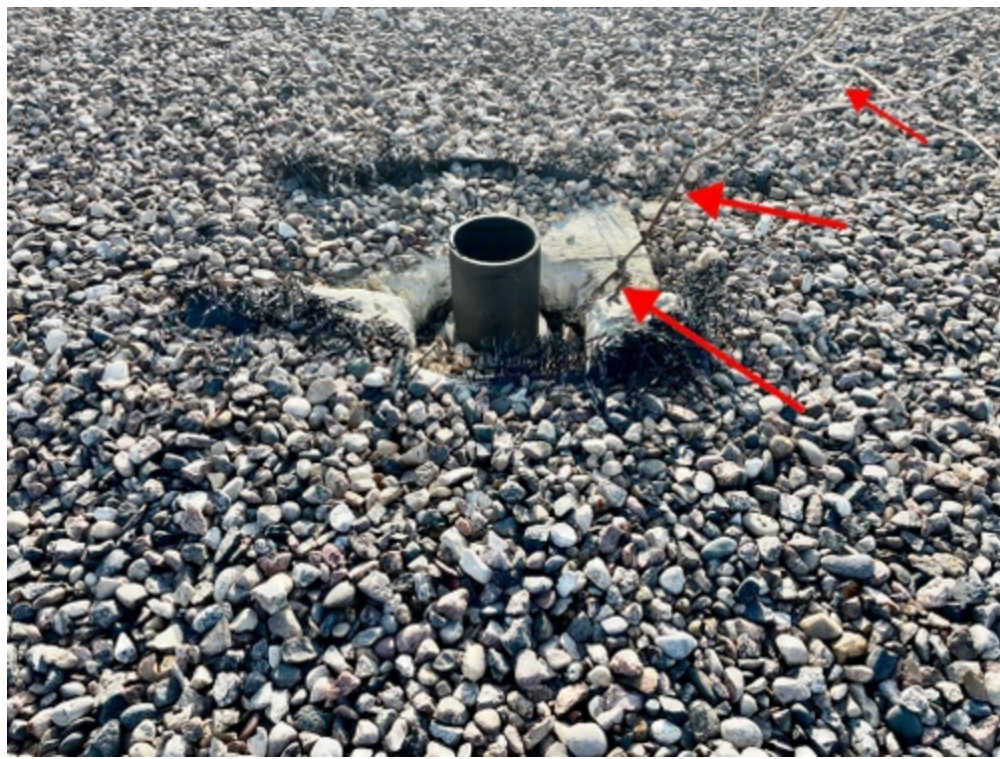
Photo 10

Insulation: Extruded polystyrene insulation beginning to shrink from exposure to UV and other elements. EPS also experiences post- molding shrinkage; it shrinks dimensionally from its molded size after processing.

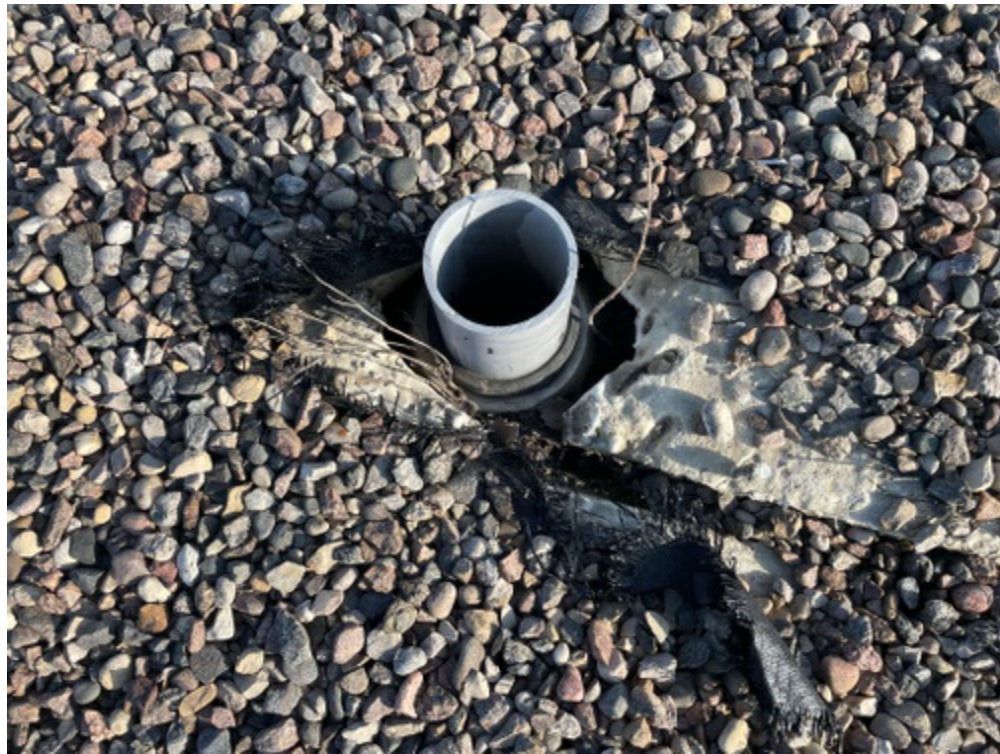
Photo 11

Insulation: Extruded polystyrene insulation beginning to shrink from exposure to UV and other elements. EPS also experiences post- molding shrinkage; it shrinks dimensionally from its molded size after processing.
