City of Prince Albert - Municipal Services Centre Roof Inspection

Prepared By  
Brett Foote

June 10, 2022

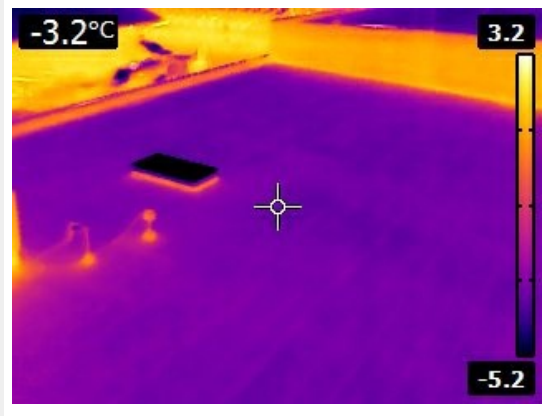
*Photo 1*  
 General view of the lower section (B1) from section A2.  
 No thermal anomaly related to wet insulation was found on this section

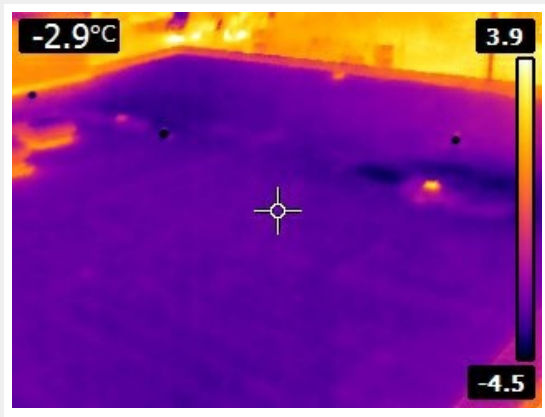
*Photo 2*  
 General view of the lower section (B1) from section A2.  
 No thermal anomaly related to wet insulation was found on this section  
 An area of light water ponding was visible around the drain.

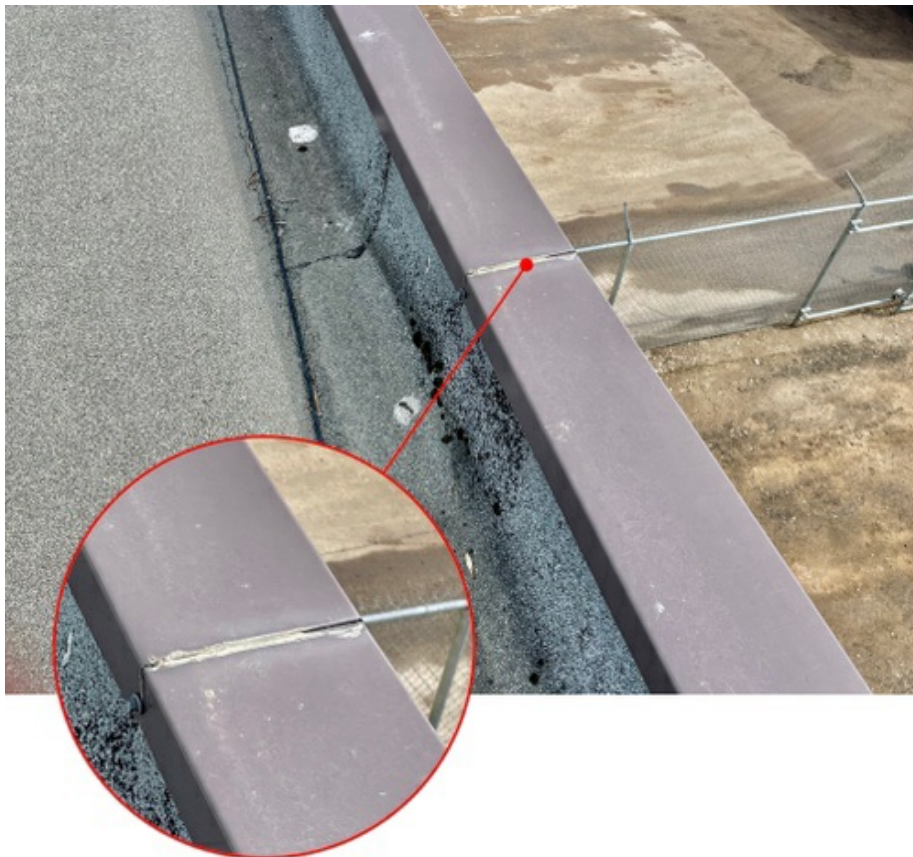
*Photo 2*

**Caulking Deterioration:** As caulking is exposed to UV rays and temperature fluctuations it loses its flexibility and develops cracks. Once this occurs splits develop allowing water to penetrate walls and buildings causing damage as well as leaks.

1. Repair all open fish mouths using high grade mastic reinforced with mesh
2. Re caulk all coping cap seams
3. Fill all pitch pockets using high grade mastic
4. Re seal around all penetrations using high grade mastic
5. Repair sagging curb flashings on units and around perimeter

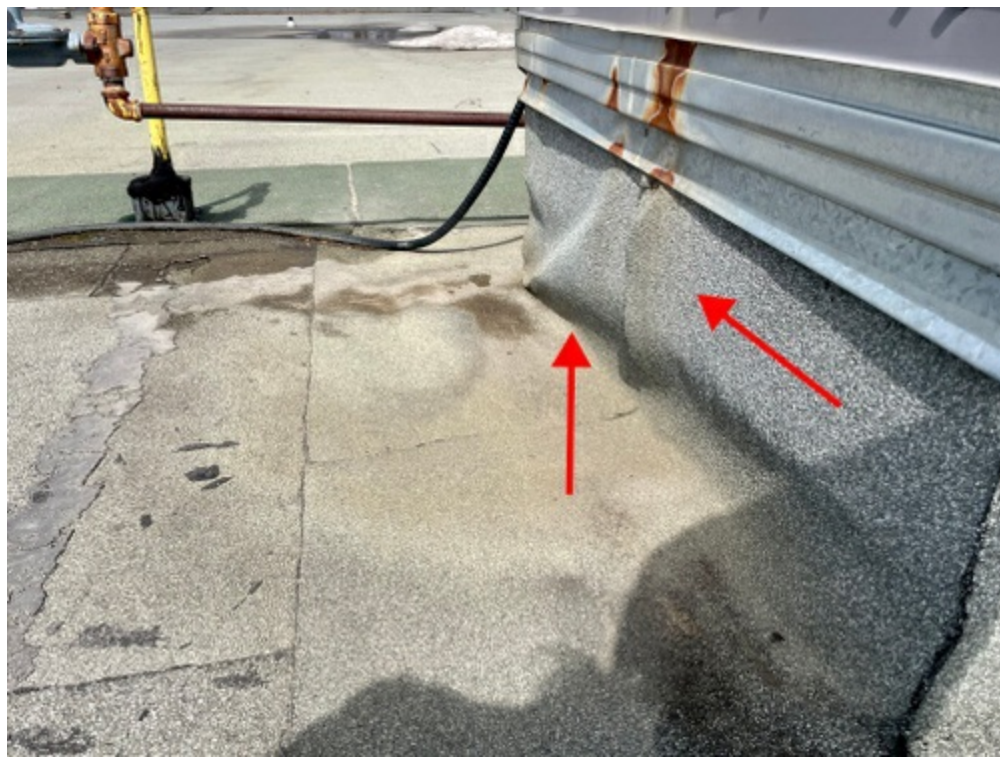
*Photo 3*

**Deterioration:** Most roof failures start at perimeter and penetration locations. Perimeter wall flashings can be damaged due to normal seasonal building movement and thermal shock. Additional damage can also be seen from UV degradation as well. At all of these deteriorated or failed points, moisture can gain direct access to the roof system insulation and the buildings interior.

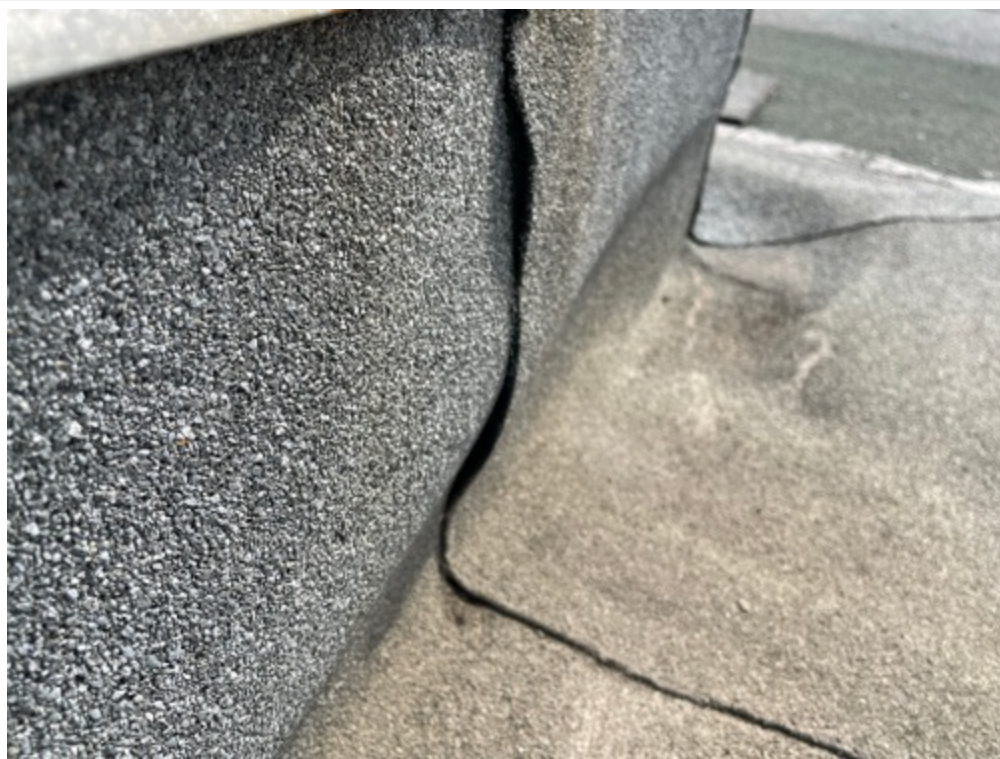
*Photo 4*

**Fish mouths:** Wrinkles or openings at the edge of the membrane caused by poor adhesion or installation. Fish mouths are a common cause of early failure on 2-ply torch down and single ply roof systems. These systems are prone to workmanship error due to two factors (1) the manual heating/welding of the adhesive, which is very unpredictable for constant heat, and (2) the roof system only consists of 1 to 2 plies, which translates in to a very thin layer of water protection.

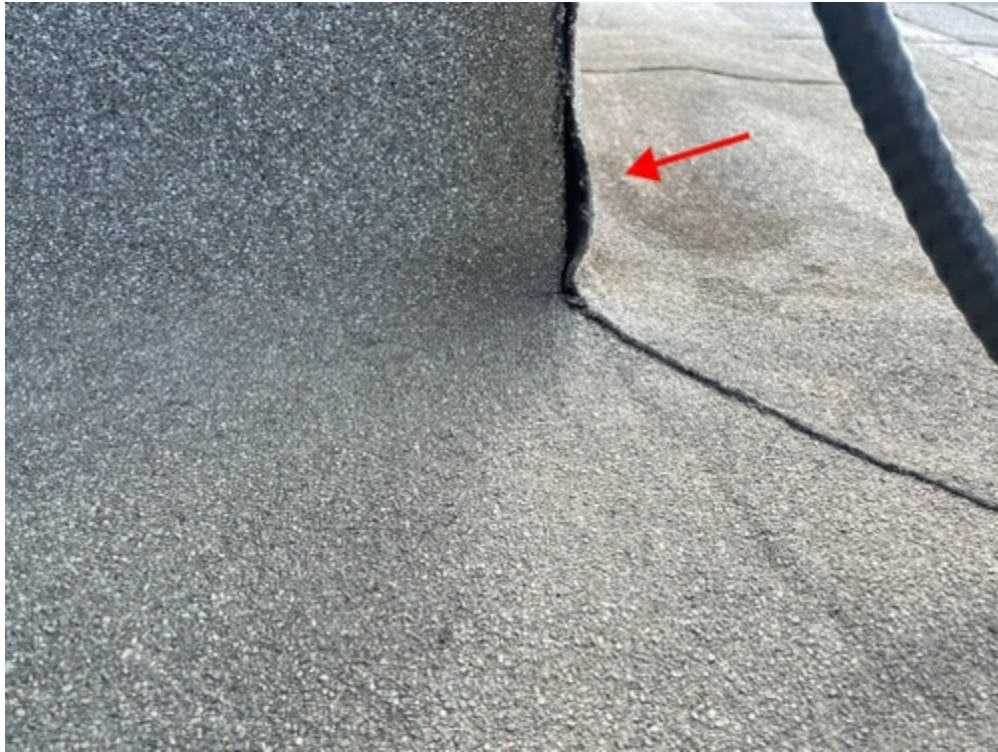
*Photo 5*

**Fish mouths:** Wrinkles or openings at the edge of the membrane caused by poor adhesion or installation. Fish mouths are a common cause of early failure on 2-ply torch down and single ply roof systems. These systems are prone to workmanship error due to two factors (1) the manual heating/welding of the adhesive, which is very unpredictable for constant heat, and (2) the roof system only consists of 1 to 2 plies, which translates in to a very thin layer of water protection.

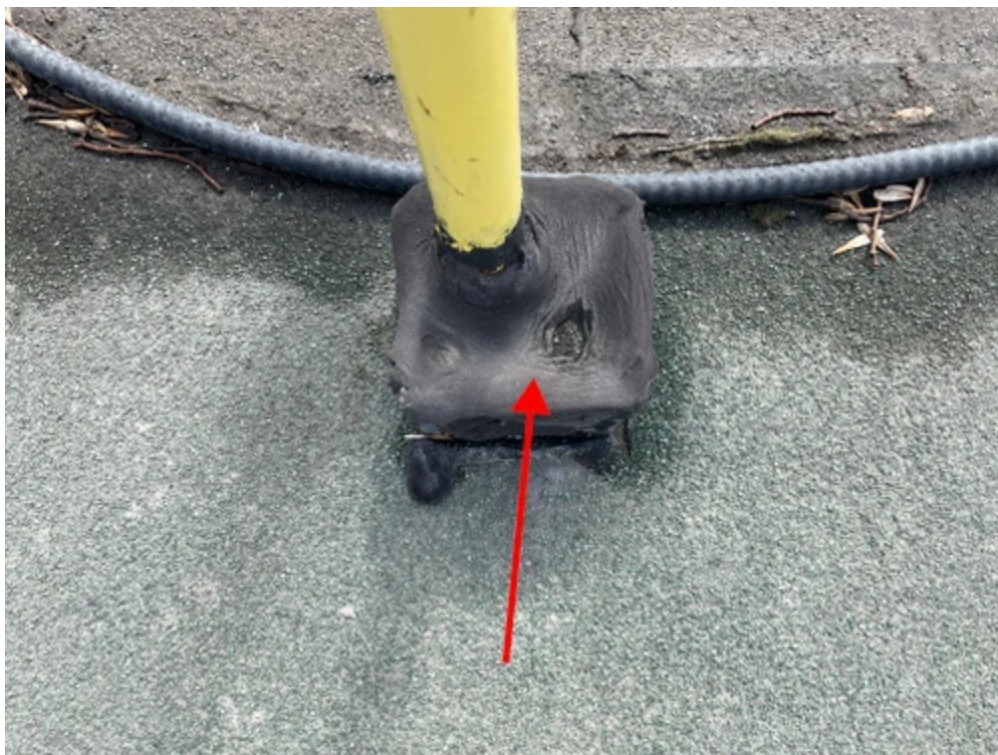
*Photo 6*

**Pitch Pocket Deterioration:** Metal protrusions that penetrate the roof system to allow conduits to run from the rooftop into the building. Movement from the protrusion can break the waterproofing compound, creating cracks. Over time, the release of solvents from the compound can cause the material to shrink, leaving gaps along the edges of the pan and around structural support. Water can enter through a defective pitch pan and find its way into the interior of the building. Moisture can also penetrate into the roof system leading to premature failure.

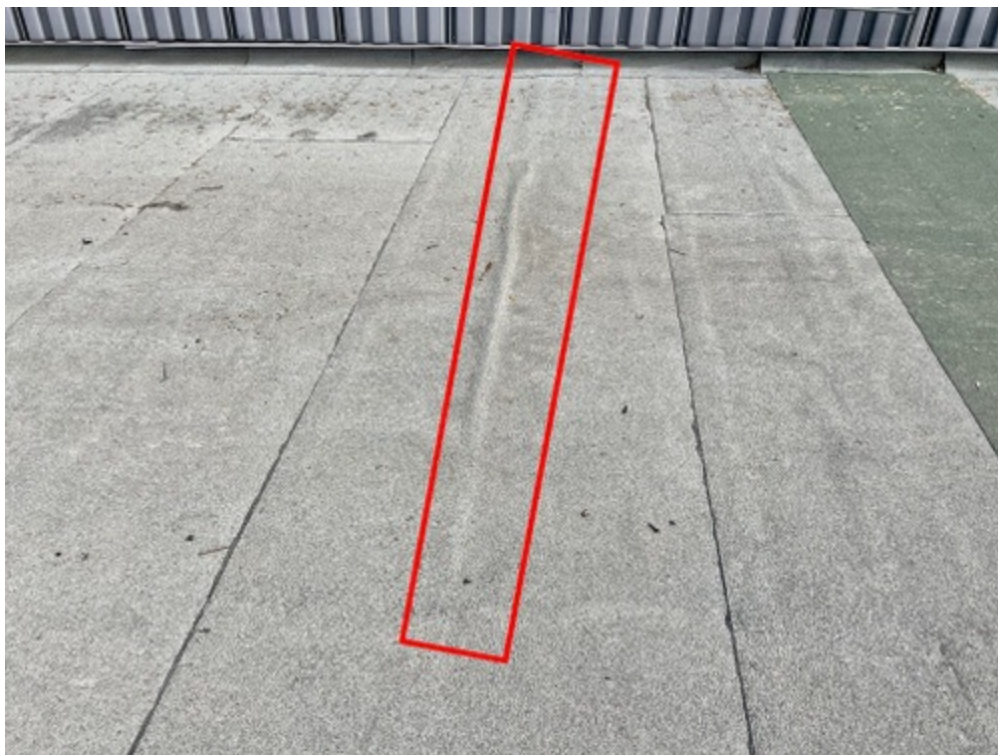
*Photo 7*

**Ridges:** These show up on the surface of built up roofs as linear buckling felt lines protruding upward through the surface layers of asphalt and aggregate. Ridges are formed by either thermal changes expanding and contracting the roofing felts or by gaps in the underlying insulation that allow vapor to migrate upwards through the roof system. Over a period of time ridges will grow and erode until they are stripped of their protective asphalt. These exposed ridges, through repeated weather cycling, will eventually crack and split to allow water into the roof system.

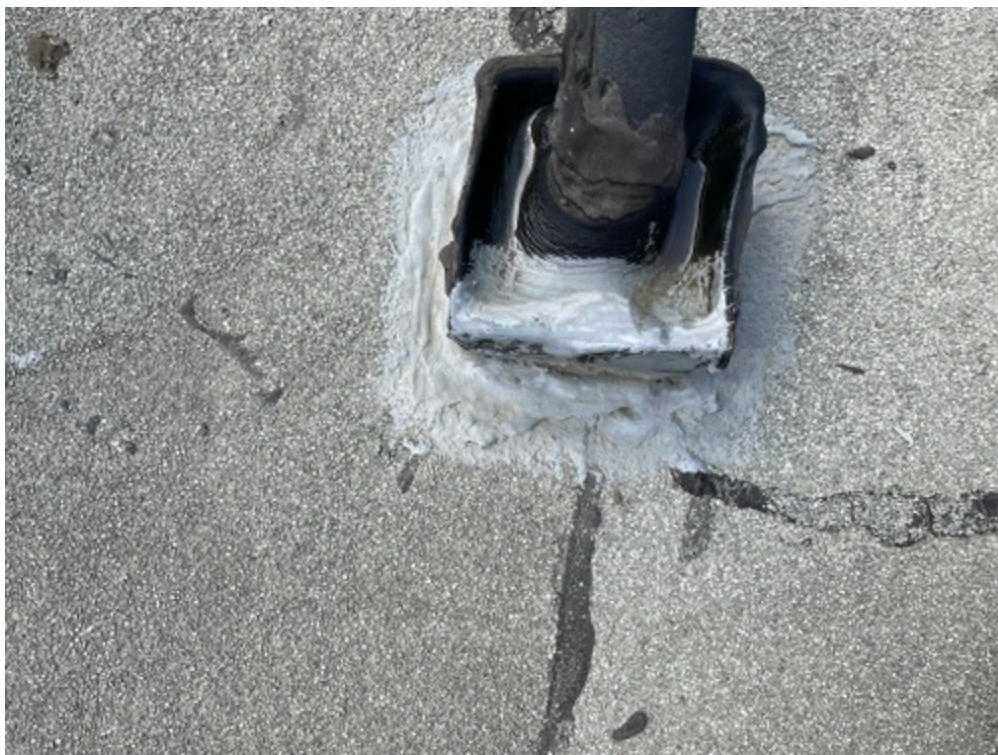
*Photo 8*

**Pitch Pocket Deterioration:** Metal protrusions that penetrate the roof system to allow conduits to run from the rooftop into the building. Movement from the protrusion can break the waterproofing compound, creating cracks. Over time, the release of solvents from the compound can cause the material to shrink, leaving gaps along the edges of the pan and around structural support. Water can enter through a defective pitch pan and find its way into the interior of the building. Moisture can also penetrate into the roof system leading to premature failure.

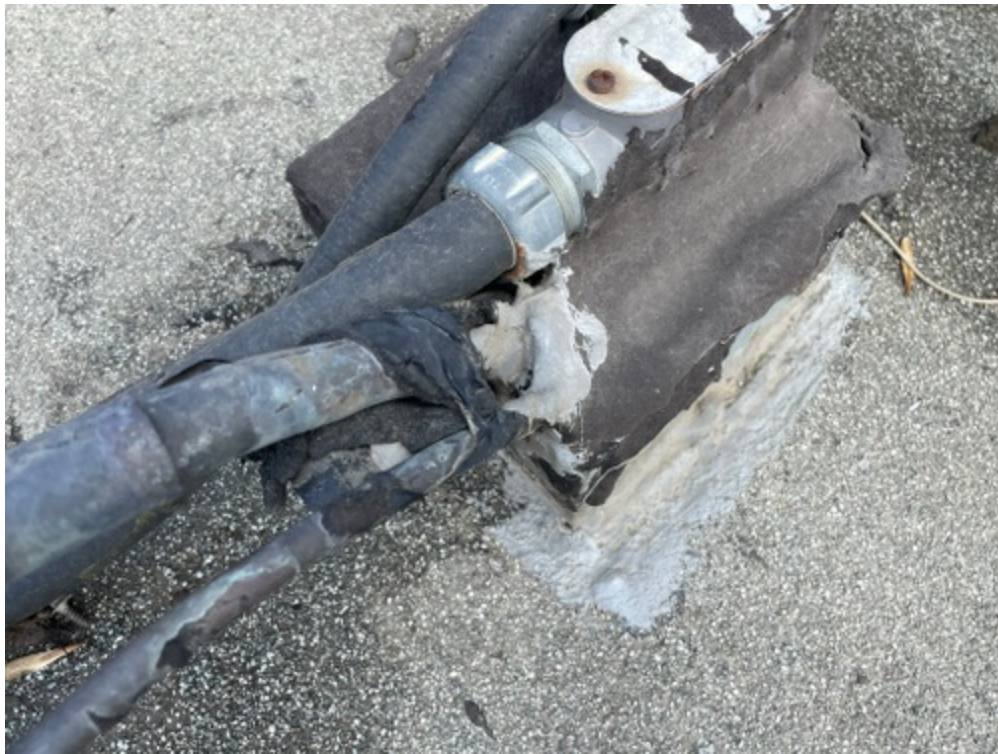
*Photo 9*

**Pitch Pocket Deterioration:** Metal protrusions that penetrate the roof system to allow conduits to run from the rooftop into the building. Movement from the protrusion can break the waterproofing compound, creating cracks. Over time, the release of solvents from the compound can cause the material to shrink, leaving gaps along the edges of the pan and around structural support. Water can enter through a defective pitch pan and find its way into the interior of the building. Moisture can also penetrate into the roof system leading to premature failure.

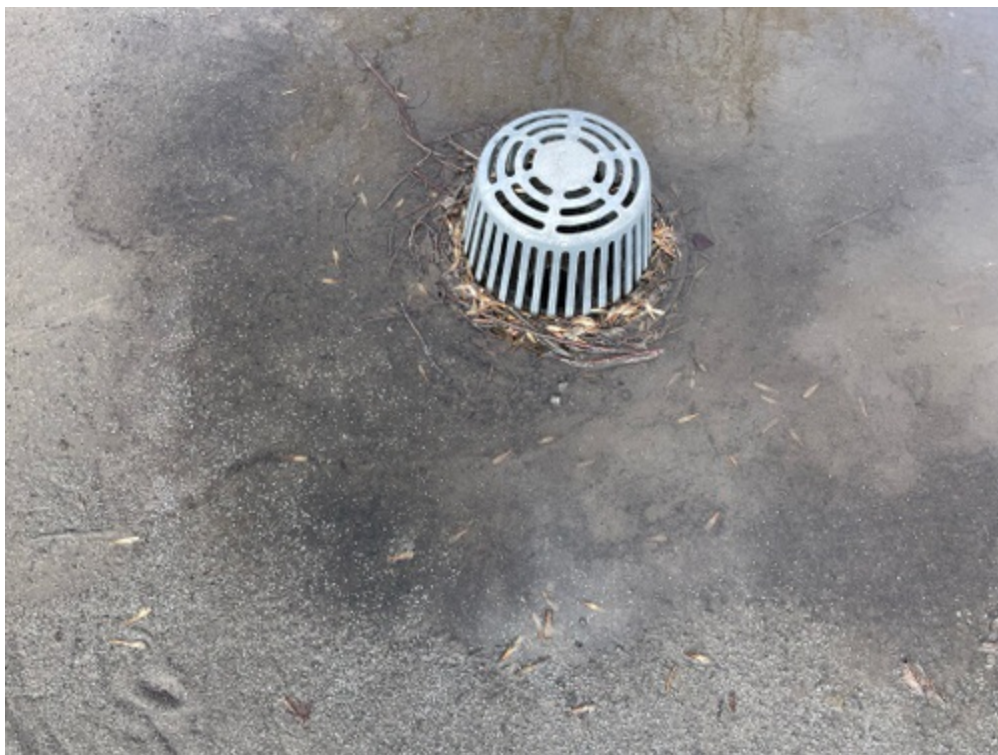
*Photo 10*

**Debris - Leafs and Pine Needles:** Pine needles and other leaves build up on the roof membrane causing plugged drains and scuppers thereby causing ponding water and structural weight loading. As the leaves and pine needles rot a "compost effect" occurs, this in effect causes soil to form on top of the roof membrane. This soil creates a perfect medium for plant and weed growth. When seeds take hold the roots will often penetrate through the membrane causing immediate leaks and damage internally.

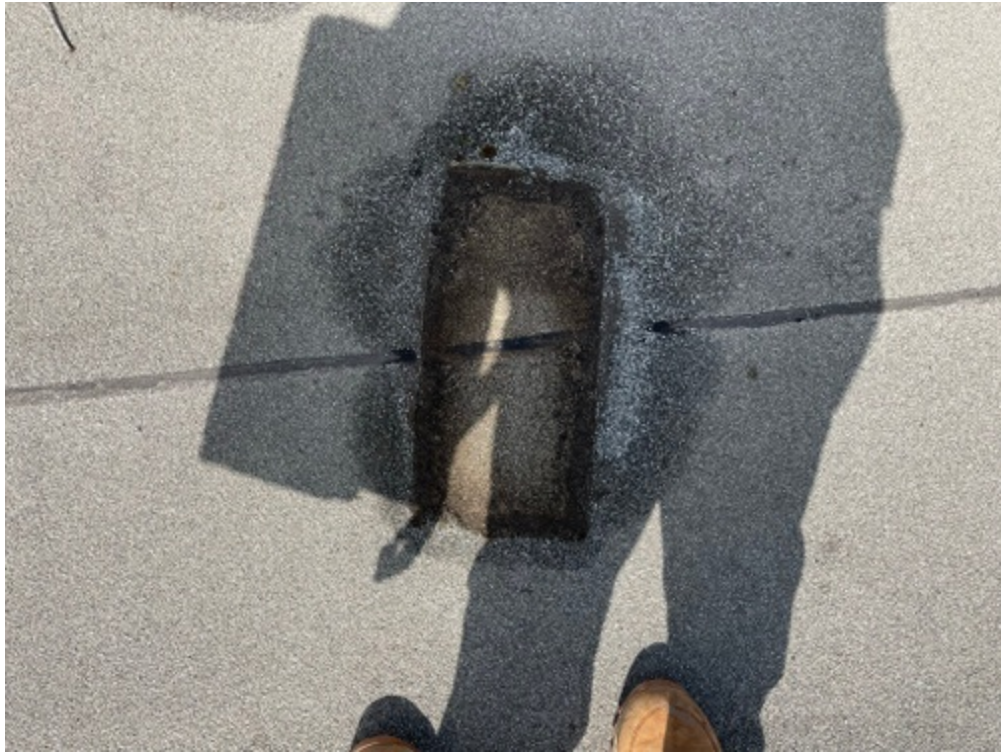
*Photo 13*

**Debris:** Left on field of roof deteriorating waterproofing membrane.

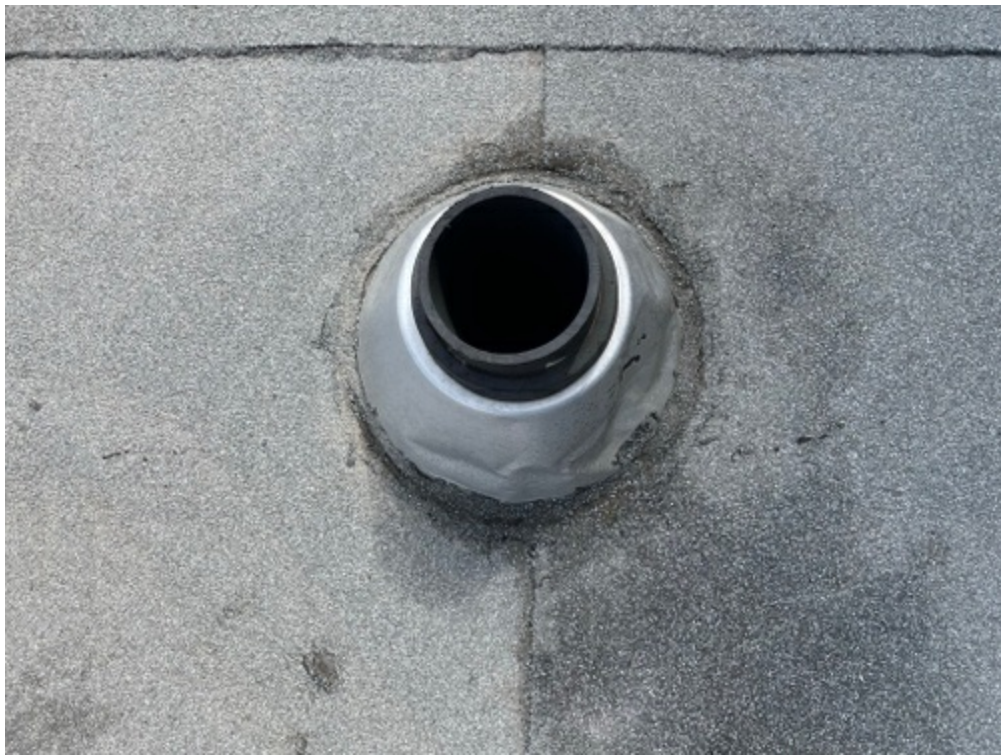
*Photo 14*

**Penetration Waterproofing:** Beginning to deteriorate around the perimeter allowing for potential moisture access.

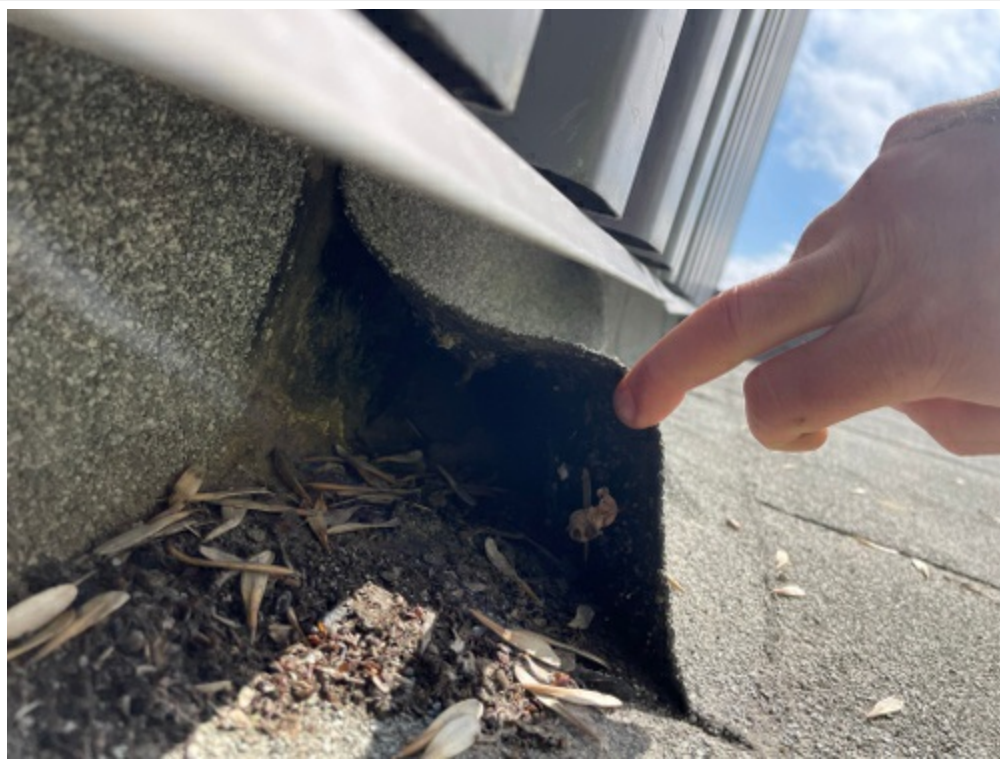
*Photo 16*

**Fish mouths:** Wrinkles or openings at the edge of the membrane caused by poor adhesion or installation. Fish mouths are a common cause of early failure on 2-ply torch down and single ply roof systems. These systems are prone to workmanship error due to two factors (1) the manual heating/welding of the adhesive, which is very unpredictable for constant heat, and (2) the roof system only consists of 1 to 2 plies, which translates in to a very thin layer of water protection.

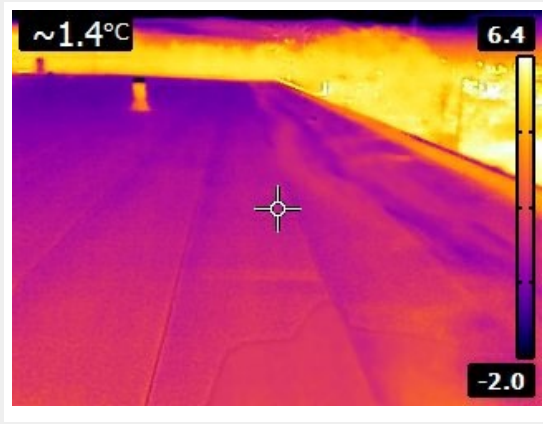
*Photo 1*

General view of section A2 (upper est) with the infrared camera.  
 No thermal anomaly related to wet insulation was found on this section.  
 Accumulation of granules were visible on the perimeters of the roof.

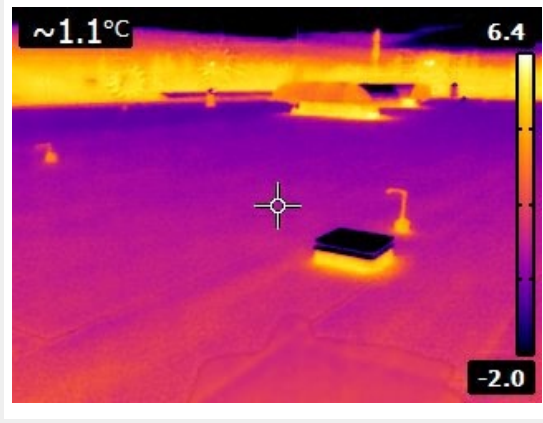
*Photo 2*

General view of section A2 (upper est) with the infrared camera.  
 No thermal anomaly related to wet insulation was found on this section.

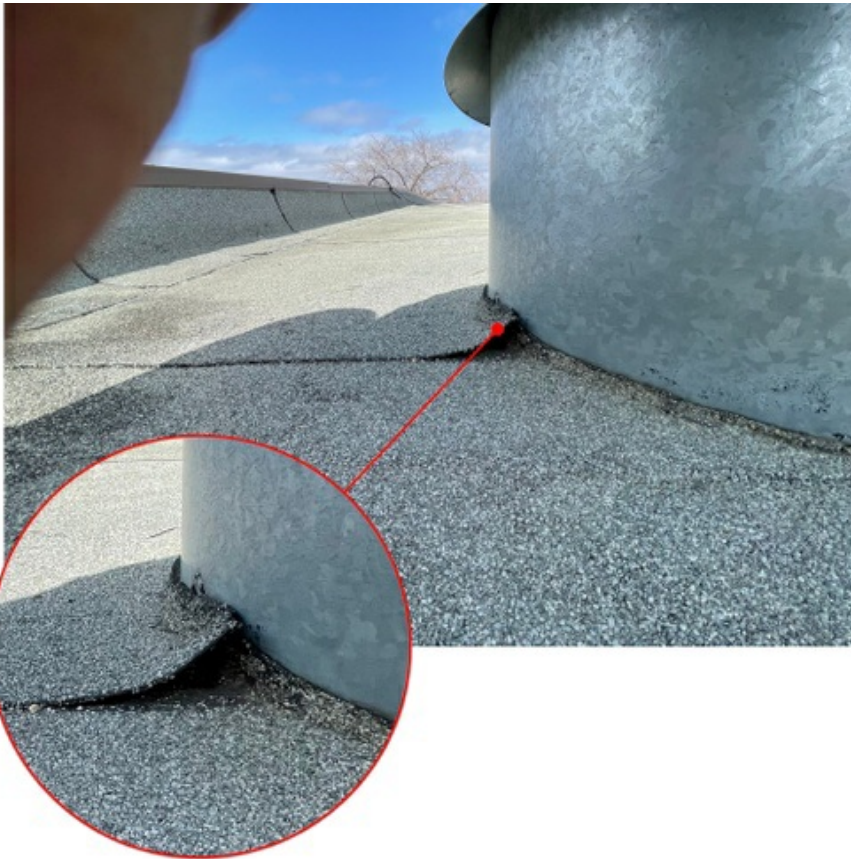
*Photo 2*

**Fish mouths:** Wrinkles or openings at the edge of the membrane caused by poor adhesion or installation. Fish mouths are a common cause of early failure on 2-ply torch down and single ply roof systems. These systems are prone to workmanship error due to two factors (1) the manual heating/welding of the adhesive, which is very unpredictable for constant heat, and (2) the roof system only consists of 1 to 2 plies, which translates in to a very thin layer of water protection.

1. Repair all open fish mouths using high grade mastic reinforced with mesh
2. Re caulk all coping cap seams
3. Fill all pitch pockets using high grade mastic
4. Re seal around all penetrations using high grade mastic
5. Repair sagging curb flashings on units and around perimeter

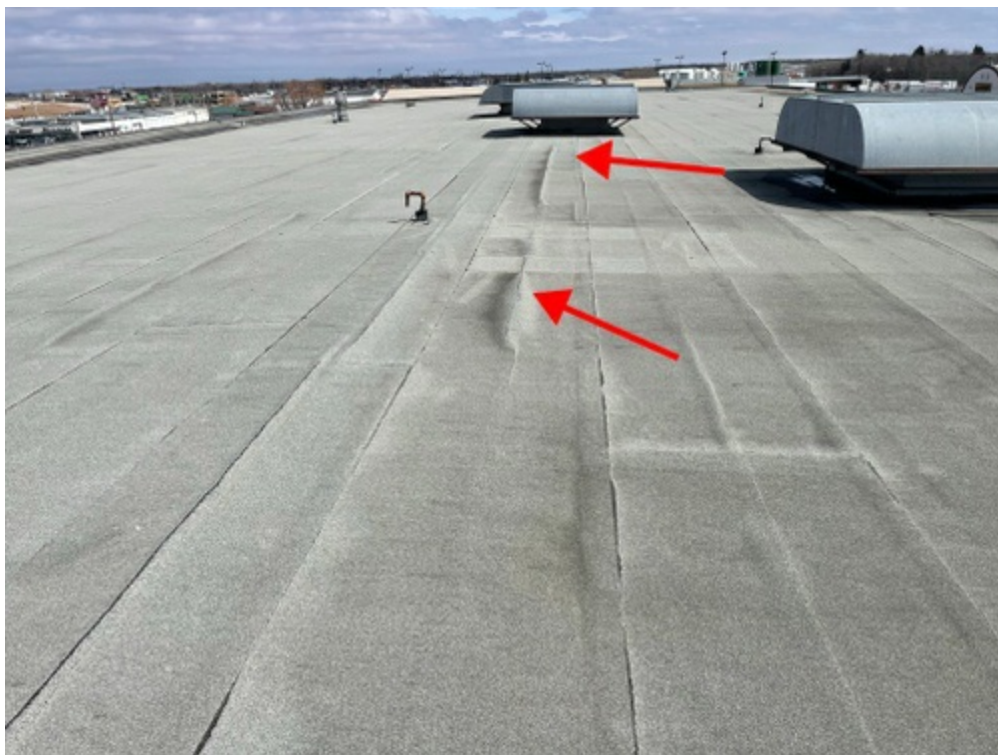
*Photo 5*

**Ridges:** These show up on the surface of built up roofs as linear buckling felt lines protruding upward through the surface layers of asphalt and aggregate. Ridges are formed by either thermal changes expanding and contracting the roofing felts or by gaps in the underlying insulation that allow vapor to migrate upwards through the roof system. Over a period of time ridges will grow and erode until they are stripped of their protective asphalt. These exposed ridges, through repeated weather cycling, will eventually crack and split to allow water into the roof system.

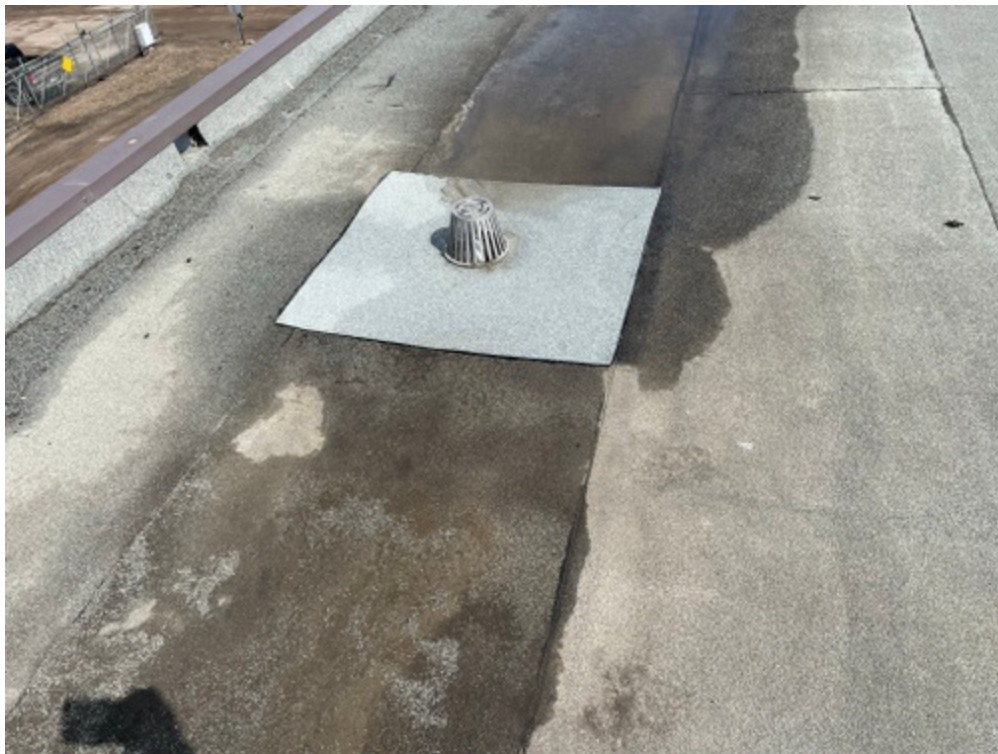
*Photo 8*

**Ponding:** Ponding water occurs when moisture collects in large pools on the surface of a roof system.

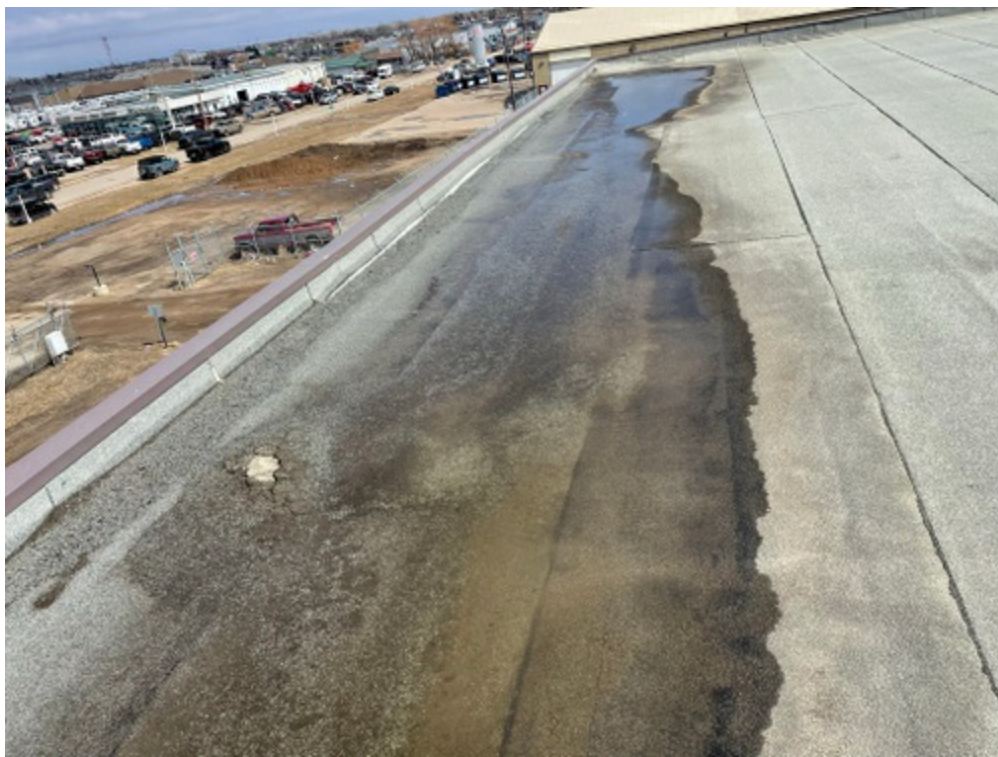
*Photo 9*

**Ponding:** Ponding water occurs when moisture collects in large pools on the surface of a roof system.

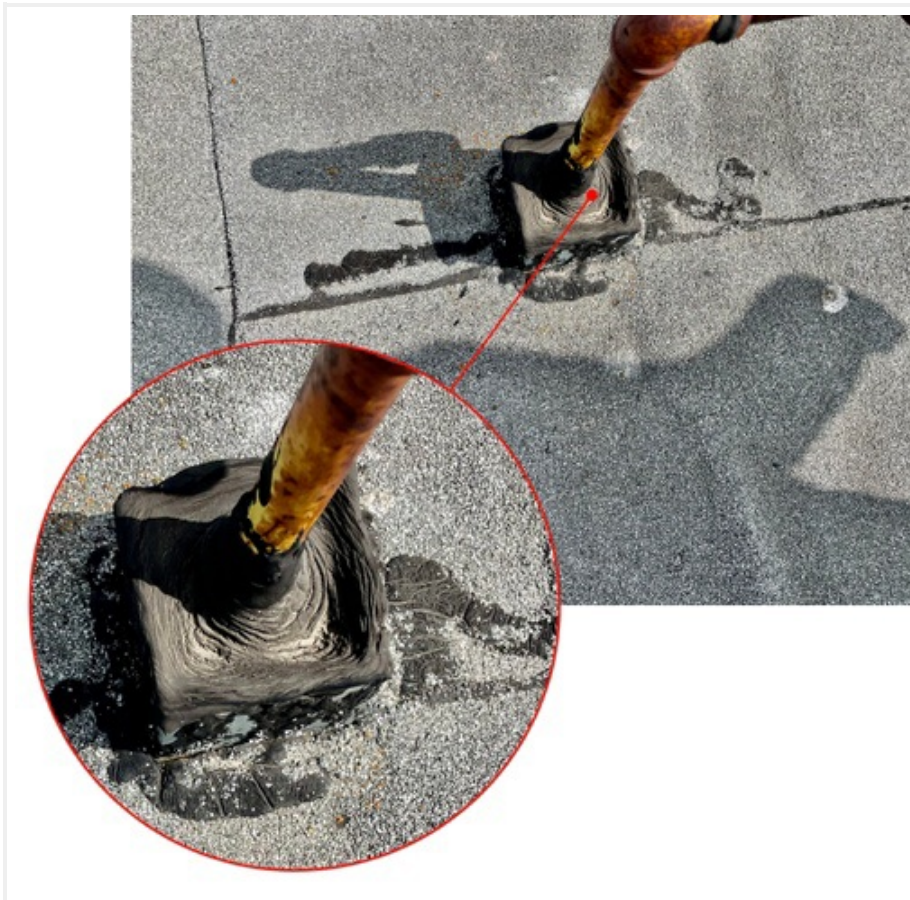
*Photo 10*

**Pitch Pocket Deterioration:** Metal protrusions that penetrate the roof system to allow conduits to run from the rooftop into the building. Movement from the protrusion can break the waterproofing compound, creating cracks. Over time, the release of solvents from the compound can cause the material to shrink, leaving gaps along the edges of the pan and around structural support. Water can enter through a defective pitch pan and find its way into the interior of the building. Moisture can also penetrate into the roof system leading to premature failure.

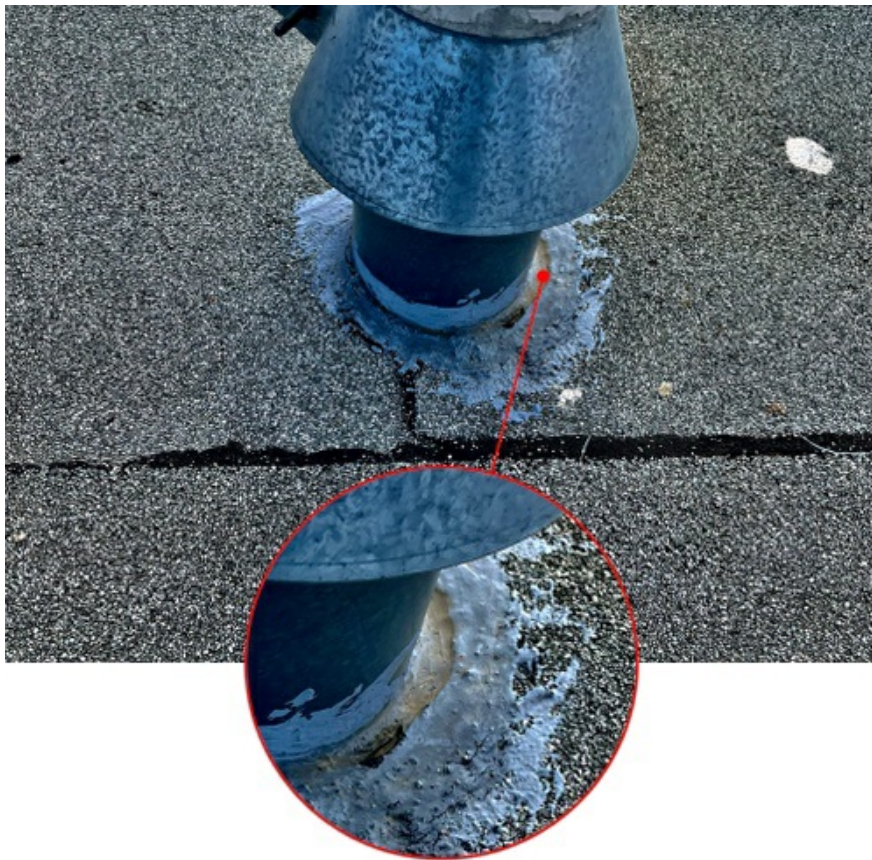
*Photo 12*

**Penetration Waterproofing:** Beginning to deteriorate around the perimeter allowing for potential moisture access.

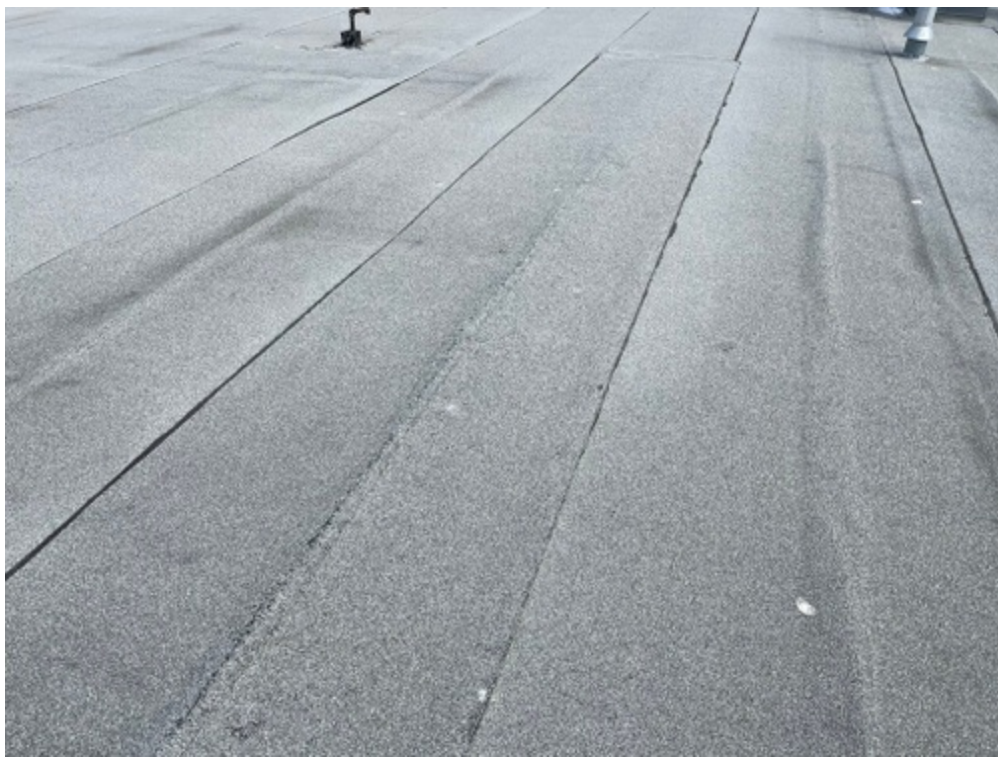
*Photo 13*

**Ridges:** These show up on the surface of built up roofs as linear buckling felt lines protruding upward through the surface layers of asphalt and aggregate.

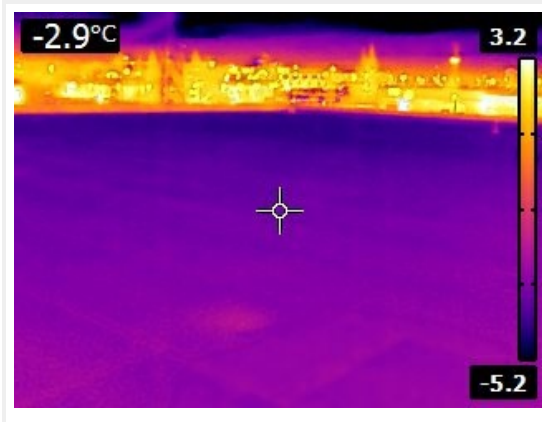
*Photo 1*

General view of section A1 (upper west)  
 No thermal anomaly related to wet insulation was found on this section.  
 The thermal patterns are homogeneous.

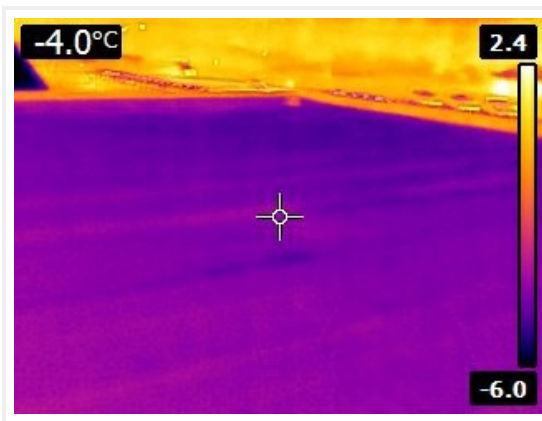
*Photo 2*

General view of section A1 (upper west)  
 No thermal anomaly related to wet insulation was found on this section.

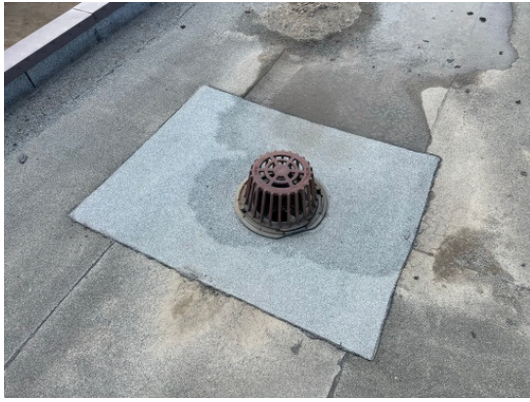
*Photo 2*

**Drains:** Membrane replaced around drains.

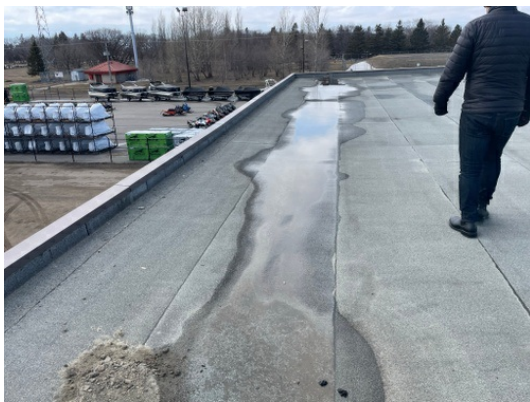
*Photo 3*

**Ponding:** Ponding water occurs when moisture collects in large pools on the surface of a roof system. These pools begin to form due to the following: 1) roof drains are blocked or clogged with debris, 2) the insulation package has lost dimensional stability and has reduced in thickness, 3) poor slope to drain design via overbuilt crickets or tapered insulation system, 4) roof drains are built along side building support columns which maintain a consistent height under load while the balance of the roof system is applied over a live deck which tends to move and deflect under normal seasonal load. In all cases, roof depressions that collect and hold water will tend to grow in size as the added weight of the ponding water will continue to deflect the roof deck even further.

This condition can damage the roof in a number of ways. Additional structural loads create more movement of the roof assembly creating more tear stress and of course a potential for structural failure. UV intensity also increases under ponding conditions as the sun's rays are increased to the point where it accelerates deterioration in most all roof systems. In asphalt based assemblies the natural waterproofing oils in the asphalt will separate from the membrane if the system remains submerged under water for sustained periods. Single ply roof system rot and burn out when the ponding area is exposed to sunlight. The added weight can crush insulation increasing the ponding condition and creating a condition where the insulation becomes a useless thermal barrier. This condition then affects the mechanical system and the cost of heating and cooling the building. In the winter ponding water will expand as it freezes. This expansion will weaken small imperfections in the roof system. Small cracks and tears will widen until they rupture to allow water into the building. And finally, a negatively deflected deck becomes a structural concern.

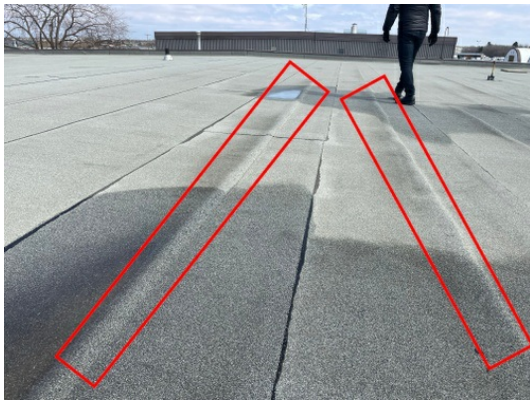
*Photo 4*

**Ridges:** These show up on the surface of built up roofs as linear buckling felt lines protruding upward through the surface layers of asphalt and aggregate. Ridges are formed by either thermal changes expanding and contracting the roofing felts or by gaps in the underlying insulation that allow vapor to migrate upwards through the roof system. Over a period of time ridges will grow and erode until they are stripped of their protective asphalt. These exposed ridges, through repeated weather cycling, will eventually crack and split to allow water into the roof system.

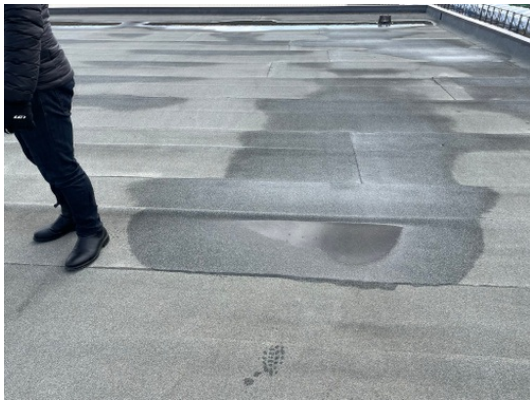
*Photo 5*

**Ponding:** Ponding water occurs when moisture collects in large pools on the surface of a roof system.

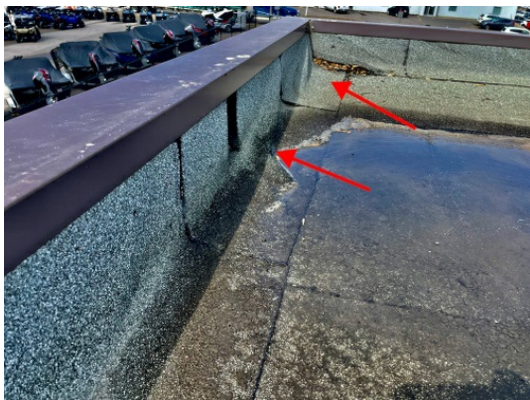
*Photo 6*

**Perimeter Flashing Deterioration:** Most roof failures start at perimeter and penetration locations. Perimeter wall flashings can be damaged due to normal seasonal building movement and thermal shock. Additional damage can also be seen from UV degradation as well. At all of these deteriorated or failed points, moisture can gain direct access to the roof system insulation and the buildings interior.

1. Repair all open fish mouths using high grade mastic reinforced with mesh
2. Re caulk all coping cap seams
3. Fill all pitch pockets using high grade mastic
4. Re seal around all penetrations using high grade mastic
5. Repair sagging curb flashings on units and around perimeter

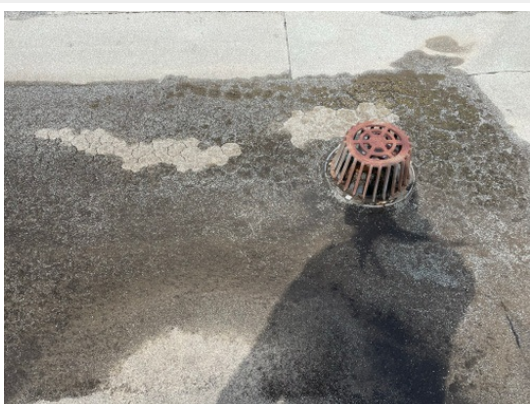
*Photo 7*

**Mineral Roof Granule Deterioration:** It is very common for mineral finished roofs to experience bare felts as early as five years after installation. Manufacturing quality control issues as well as weather "washing off" the factory applied mineral coating causes these areas. Typically this is indicated by accumulations of mineral where ponding is present. Bare felts cause exposure of the membrane to the sun/UV rays, which cause rapid membrane deterioration. Therefore, it is extremely important to coat these areas as soon as they appear.

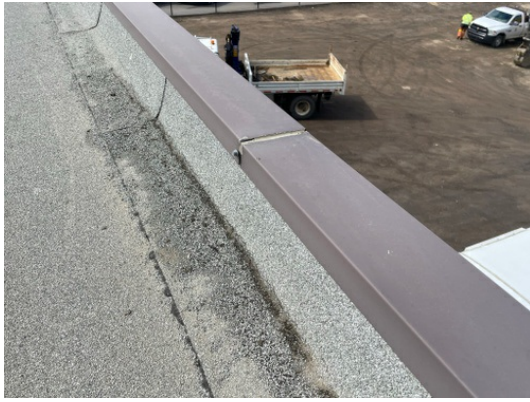
*Photo 8*

**Mineral Roof Granule Deterioration:** It is very common for mineral finished roofs to experience bare felts as early as five years after installation. Manufacturing quality control issues as well as weather “washing off” the factory applied mineral coating causes these areas. Typically this is indicated by accumulations of mineral where ponding is present. Bare felts cause exposure of the membrane to the sun/UV rays, which cause rapid membrane deterioration. Therefore, it is extremely important to coat these areas as soon as they appear.

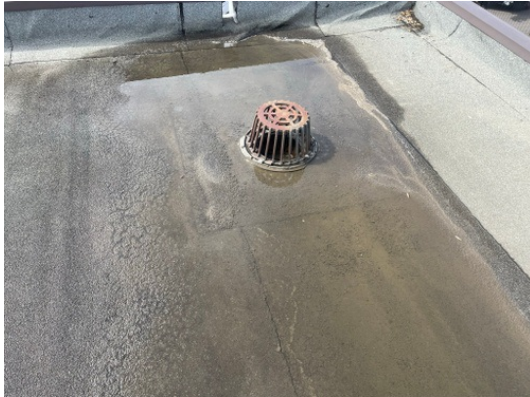
*Photo 9*

**Ponding:** Ponding water occurs when moisture collects in large pools on the surface of a roof system. These pools begin to form due to the following: 1) roof drains are blocked or clogged with debris, 2) the insulation package has lost dimensional stability and has reduced in thickness, 3) poor slope to drain design via overbuilt crickets or tapered insulation system, 4) roof drains are built along side building support columns which maintain a consistent height under load while the balance of the roof system is applied over a live deck which tends to move and deflect under normal seasonal load. In all cases, roof depressions that collect and hold water will tend to grow in size as the added weight of the ponding water will continue to deflect the roof deck even further.

This condition can damage the roof in a number of ways. Additional structural loads create more movement of the roof assembly creating more tear stress and of course a potential for structural failure. UV intensity also increases under ponding conditions as the sun’s rays are increased to the point where it accelerates deterioration in most all roof systems. In asphalt based assemblies the natural waterproofing oils in the asphalt will separate from the membrane if the system remains submerged under water for sustained periods. Single ply roof system rot and burn out when the ponding area is exposed to sunlight. The added weight can crush insulation increasing the ponding condition and creating a condition where the insulation becomes a useless thermal barrier. This condition then affects the mechanical system and the cost of heating and cooling the building. In the winter ponding water will expand as it freezes. This expansion will weaken small imperfections in the roof system. Small cracks and tears will widen until they rupture to allow water into the building. And finally, a negatively deflected deck becomes a structural concern.
