FACILITY REVIEW 2025 – 2029

Parks, Recreation &
Culture Department

City of
Prince Albert

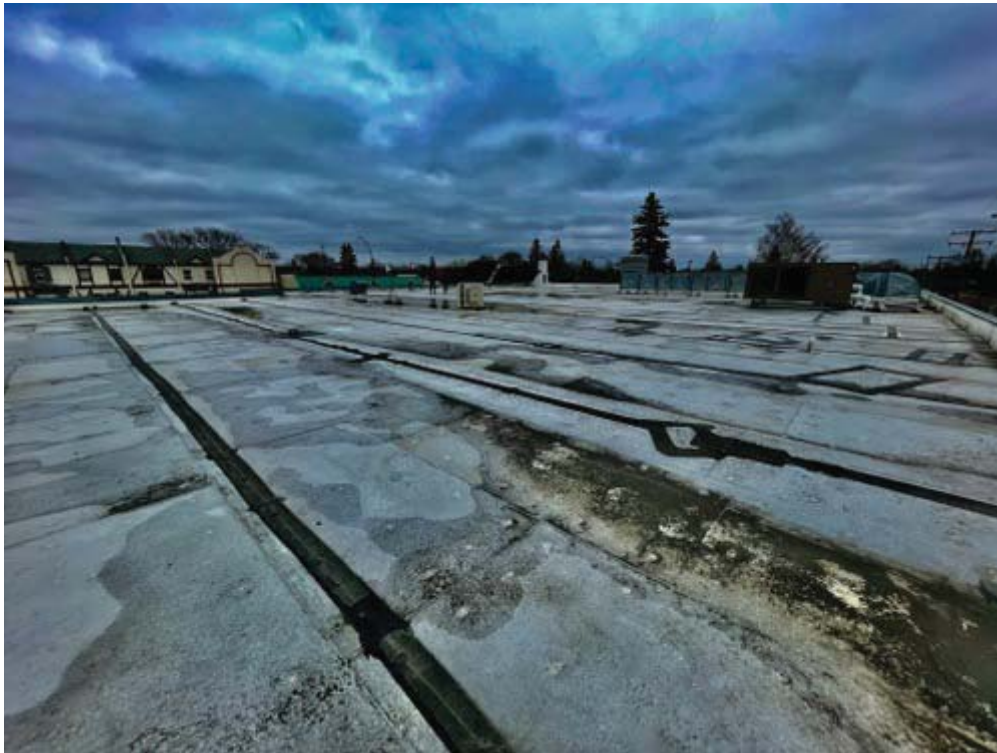
Photo 1

Library Roof - TPO

Overall Condition: Poor

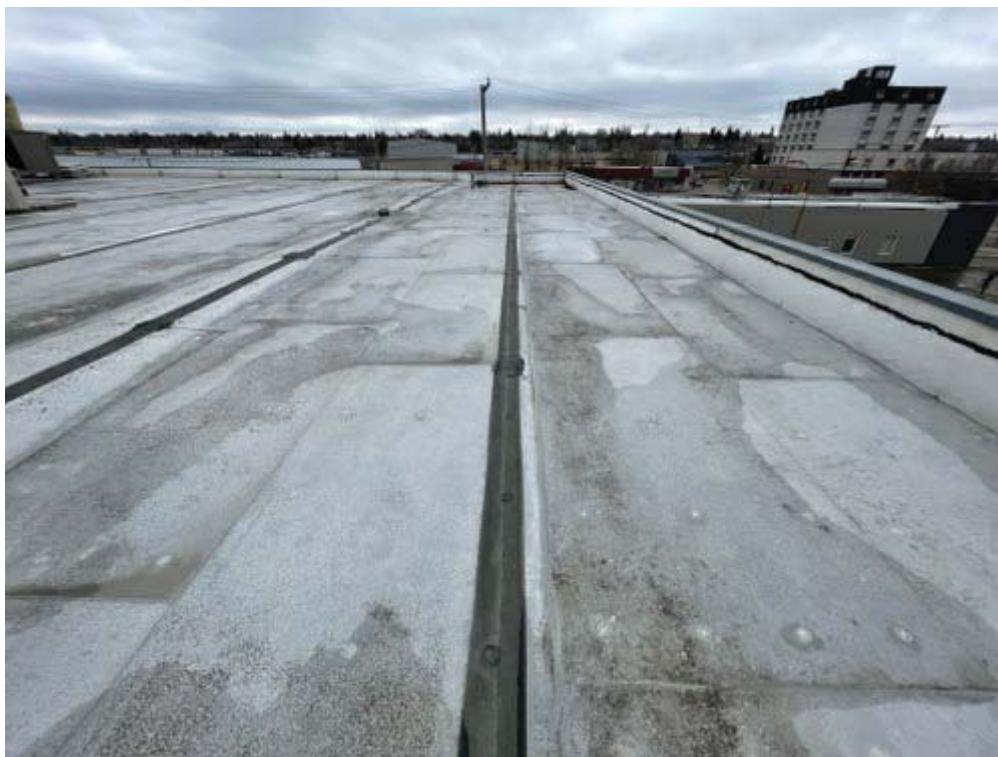
Photo 3

Previously reinforced seams, approximately 10 years old.

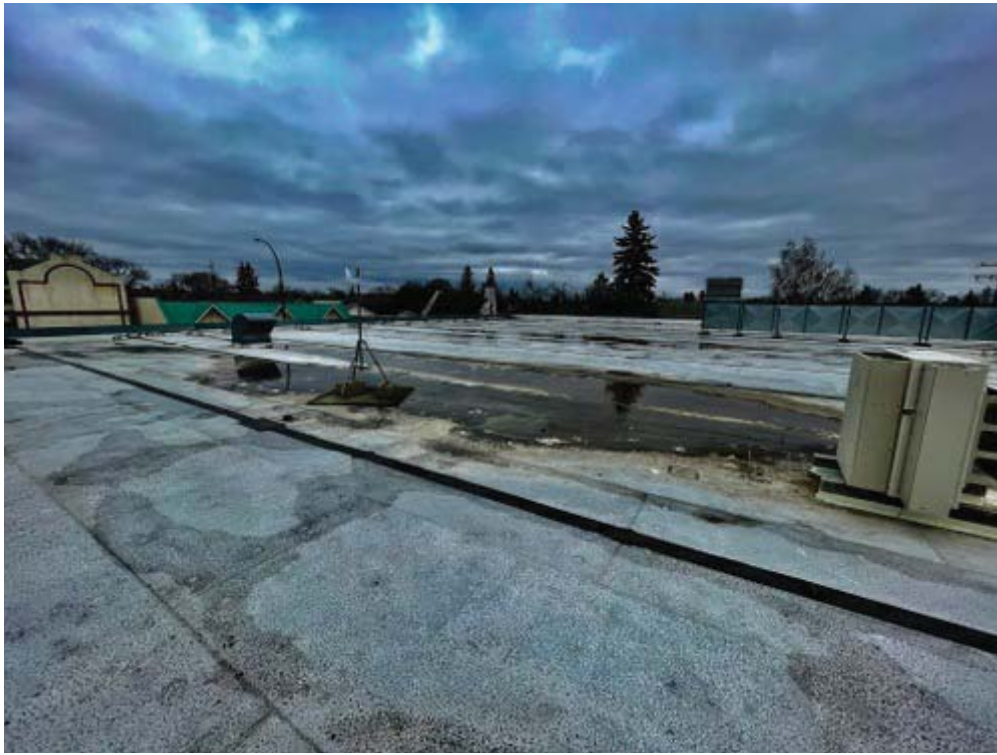
Photo 5

Ponding: Ponding water occurs when moisture collects in large pools on the surface of a roof system. These pools begin to form due to the following: 1) roof drains are blocked or clogged with debris, 2) the insulation package has lost dimensional stability and has reduced in thickness, 3) poor slope to drain design via overbuilt crickets or tapered insulation system, 4) roof drains are

built along side building support columns which maintain a consistent height under load while the balance of the roof system is applied over a live deck which tends to move and deflect under normal seasonal load. In all cases, roof depressions that collect and hold water will tend to grow in size as the added weight of the ponding water will continue to deflect the roof deck even further.

This condition can damage the roof in a number of ways. Additional structural loads create more movement of the roof assembly creating more tear stress and of course a potential for structural failure. UV intensity also increases under ponding conditions as the sun's rays are increased to the point where it accelerates deterioration in most all roof systems. In asphalt based assemblies the natural waterproofing oils in the asphalt will separate from the membrane if the system remains submerged under water for sustained periods. Single ply roof system rot and burn out when the ponding area is exposed to sunlight. The added weight can crush insulation increasing the ponding condition and creating a condition where the insulation becomes a useless thermal barrier. This condition then affects the mechanical system and the cost of heating and cooling the building. In the winter ponding water will expand as it freezes. This expansion will weaken small imperfections in the roof system. Small cracks and tears will widen until they rupture to allow

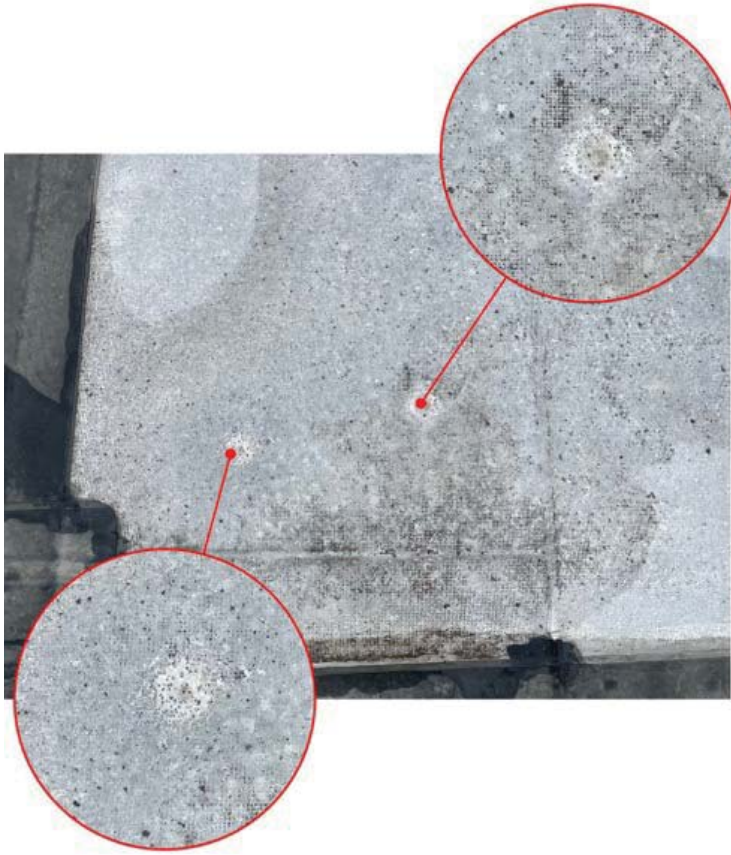
Photo 7

Fastener Back-Out: This condition can occur on mechanically fastened roof systems depending upon the location of the fastener.

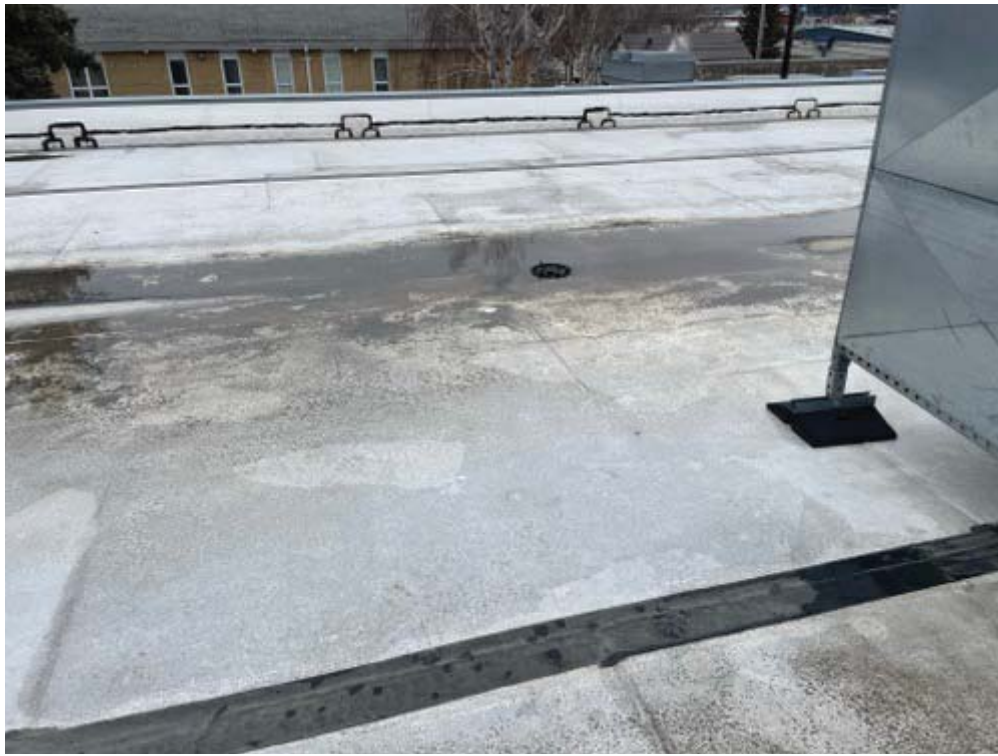
Photo 15

Ponding: Ponding water occurs when moisture collects in large pools on the surface of a roof system

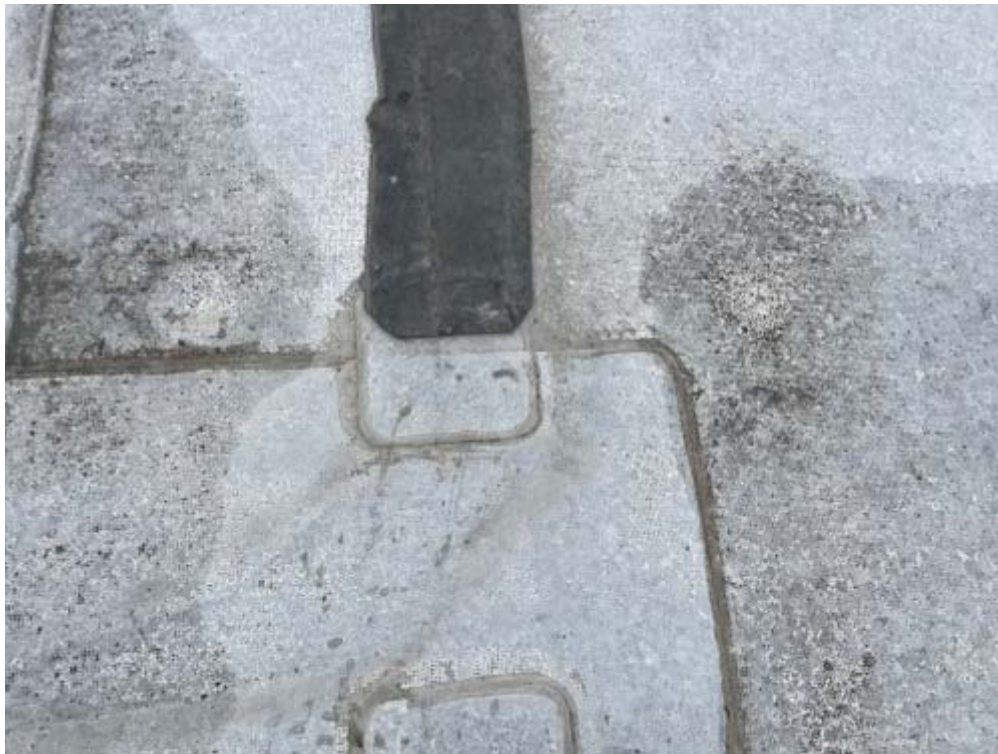
Photo 17

Previously reinforced seams, approximately 10 years old.

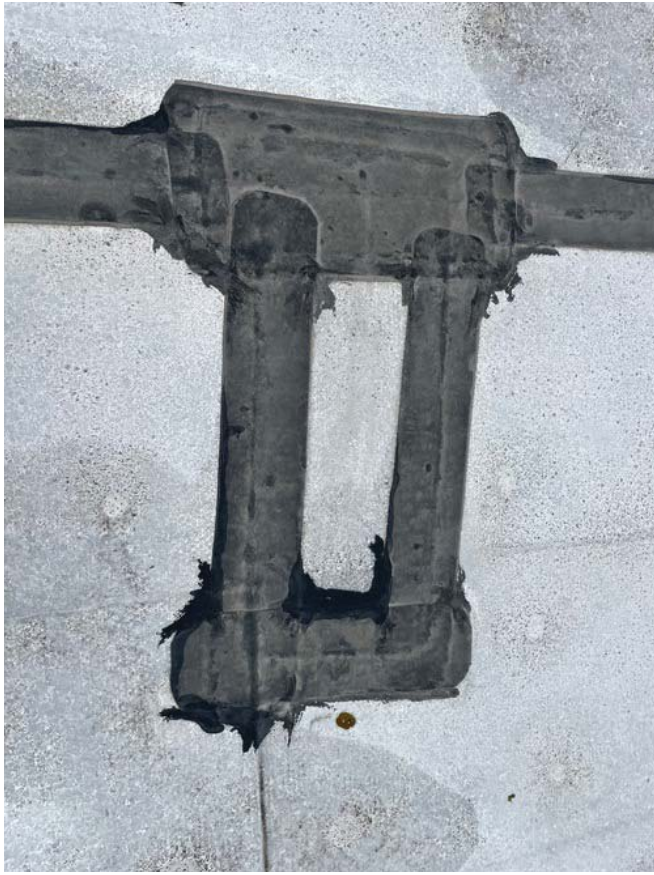
Photo 19

Previously reinforced seams, approximately 10 years old.

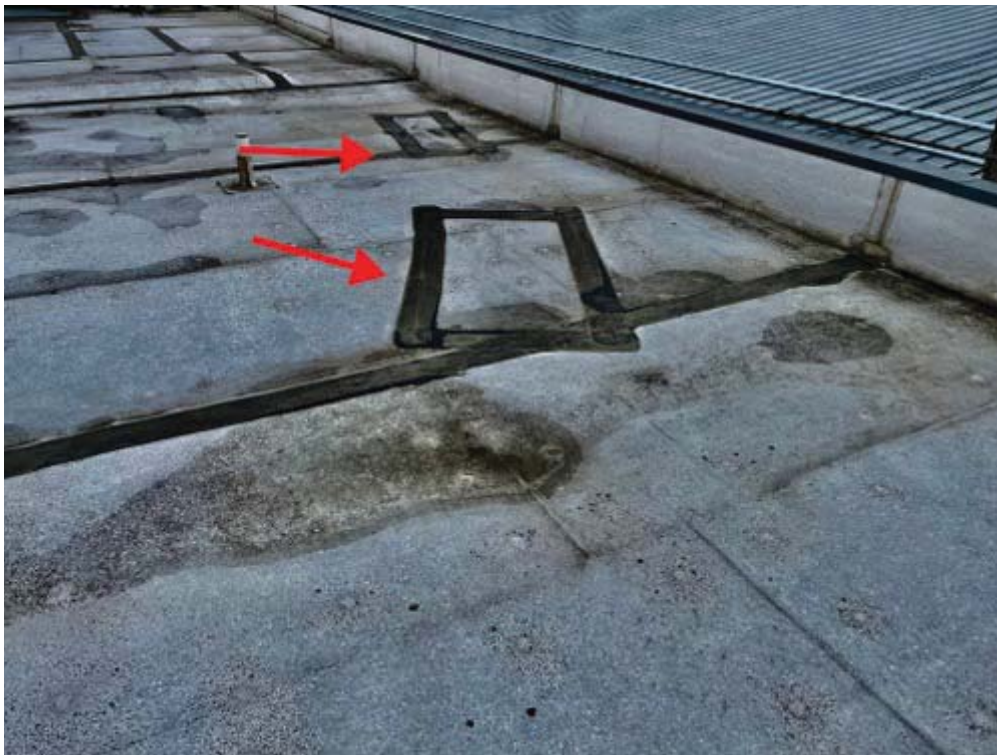
Photo 20

Previous patches.

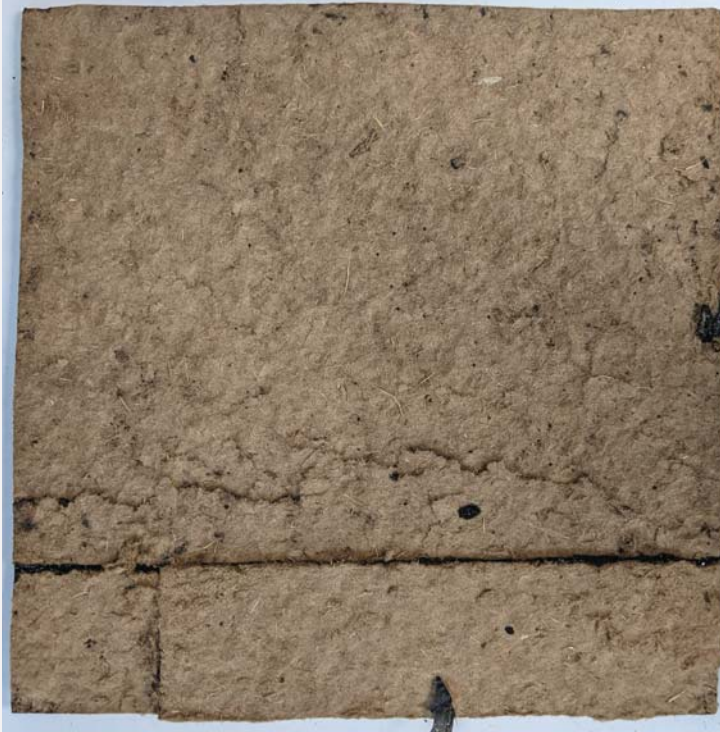
Figure 5: Alfred Jenkins bottom view.

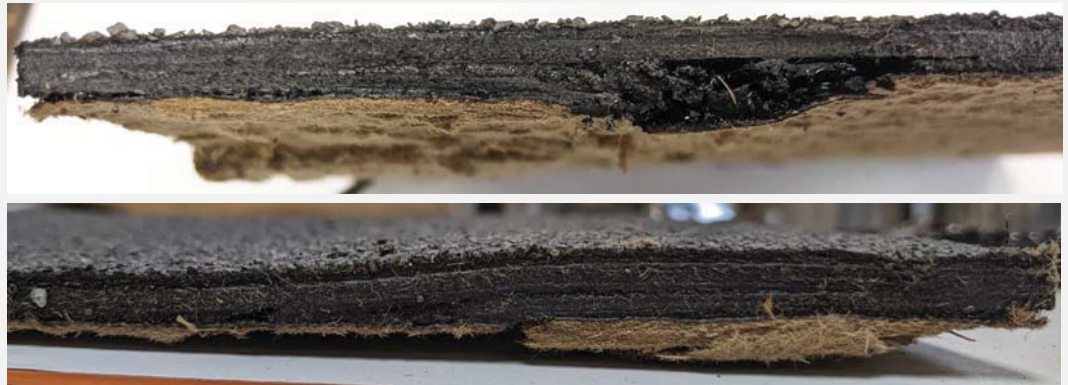
The 12 year old core sample is from a 2 ply modified roof system with fiberglass felt interplies in an asphalt adhesive. The lower interplies of the core are hard and brittle, and easily crumble by hand (Figure 6). The interplies could not be easily delaminated by hand. The mineral surfacing on this core has maintained good coverage. The softening point and pen tests show that the asphalt adhesive responsible for keeping the system intact has lost its oils over time, causing the system to become more brittle. The cores tested below the recommended tensile strength and elongation recommendations. The sample performed well when undergoing puncture testing, implying that the system can withstand foot traffic and most weather phenomena.

Figure 6: Alfred Jenkins side profile.

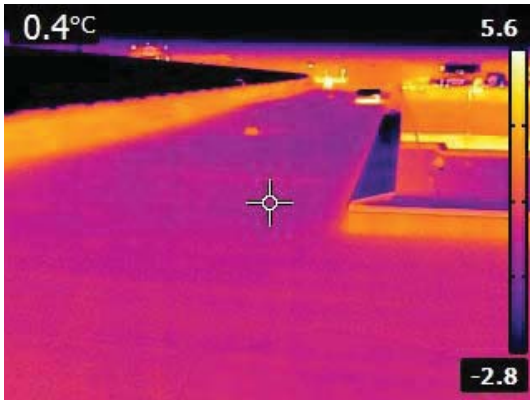
Photo 1

General view of section A2 (upper section)

No thermal anomaly was found on this section.

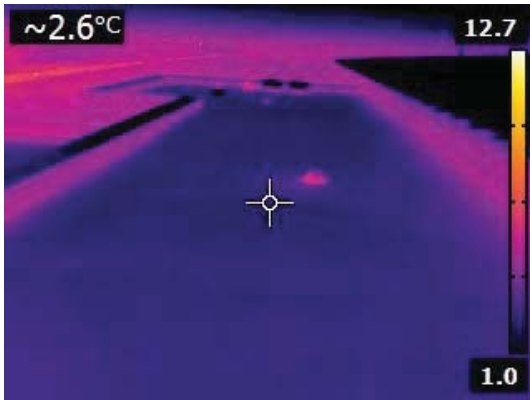
Photo 2

General view of section A2 (upper section)

No thermal anomaly was found on this section.

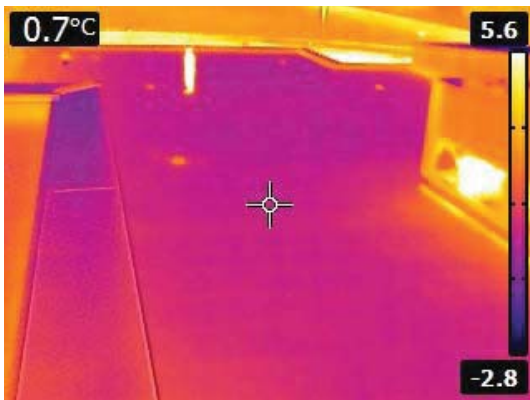
Photo 3

General view of section B1 (lower section) - from above

No thermal anomaly related to wet areas was found on this section.

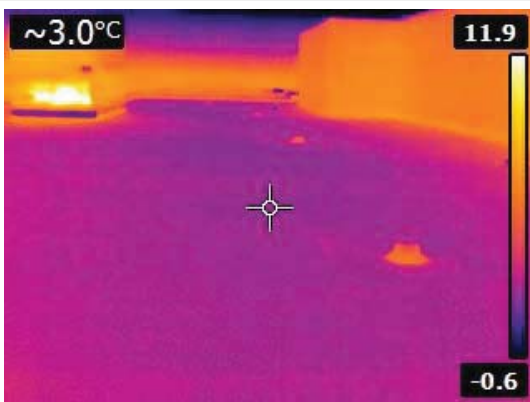
Photo 4

General view of section B1 (lower section) - from the roof surface

No thermal anomaly related to wet areas was found on this section.

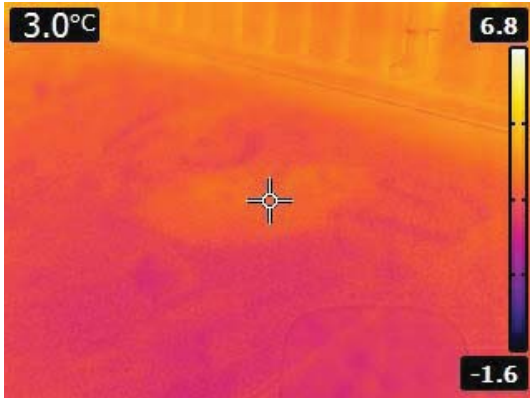
Photo 5

General view of a blister on the membrane with the infrared camera.

A humidity meter was used to confirm that the roofing assembly around the blister is still dry.

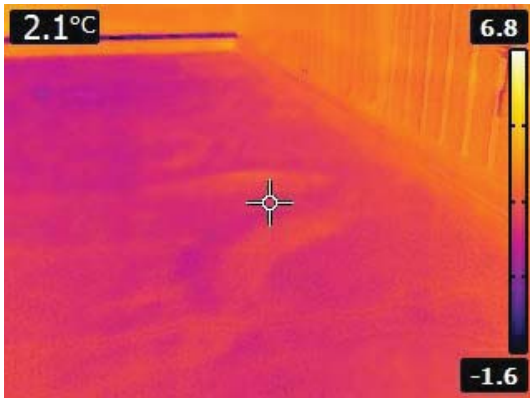
Photo 6

General view of ridges on the membrane with the infrared camera.

A humidity meter was used to confirm that the roofing assembly around the ridges is still dry.

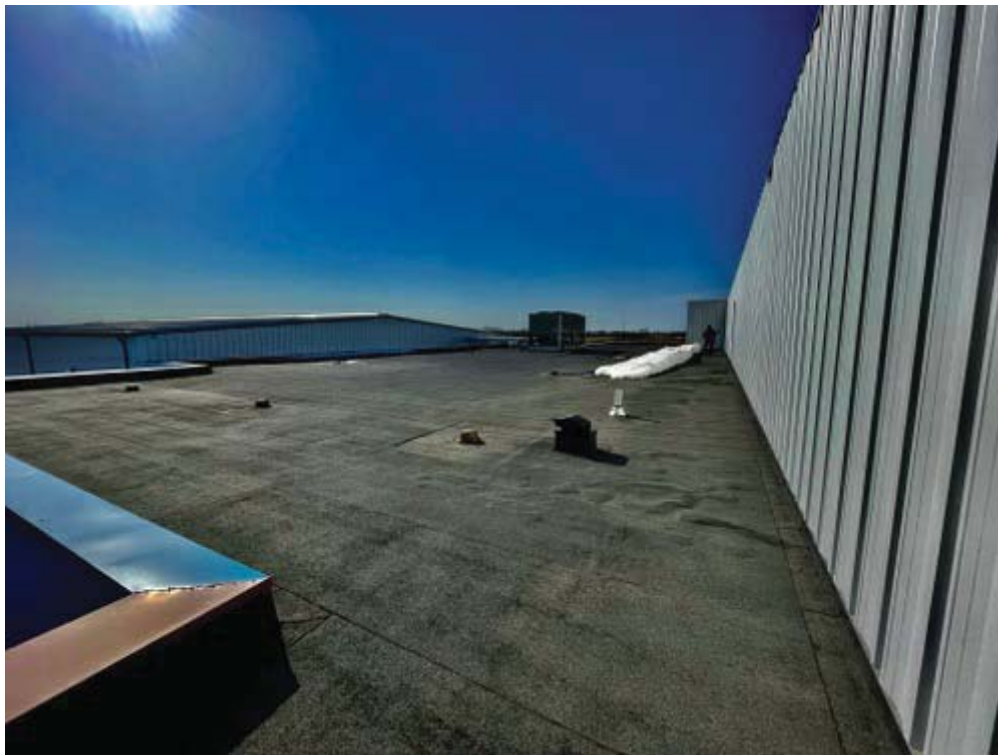
Photo 1

Section 1 - 2 ply Modified Bitumen

Overall Condition: Failed

CLEAR Analysis: The 12 year old core sample is from a 2 ply modified roof system with fiberglass felt interplies in an asphalt adhesive. The lower interplies of the core are hard and brittle, and easily crumble by hand (Figure 6). The interplies could not be easily delaminated by hand. The mineral surfacing on this core has maintained good coverage. The softening point and pen tests show that the asphalt adhesive responsible for keeping the system intact has lost its oils over time, causing the system to become more brittle. The cores tested below the recommended tensile strength and elongation recommendations. The sample performed well when undergoing puncture testing, implying that the system can withstand foot traffic and most weather phenomena.

IR Scan: 0% Wet

Scope of Work: Replacement of Waterproofing Membrane With Up to 30 Year Water Tight Warranty

1. Remove all roof components down to dry insulation;
2. Install new recovery board in damaged areas;
3. Install new SBS modified bitumen base sheet
4. Install new SBS modified bitumen cap sheet

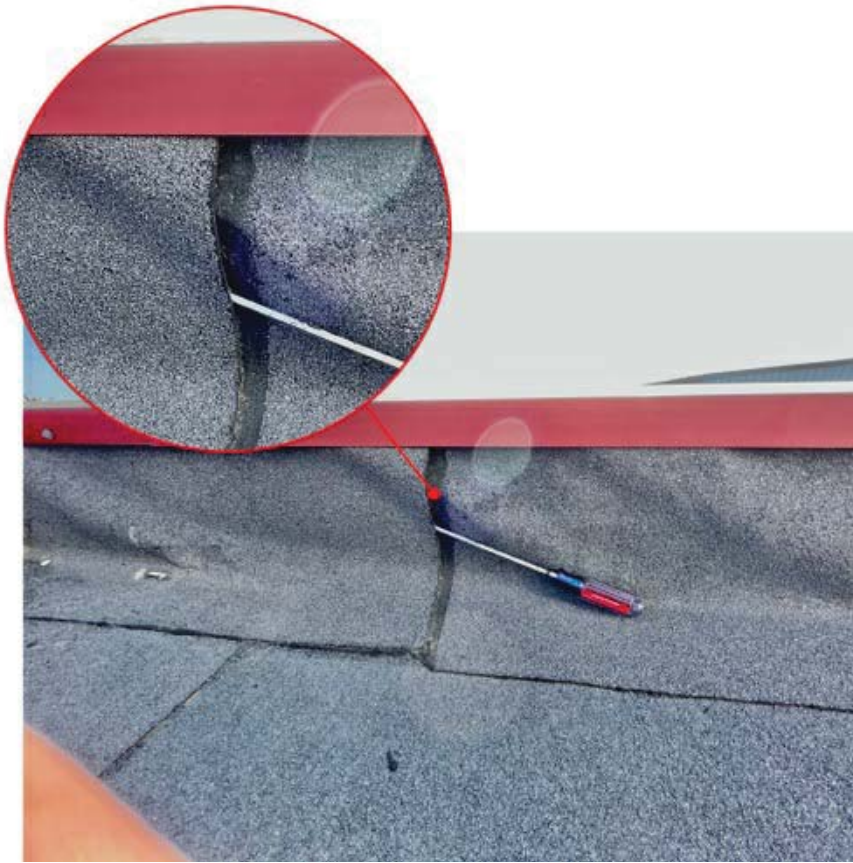
Photo 2

Fish mouths: Wrinkles or openings at the edge of the membrane caused by poor adhesion or installation. Fish mouths are a common cause of early failure on 2-ply torch down and single ply roof systems. These systems are prone to workmanship error due to two factors (1) the manual heating/welding of the adhesive, which is very unpredictable for constant heat, and (2) the roof system only consists of 1 to 2 plies, which translates in to a very thin layer of water protection.

Perimeter Flashing Deterioration:

Most roof failures start at perimeter and penetration locations. Metal edge conditions that are poorly designed and improperly installed fail due to the extreme expansion and contraction that is typical with metal. Perimeter wall flashings can also be damaged due to normal seasonal building movement and thermal shock. Additional damage can also be see from UV degradation as well. At all of these deteriorated or failed points, moisture can gain direct access to the roof system insulation and the buildings interior.

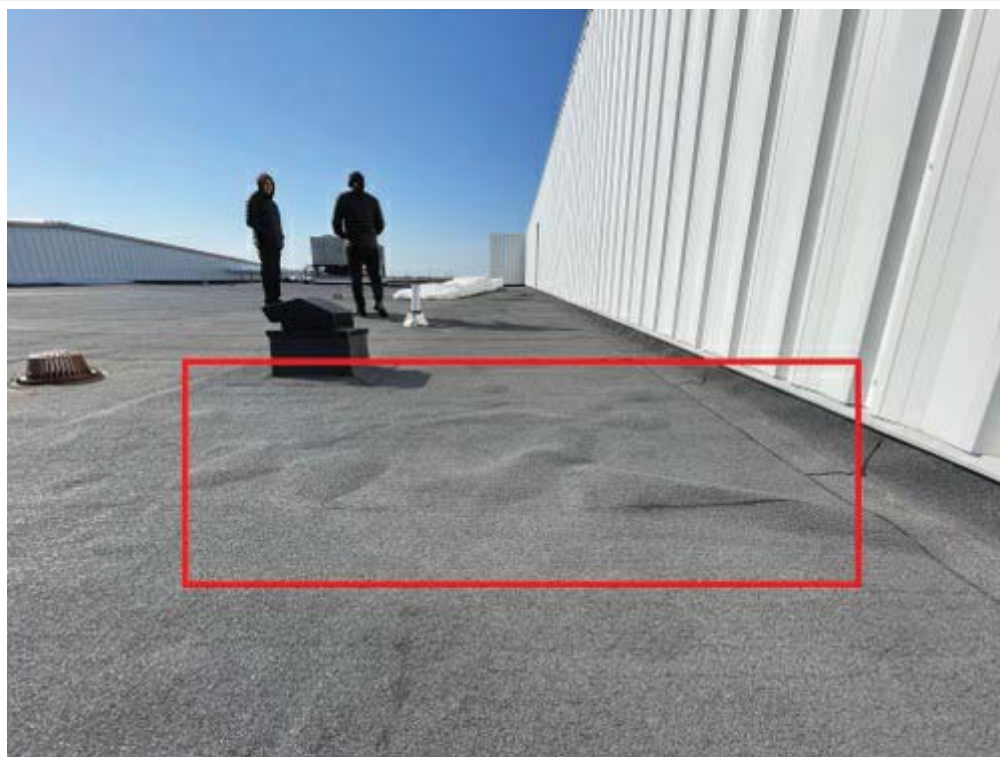
Photo 4

Blisters: Soft spongy pockets or swellings in the roofing material. They occur between layers of felt or between the roof membrane and substrate. Air or moisture vapor entrapped within a blister expands as the roof and outside air temperatures rise. This results in sufficient pressure to push the roofing felts upwards and apart. Blisters may be ruptured by roof traffic, expanding frozen water, or hail (especially during colder weather). Some blisters may become so large as to affect drainage, which may then cause ponding water. Laps could also be pulled apart, resulting in leakage. A ruptured blister will immediately allow water to penetrate and damage the roof system.

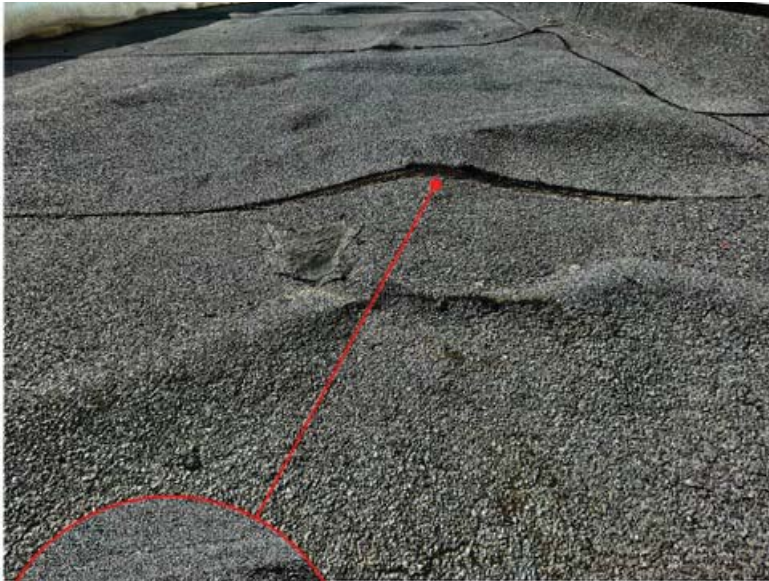
Photo 5

Blisters: Soft spongy pockets or swellings in the roofing material. They occur between layers of felt or between the roof membrane and substrate. Air or moisture vapor entrapped within a blister expands as the roof and outside air temperatures rise.

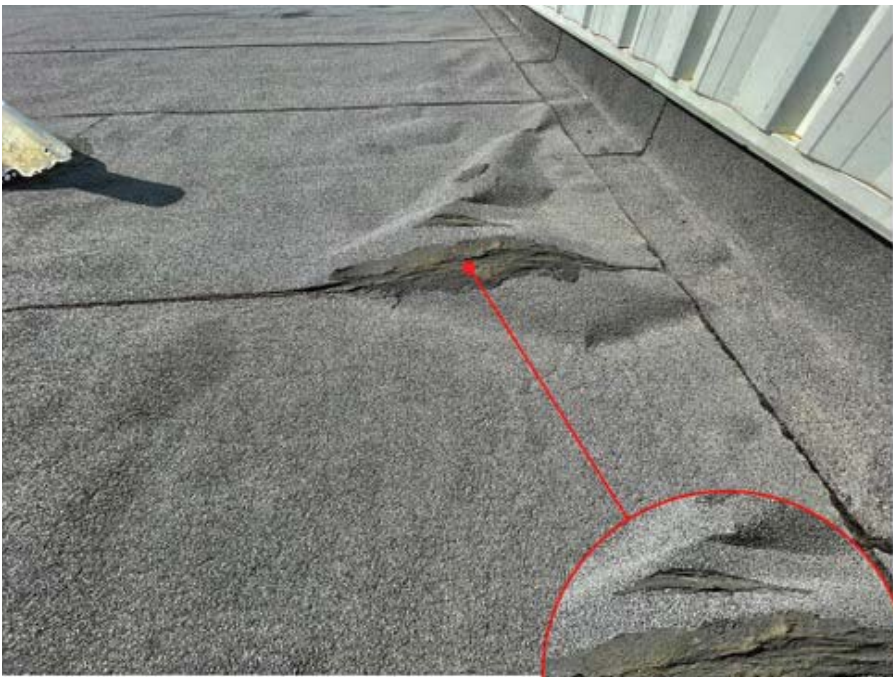
Photo 6

Blisters: Soft spongy pockets or swellings in the roofing material. They occur between layers of felt or between the roof membrane and substrate. Air or moisture vapor entrapped within a blister expands as the roof and outside air temperatures rise.

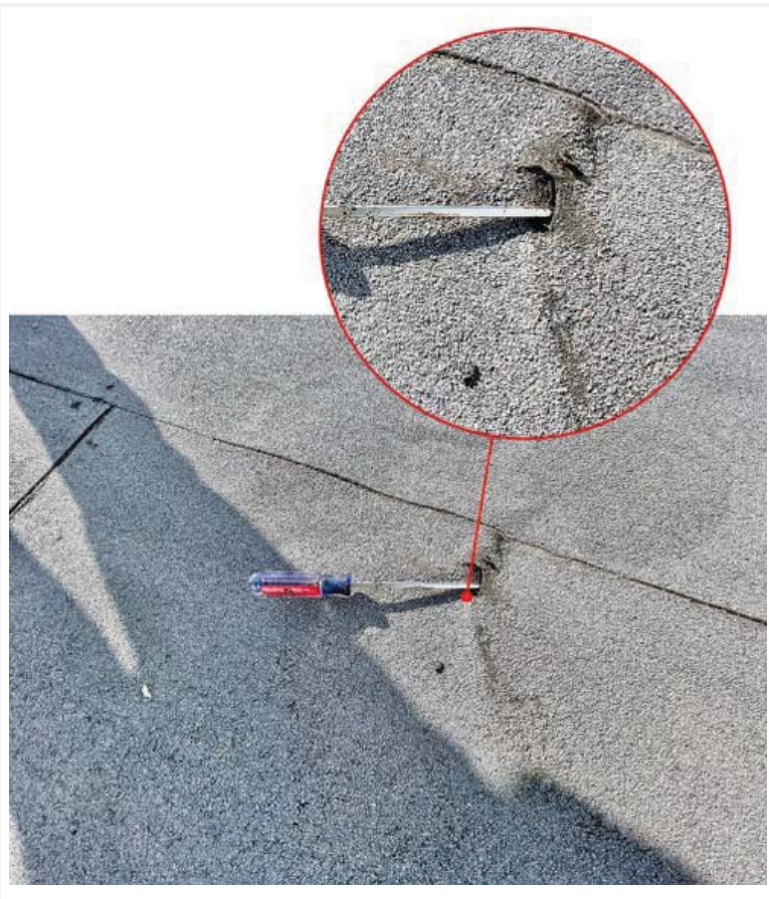
Photo 7

Membrane Puncture: Large puncture hole in waterproofing membrane allowing for moisture access the building.

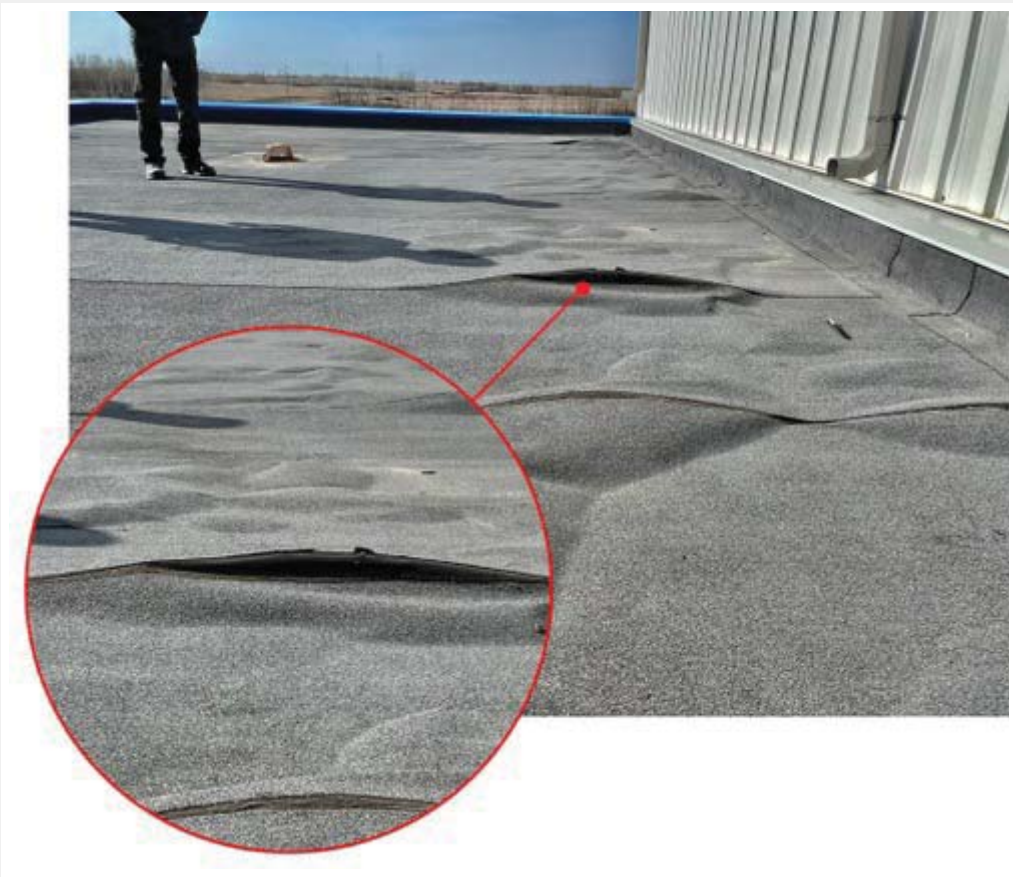
Photo 8

Seams: As the membrane blisters, this puts added stress on the seams. They are starting to split in many places allowing for moisture access into the building.

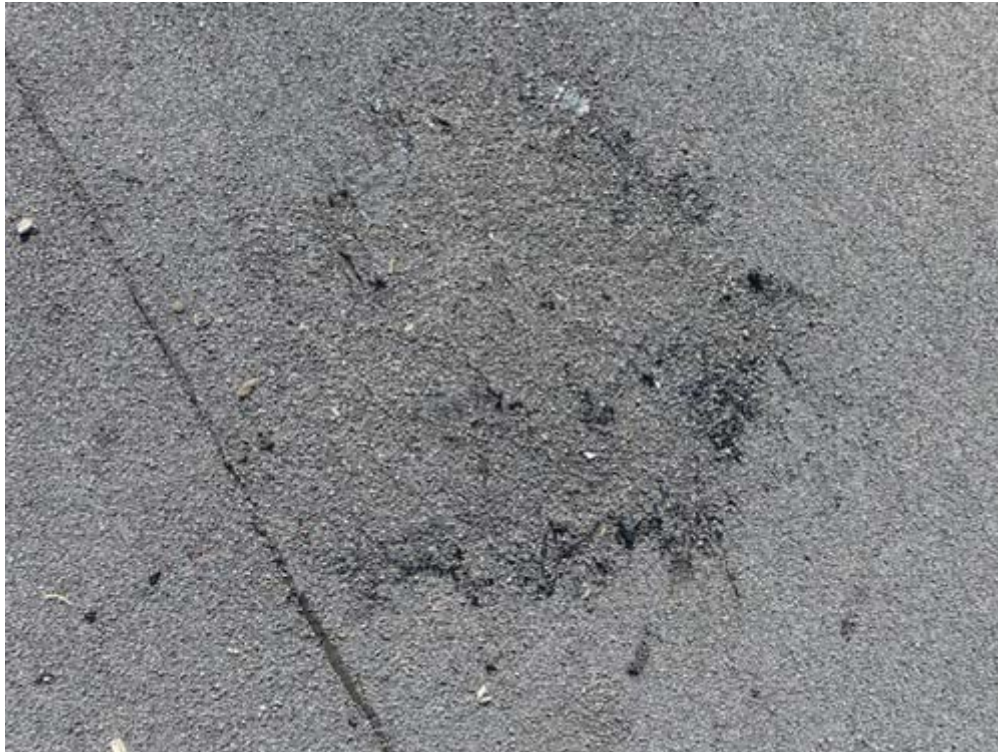
Photo 13

Core Cut: Repaired core cut using high-grade roof mastic imbedded with mesh to increase tensile strength of repair. Imbedded with gravel worn off of the membrane to help against UV.

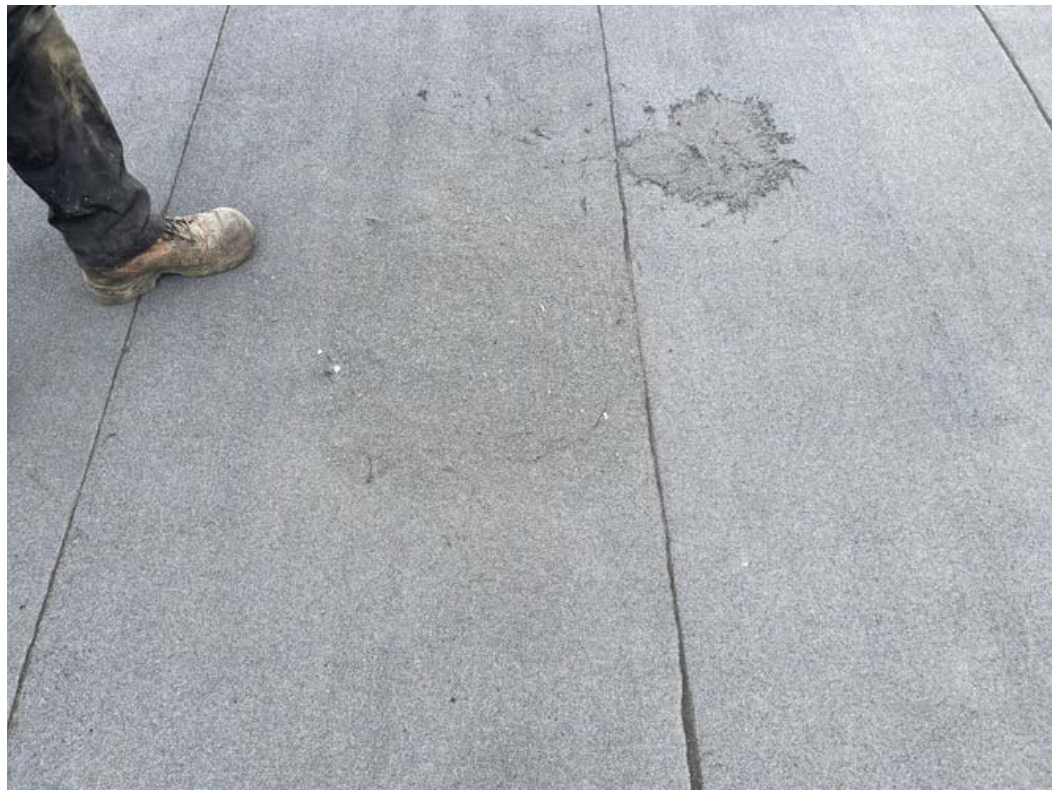
Photo 16

CLEAR Analysis: Reinforced repair using roof granules to protect from UV and other elements.

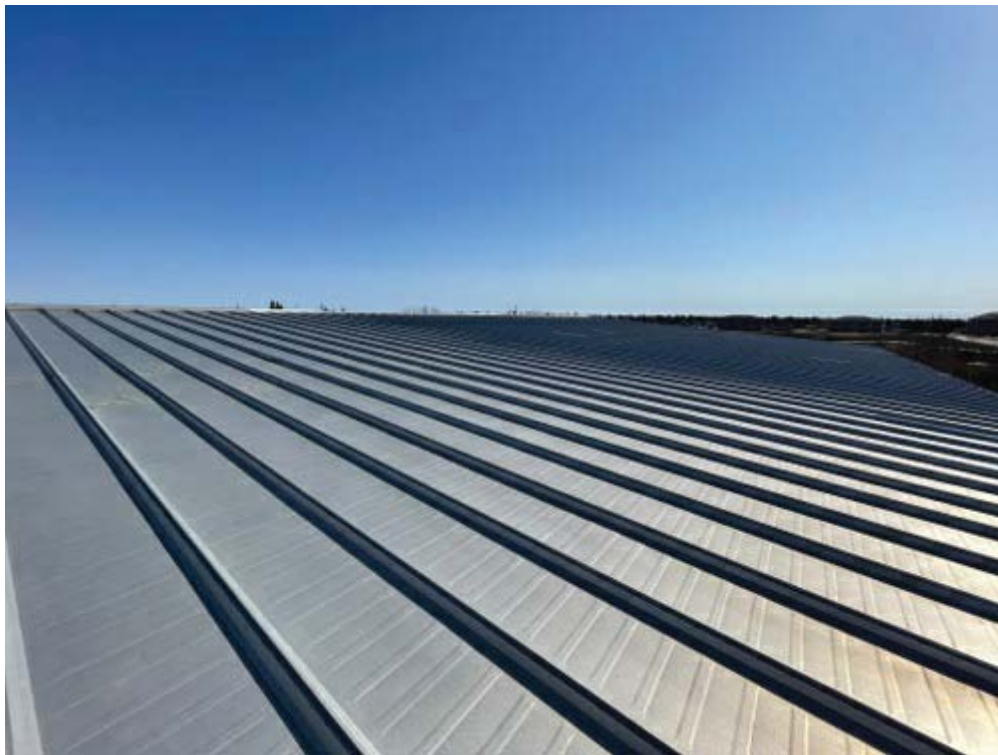
Photo 1

Section 2: Standing Seam Metal

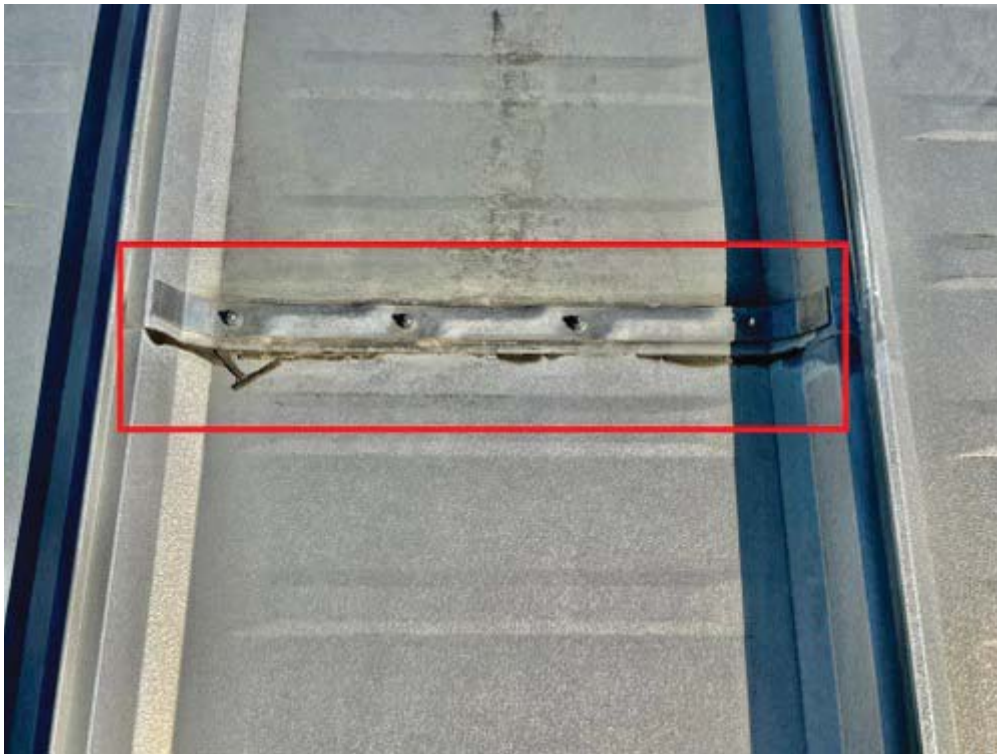
Photo 3

Ridge Cap Vent: Sealant around Ridge Cap Vent deteriorating allowing for potential moisture access.

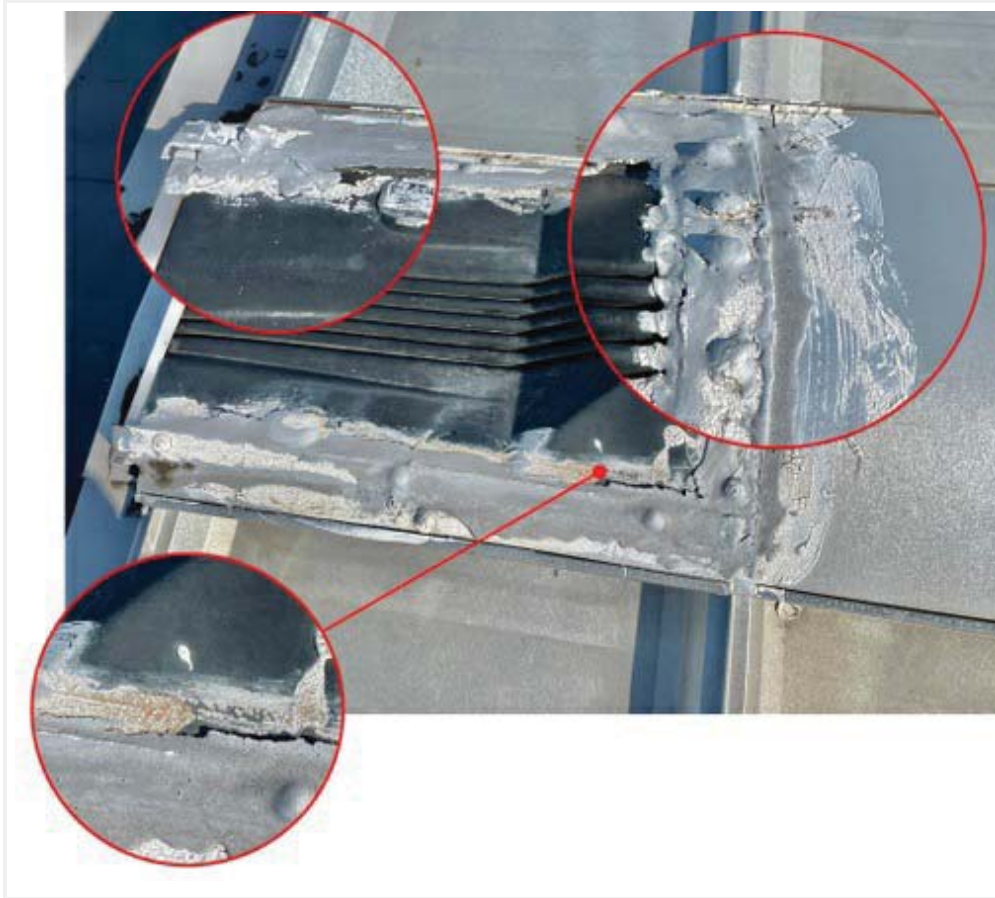
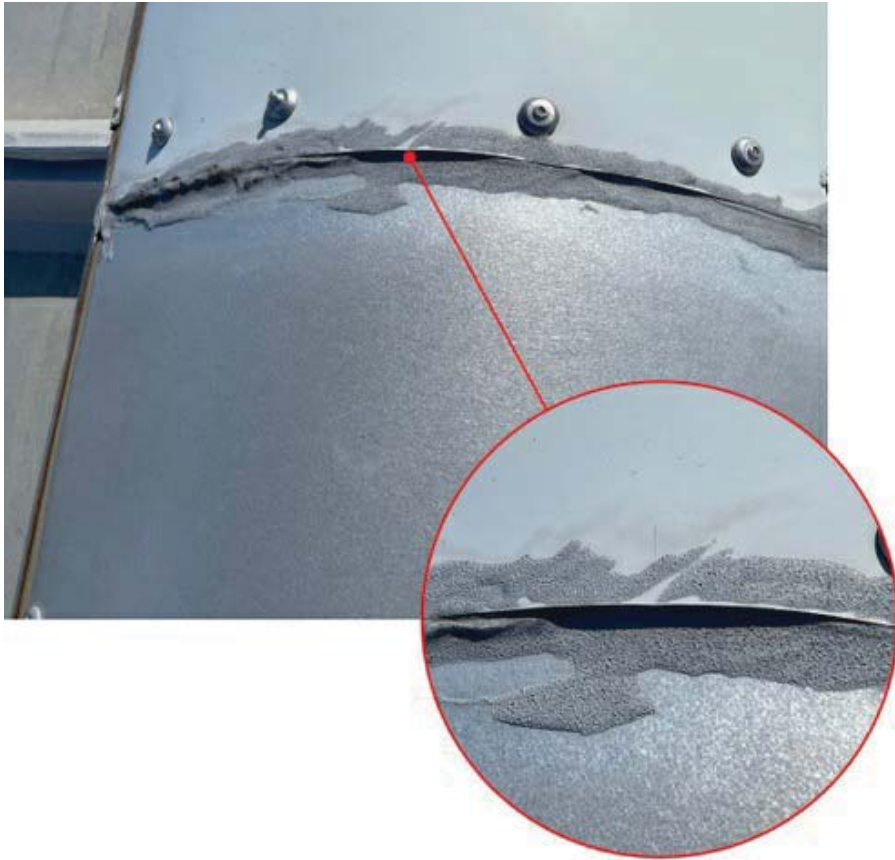
Photo 4

Ridge Cap Seam Caulking

Deterioration: As caulking is exposed to UV rays and temperature fluctuations it loses its flexibility and develops cracks. Once this occurs splits develop allowing water to penetrate walls and buildings causing damage as well as leaks.

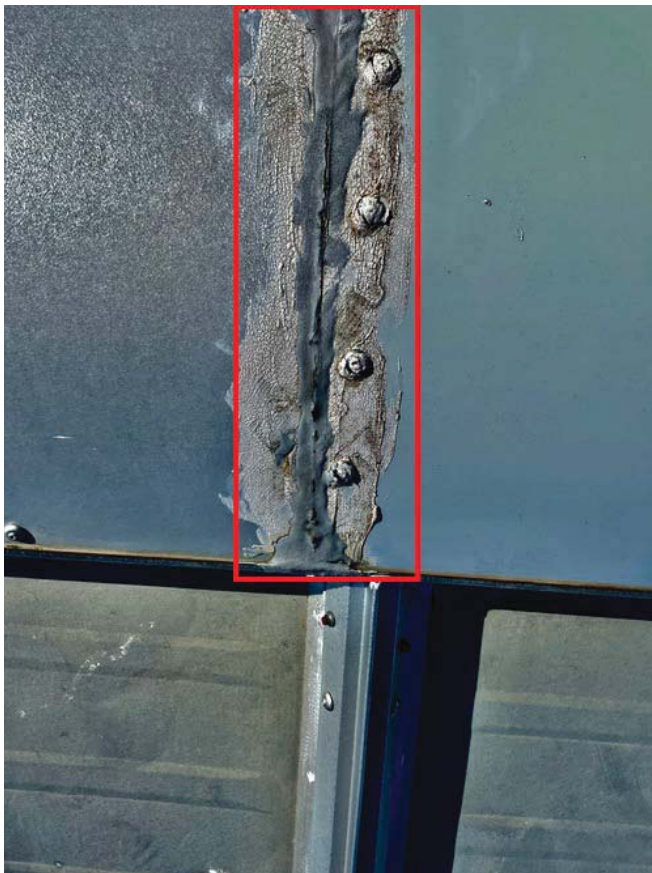
Photo 5

Ridge Cap Seam Caulking Deterioration: As caulking is exposed to UV rays and temperature fluctuations it loses its flexibility and develops cracks. Once this occurs splits develop allowing water to penetrate walls and buildings causing damage as well as leaks.

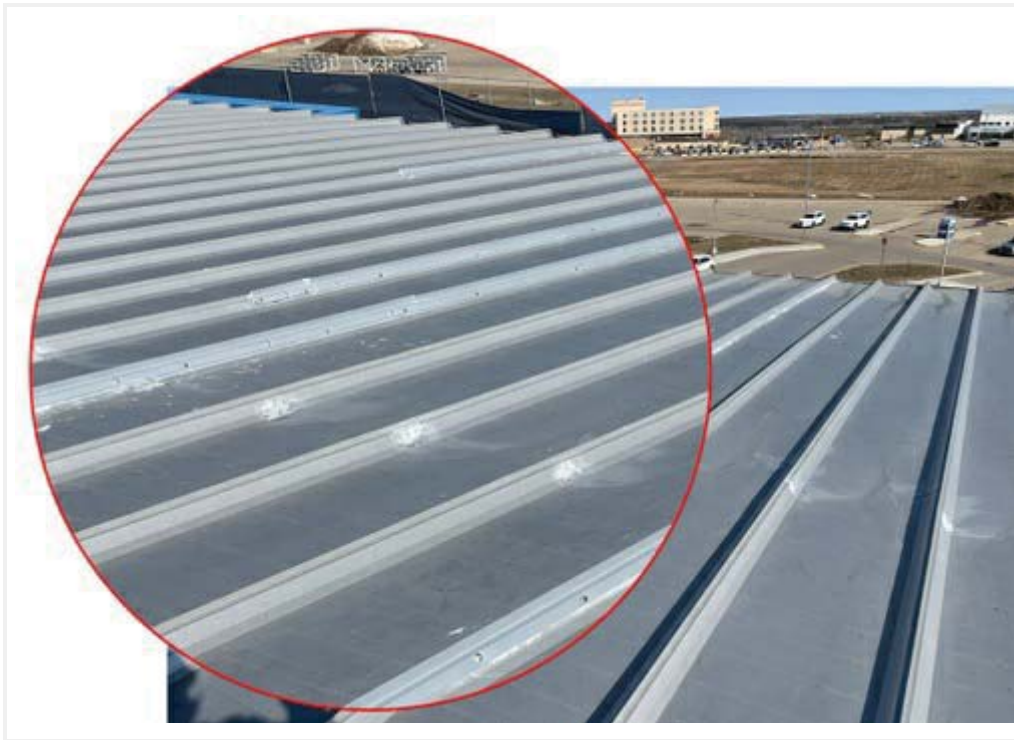
Photo 8

Previous Repair: Previous reinforcement of standing vertical seams found on several areas of the roof varying in length.

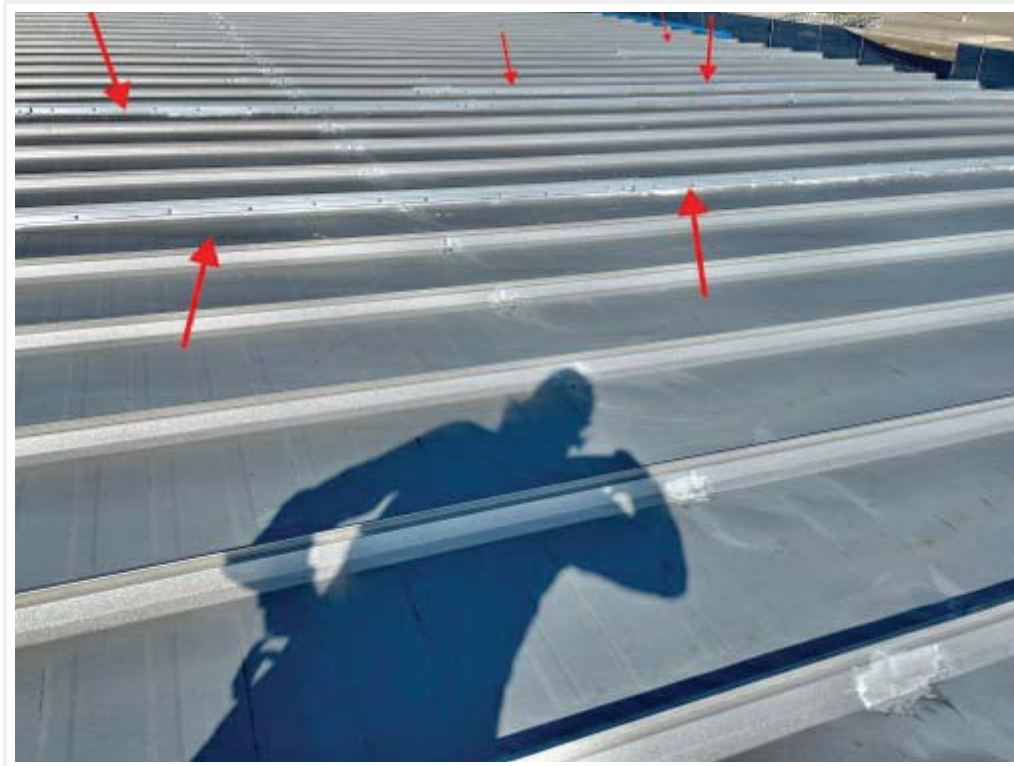
Photo 9

Previous Repair: Previous reinforcement of standing vertical seams found on several areas of the roof varying in length.
