FACILITY REVIEW 2025 – 2029

Parks, Recreation &
Culture Department

City of
Prince Albert

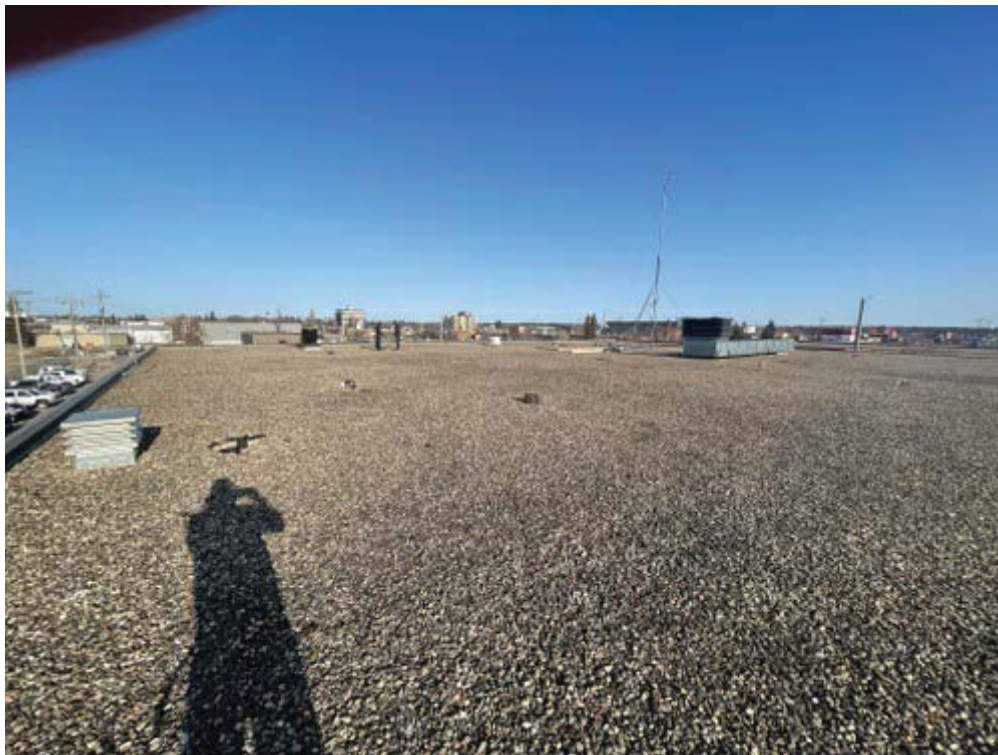
Photo 1

Roof Section - I.R.M.A.

CLEAR Analysis: The 30 year old core sample is from a 4 ply inverted roofing membrane assembly (IRMA) with felt paper interplies in an asphalt adhesive. The interplies were very easily delaminated by hand as shown in Figure 9. The interplies and overall thickness of the core imply that the system was installed at a lower than specified temperature resulting in thick, viscous layers. The thickest point of adhesive was measured at 125 mils. A typical interply thickness when installed correctly is between 32-40 mils. Due to the overall thickness of the core, specimens could not be cut for tensile, elongation, and flexural strength. A surface coating was used on the membrane, which is unusual for an IRMA system. Instead, a final layer such as paving stones typically protect the membrane from

the elements. The softening point and pen tests show that the asphalt adhesive and flood coat responsible for keeping the system intact has lost its oils over time, causing the system to become more brittle. The sample performed well when undergoing puncture testing, implying that the system can withstand foot traffic and most weather phenomena.

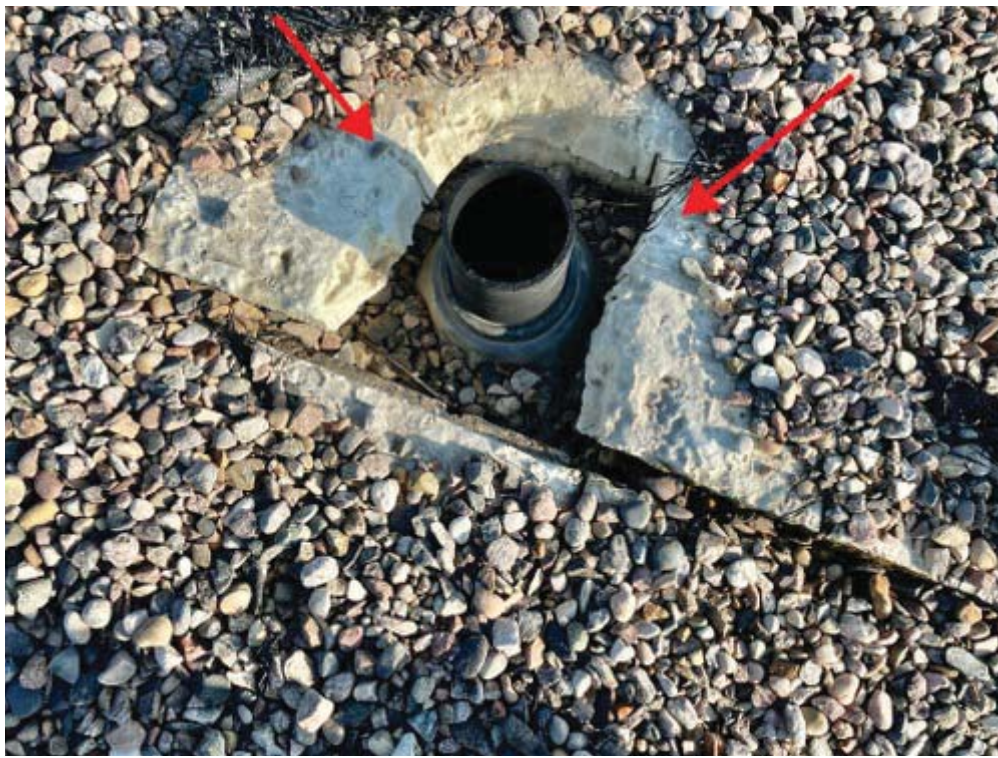
Photo 2

Insulation: Extruded polystyrene insulation beginning to shrink from exposure to UV and other elements. EPS also experiences post- molding shrinkage; it shrinks dimensionally from its molded size after processing.

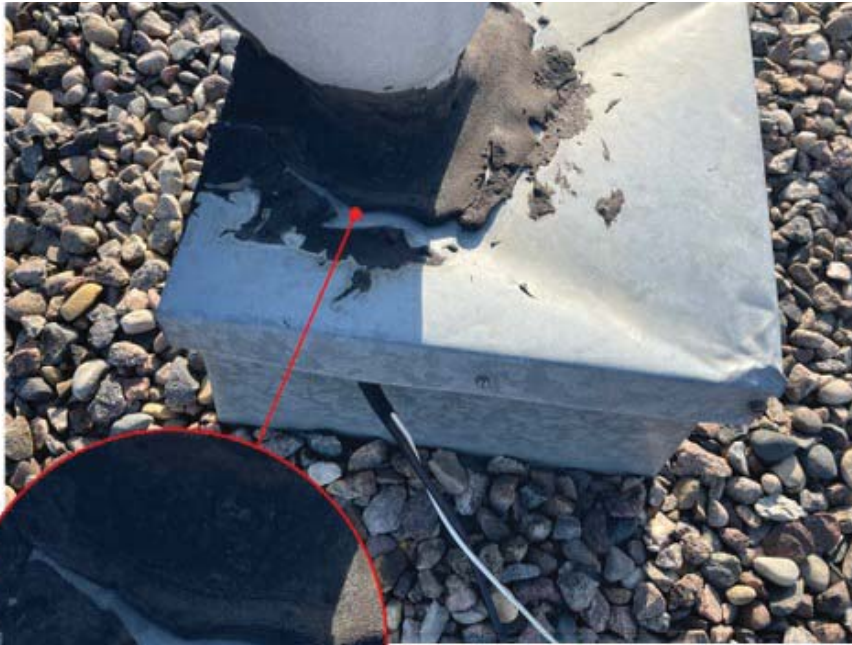
Photo 3

Caulking Deterioration: As caulking is exposed to UV rays and temperature fluctuations it loses its flexibility and develops cracks. Once this occurs splits develop allowing water to penetrate walls and buildings causing damage as well as leaks.

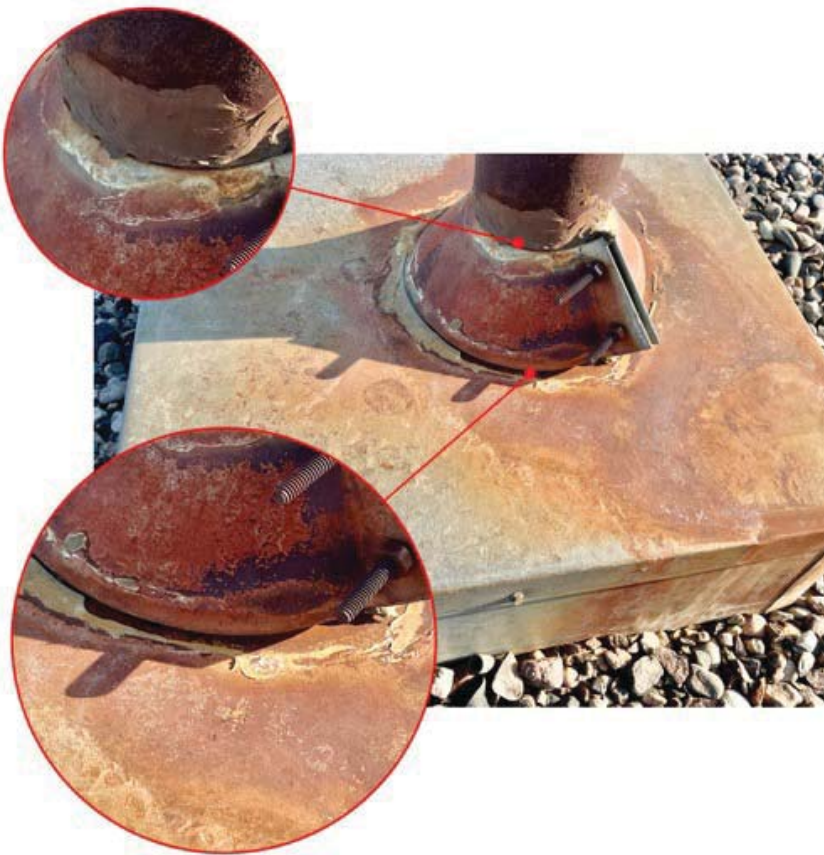
Photo 4

Caulking Deterioration: As caulking is exposed to UV rays and temperature fluctuations it loses its flexibility and develops cracks. Once this occurs splits develop allowing water to penetrate walls and buildings causing damage as well as leaks.

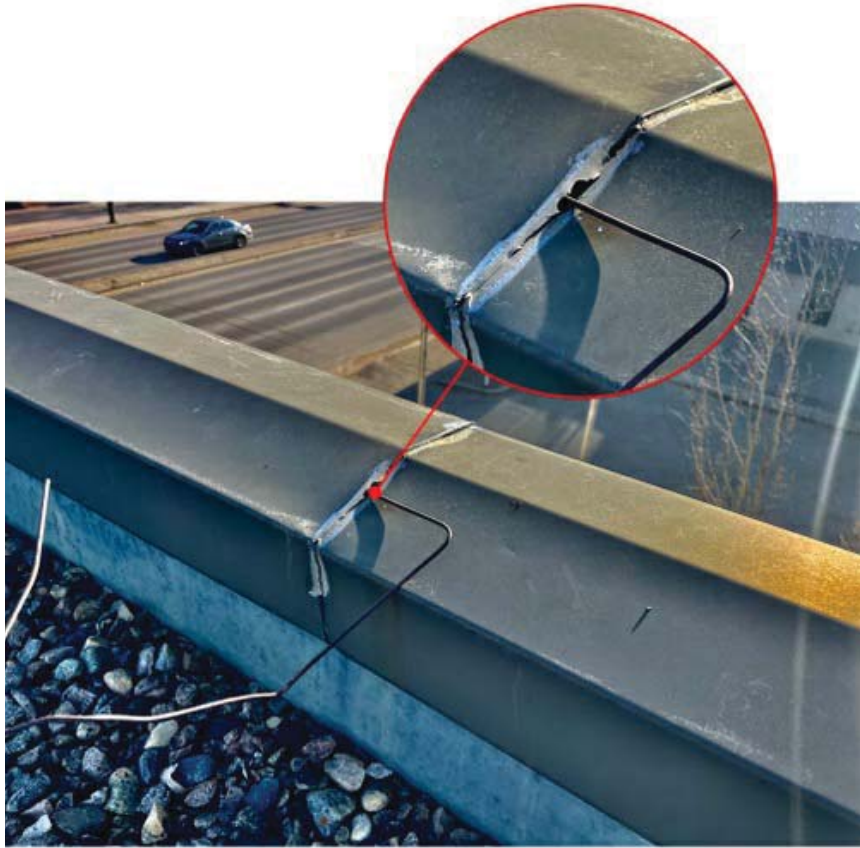
Photo 5

Caulking Deterioration: As caulking is exposed to UV rays and temperature fluctuations it loses its flexibility and develops cracks. Once this occurs splits develop allowing water to penetrate walls and buildings causing damage as well as leaks.

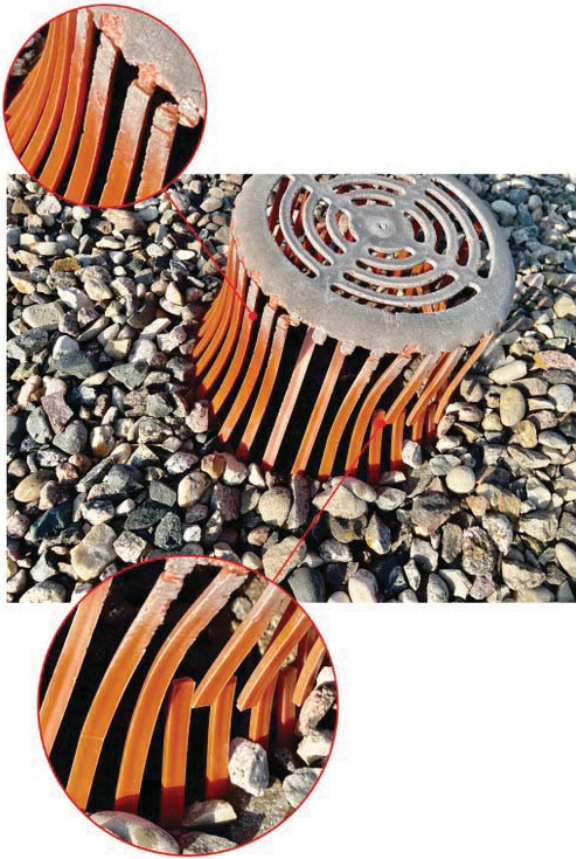
Photo 6

Drain Screen: Cracked

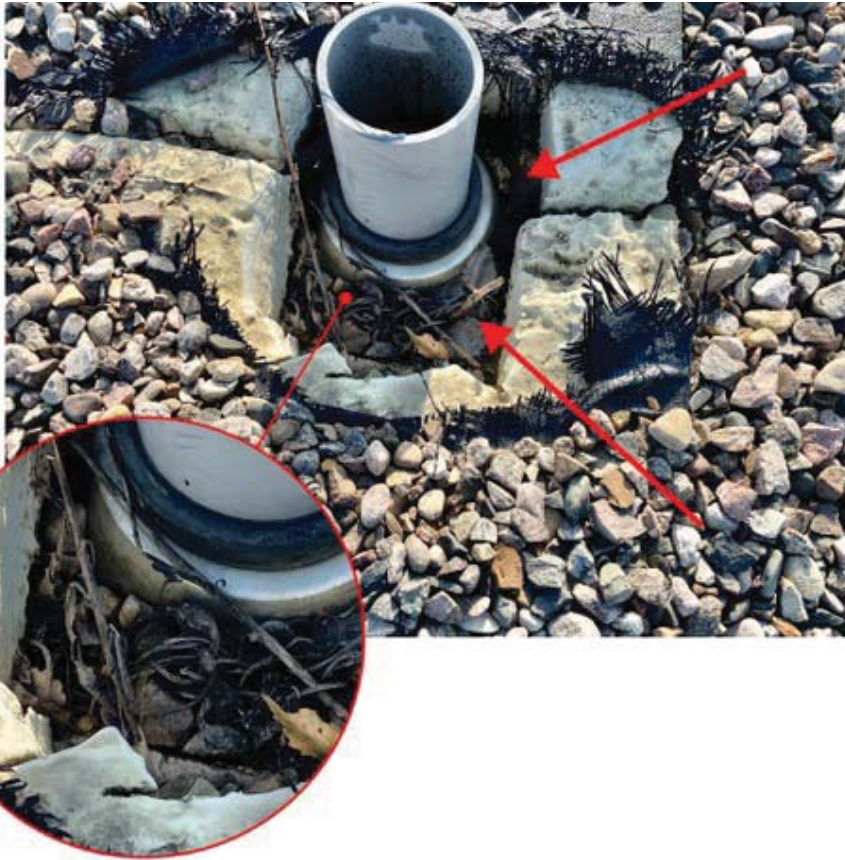
Photo 7

Insulation: Extruded polystyrene insulation beginning to shrink from exposure to UV and other elements. EPS also experiences post- molding shrinkage; it shrinks dimensionally from its molded size after processin

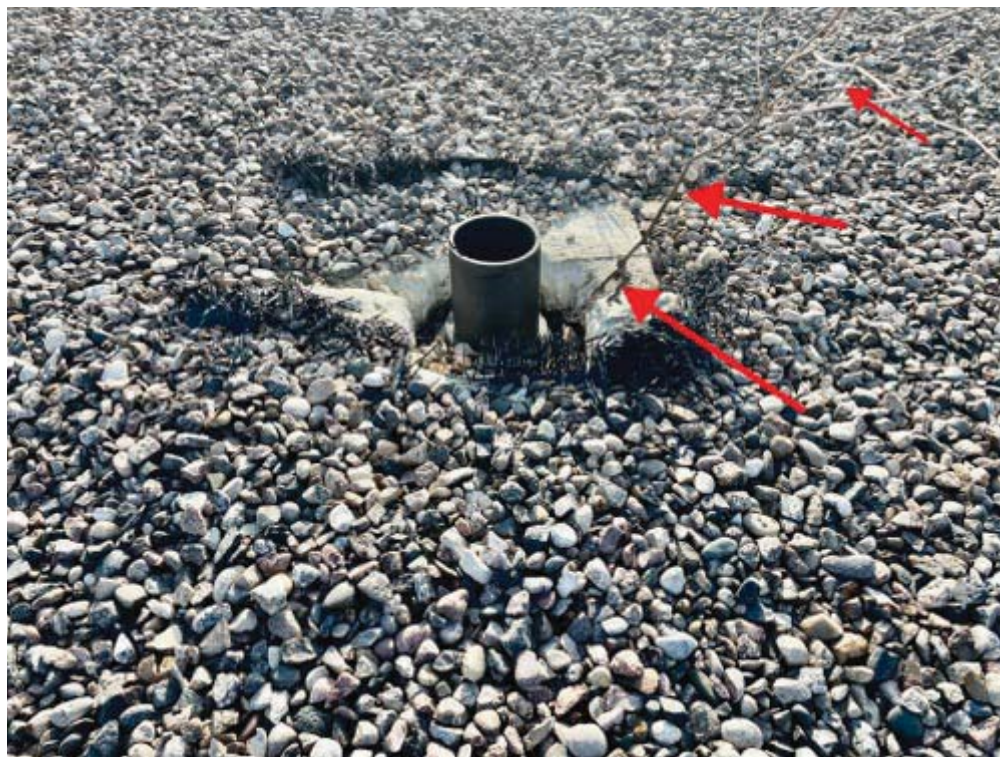
Photo 10

Insulation: Extruded polystyrene insulation beginning to shrink from exposure to UV and other elements. EPS also experiences post- molding shrinkage; it shrinks dimensionally from its molded size after processing.

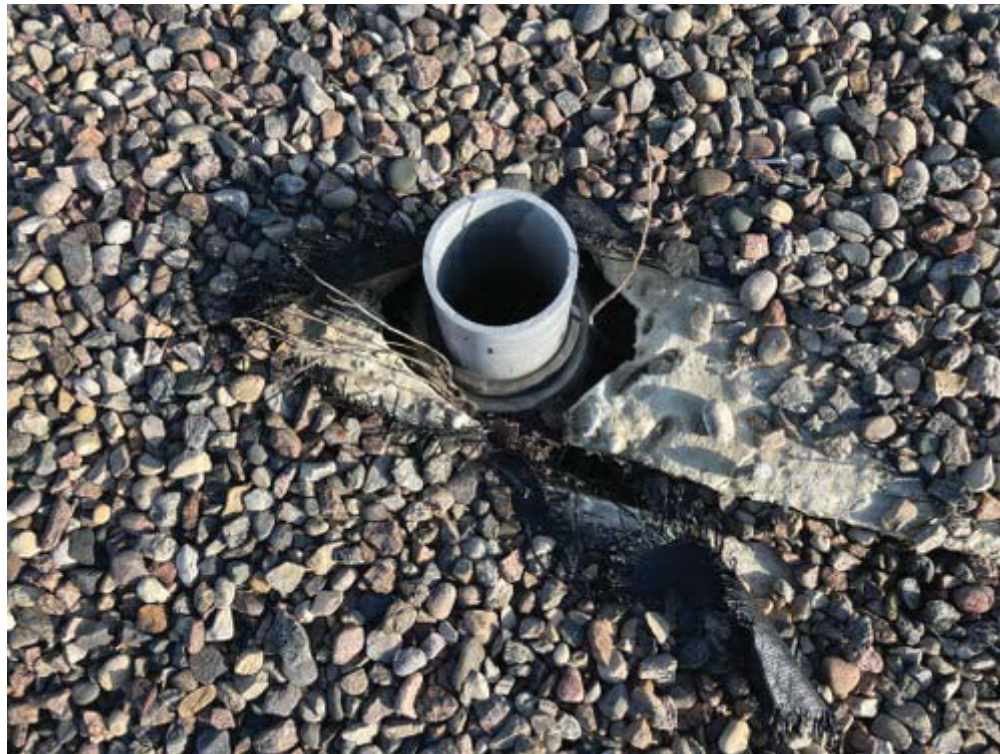
Photo 11

Insulation: Extruded polystyrene insulation beginning to shrink from exposure to UV and other elements. EPS also experiences post- molding shrinkage; it shrinks dimensionally from its molded size after processing.

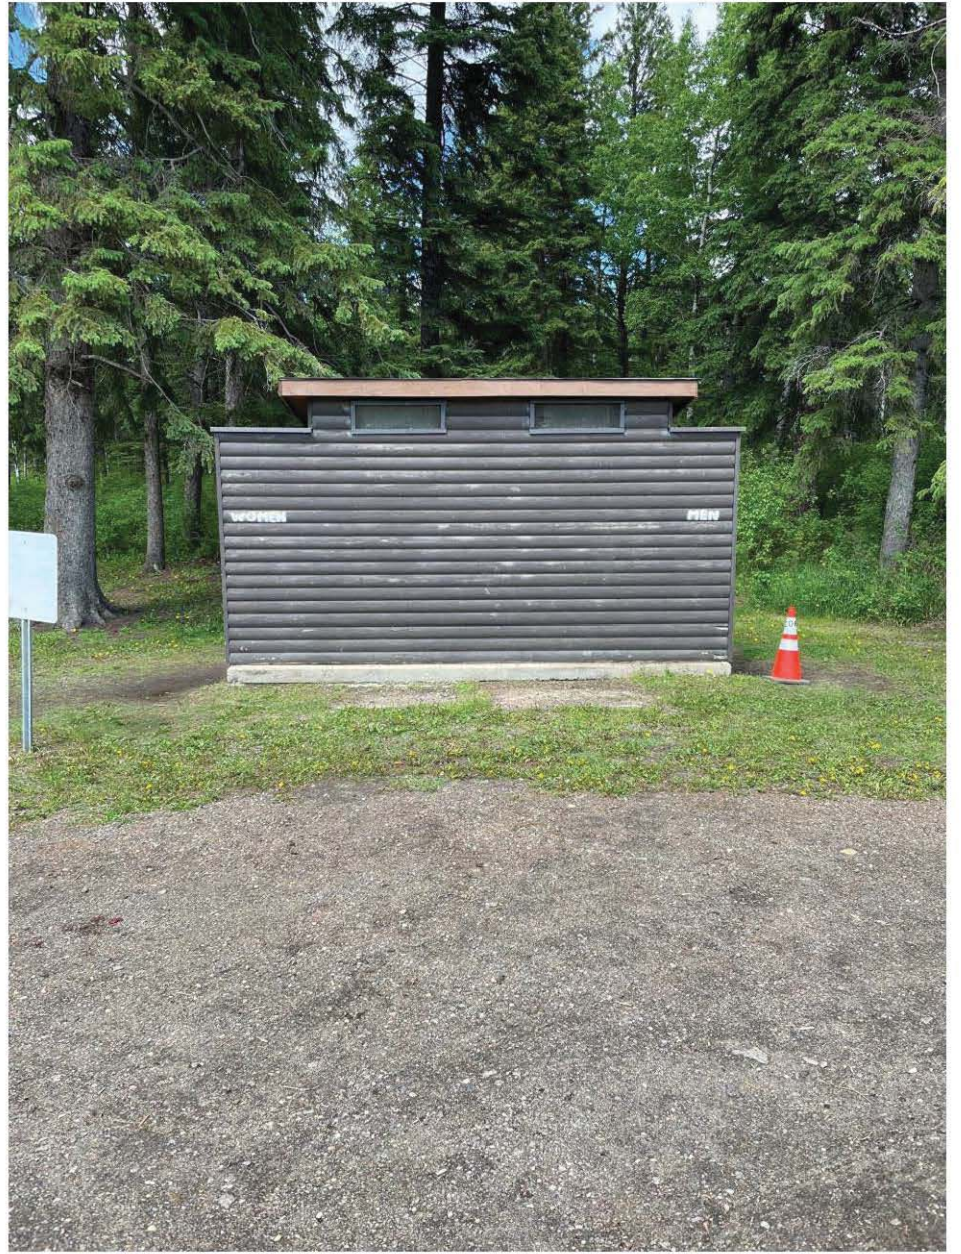
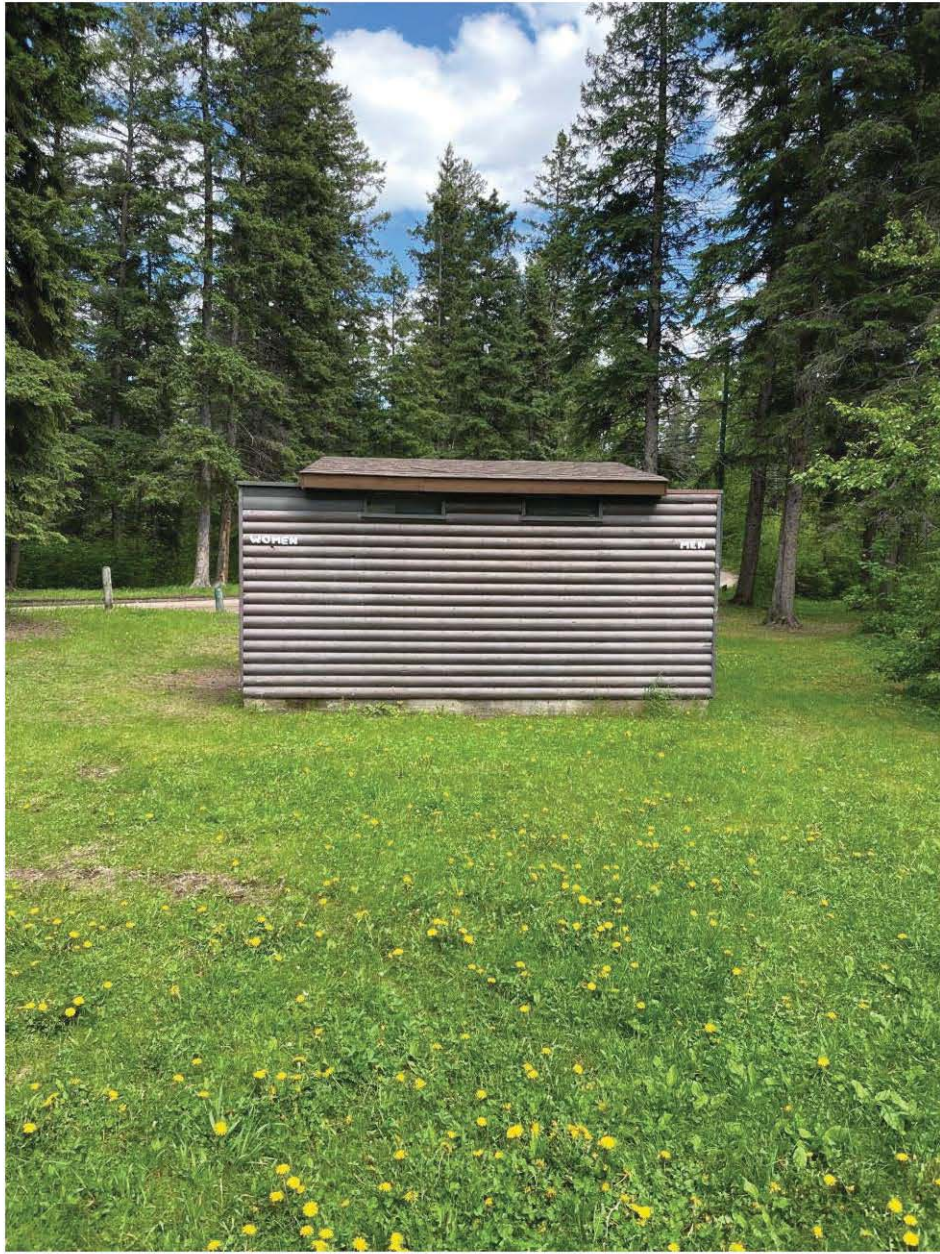
Facility Condition: (Good, Fair or Poor) Fair

Summary: The locations are being used as intended but the introduction of proper doors, frames and hardware will improve the maintenance and administration of the washrooms at the two locations

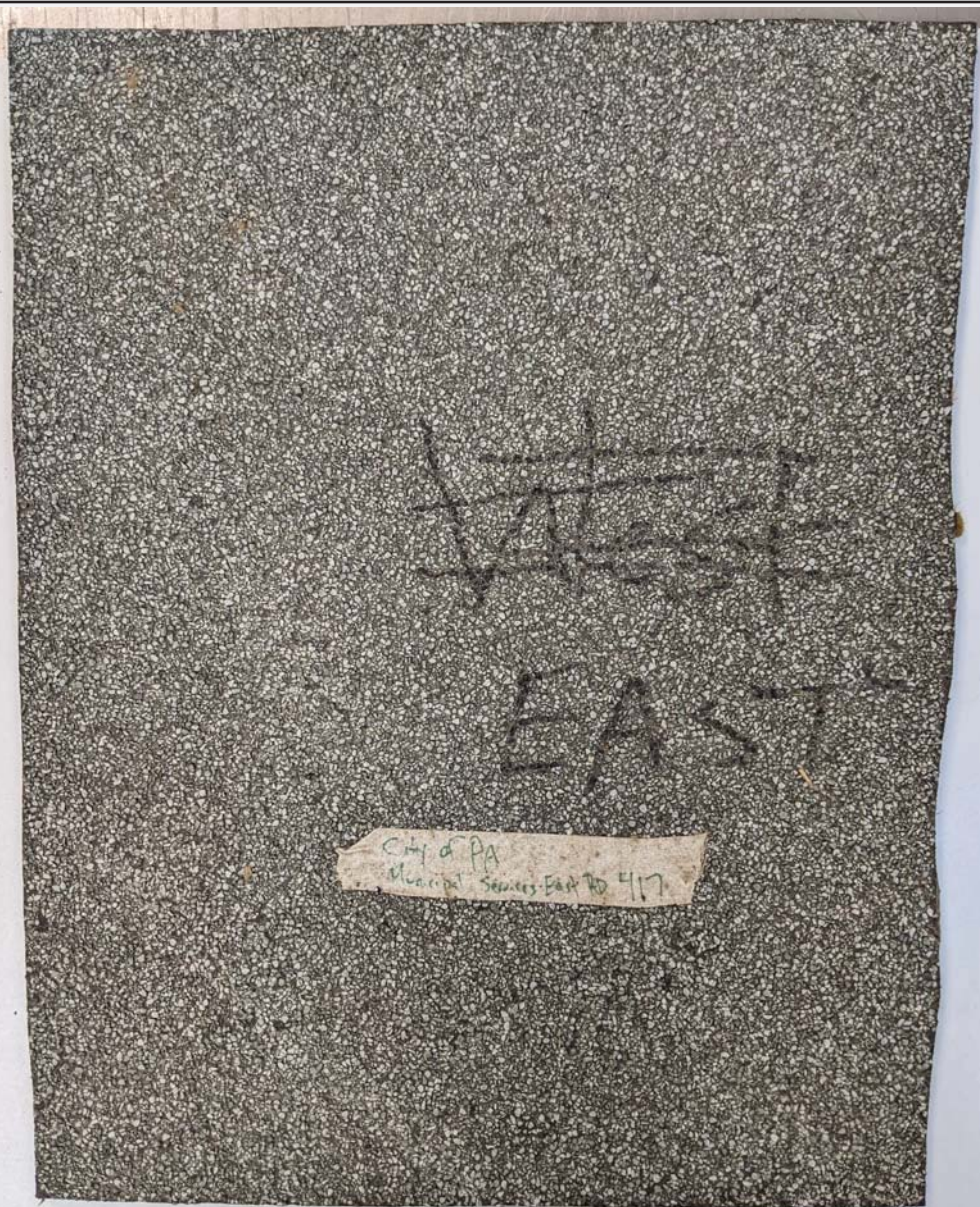
Figure 10: Municipal Services Centre East top view.

The 25 year old core samples are from a 2 ply modified roof system with fiberglass felt interplies in an asphalt adhesive. After visual inspection, both cores from the system appear to be in similar condition, implying that both sections of the roof have aged at a similar rate. For this reason, testing values were reported from the East section core. The interplies were very easily delaminated by hand as shown in Figures 12 and 15. Some mineral loss is expressed by exposed asphalt spots on the surface of the core but overall the coverage is still fairly good. The softening point and pen tests show that the asphalt adhesive responsible for keeping the system intact has lost its oils over time, causing the system to become more brittle. The core tested below the recommended tensile strength, but elongation was well above the recommendation. The sample performed well when undergoing puncture testing, implying that the system can withstand foot traffic and most weather phenomena.

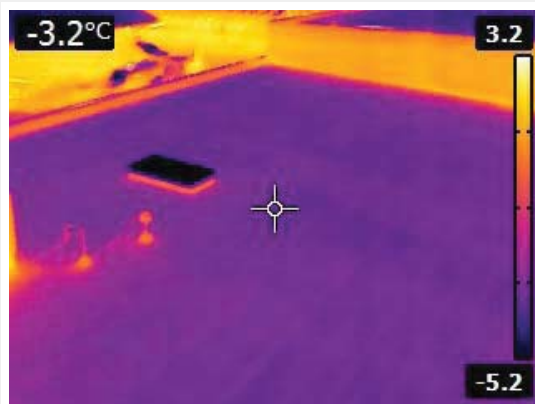
Photo 1

General view of the lower section (B1) from section A2.
No thermal anomaly related to wet insulation was found on this section

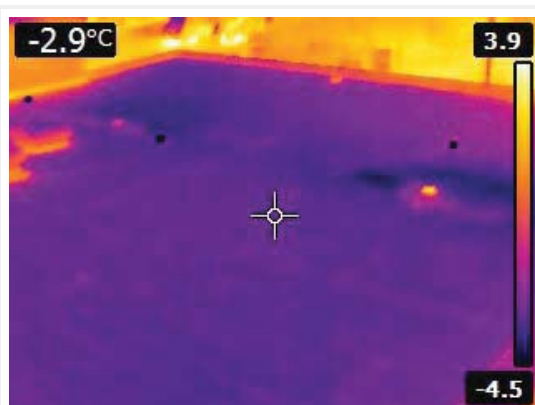
Photo 2

General view of the lower section (B1) from section A2.
No thermal anomaly related to wet insulation was found on this section
An area of light water ponding was visible around the drain.

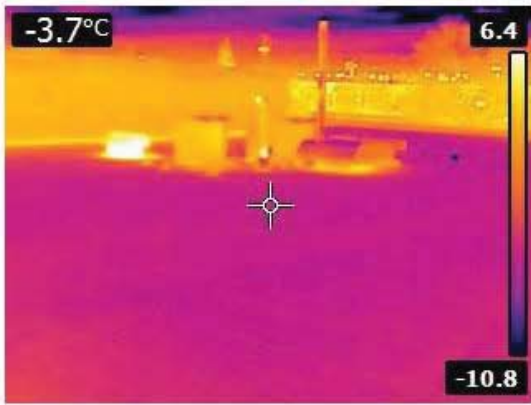
Photo 3

General view of the lower section (B1) from the roof surface.
The thermal patterns on the roof surface were homogeneous.

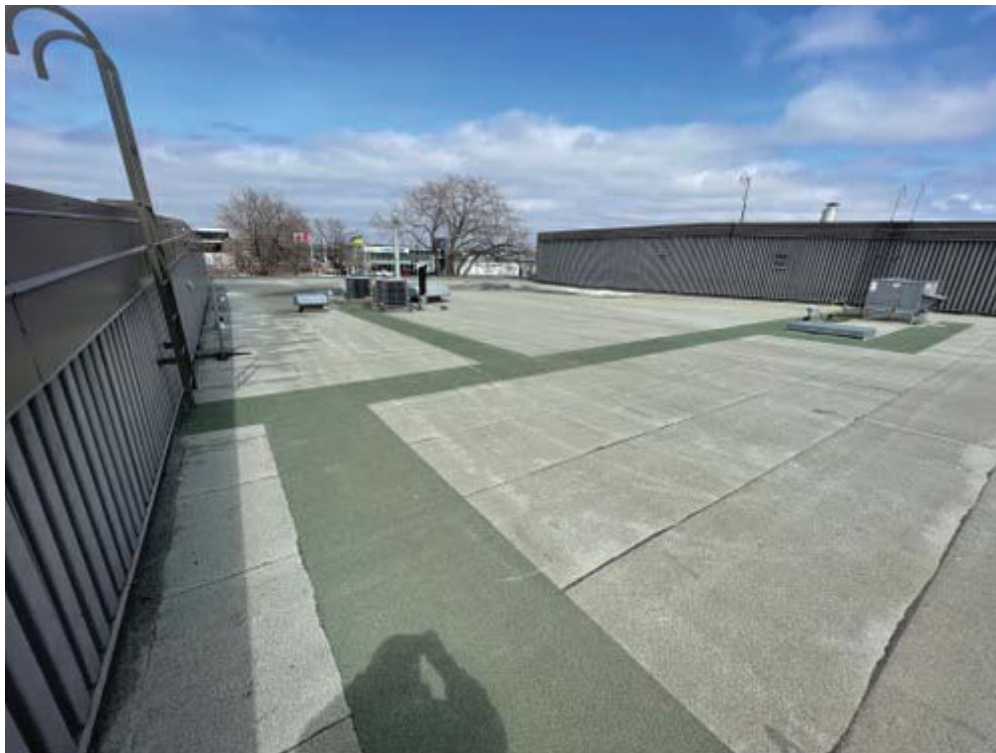
Photo 1

Lower Middle Section:
Modified Bitumen

Overall Condition: Good -
Fair

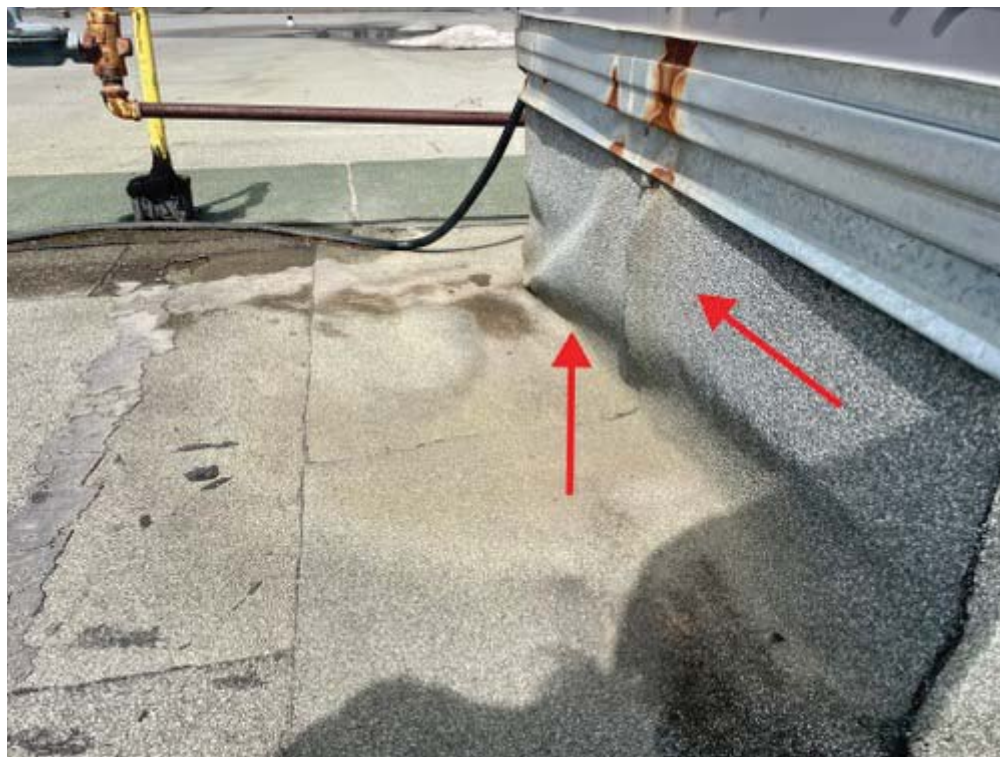
Photo 3

Perimeter Flashing

Deterioration: Most roof failures start at perimeter and penetration locations. Perimeter wall flashings can be damaged due to normal seasonal building movement and thermal shock. Additional damage can also be seen from UV degradation as well. At all of these deteriorated or failed points, moisture can gain direct access to the roof system insulation and the buildings interior.

1. Repair all open fish mouths using high grade mastic reinforced with mesh
2. Re caulk all coping cap seams
3. Fill all pitch pockets using high grade mastic
4. Re seal around all penetrations using high grade mastic
5. Repair sagging curb flashings on units and around perimeter

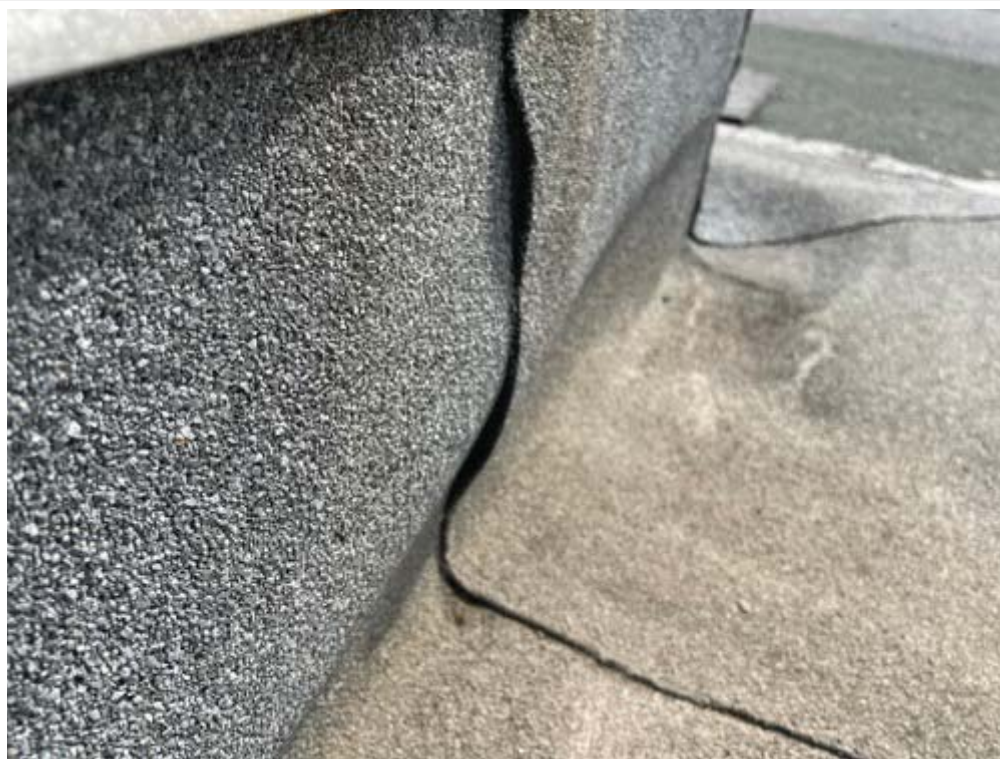
Photo 4

Fish mouths: Wrinkles or openings at the edge of the membrane caused by poor adhesion or installation. Fish mouths are a common cause of early failure on 2-ply torch down and single ply roof systems. These systems are prone to workmanship error due to two factors (1) the manual heating/welding of the adhesive, which is very unpredictable for constant heat, and (2) the roof system only consists of 1 to 2 plies, which translates in to a very thin layer of water protection.

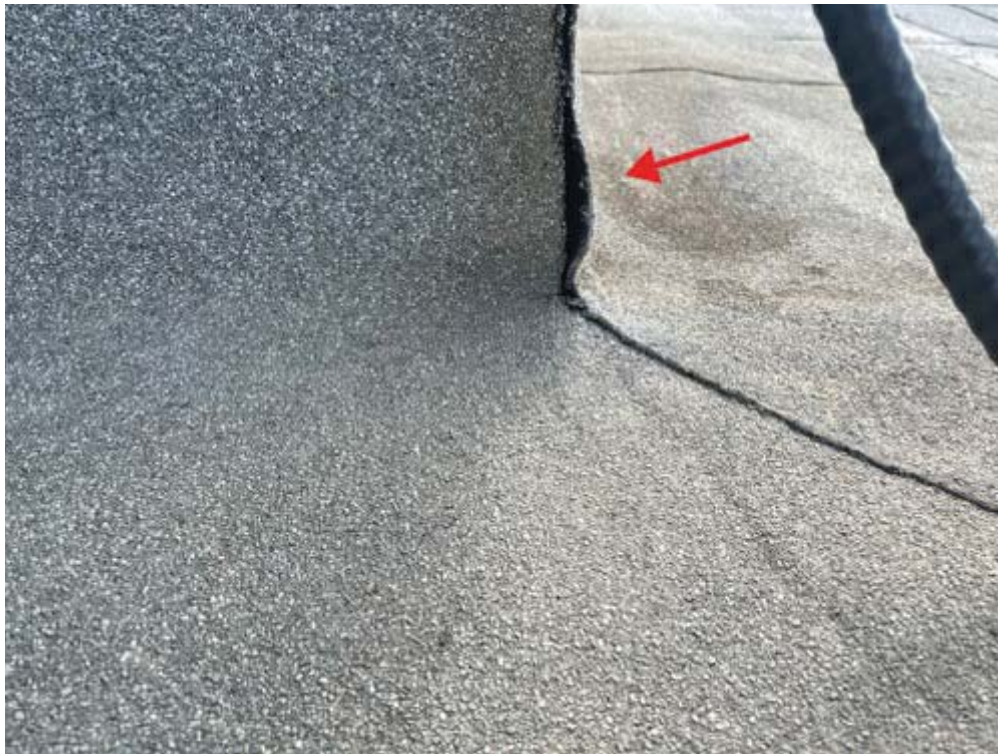
Photo 5

Fish mouths: Wrinkles or openings at the edge of the membrane caused by poor adhesion or installation. Fish mouths are a common cause of early failure on 2-ply torch down and single ply roof systems. These systems are prone to workmanship error due to two factors (1) the manual heating/welding of the adhesive, which is very unpredictable for constant heat, and (2) the roof system only consists of 1 to 2 plies, which translates in to a very thin layer of water protection.

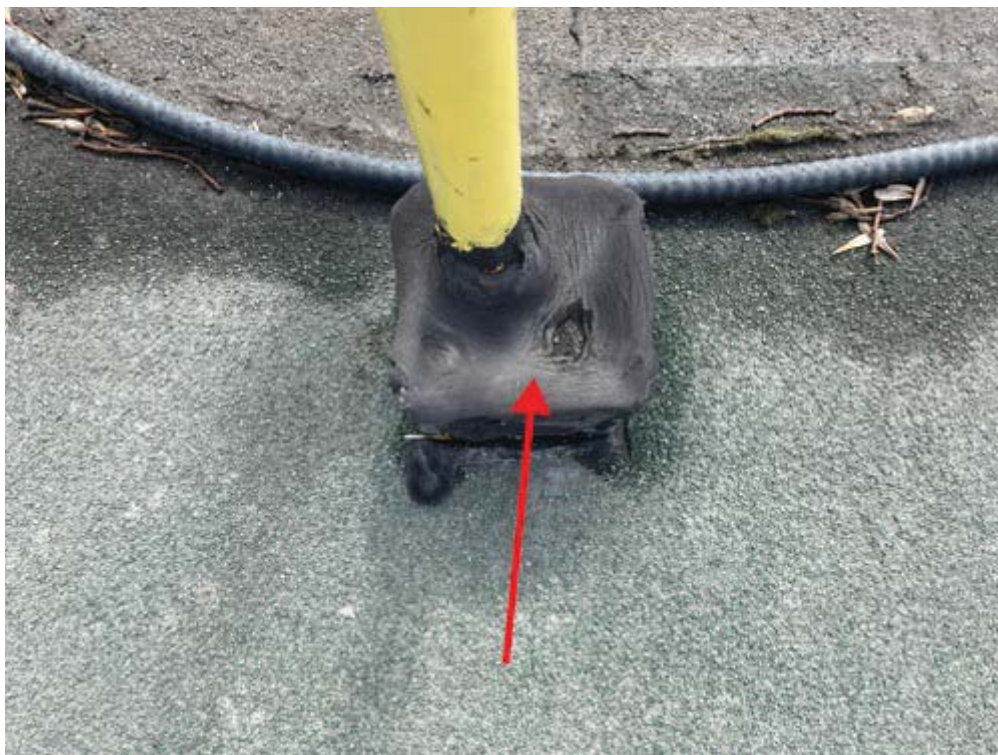
Photo 6

Pitch Pocket Deterioration: Metal protrusions that penetrate the roof system to allow conduits to run from the rooftop into the building. Movement from the protrusion can break the waterproofing compound, creating cracks. Over time, the release of solvents from the compound can cause the material to shrink, leaving gaps along the edges of the pan and around structural support. Water can enter through a defective pitch pan and find its way into the interior of the building. Moisture can also penetrate into the roof system leading to premature failure.

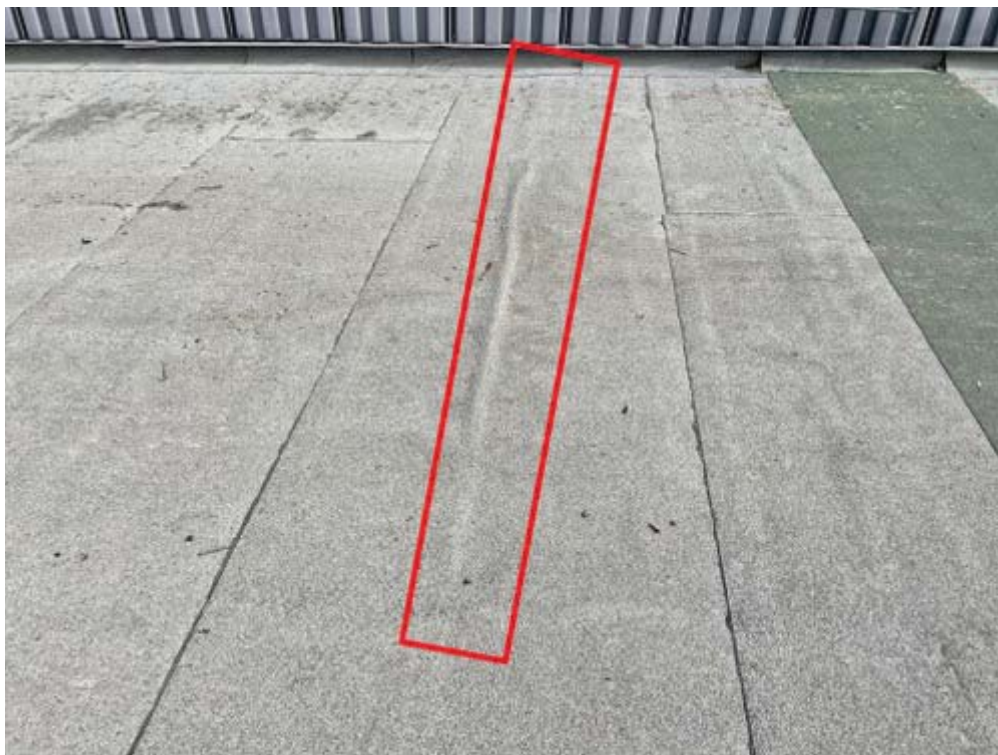
Photo 7

Ridges: These show up on the surface of built up roofs as linear buckling felt lines protruding upward through the surface layers of asphalt and aggregate. Ridges are formed by either thermal changes expanding and contracting the roofing felts or by gaps in the underlying insulation that allow vapor to migrate upwards through the roof system. Over a period of time ridges will grow and erode until they are stripped of their protective asphalt. These exposed ridges, through repeated weather cycling, will eventually crack and split to allow water into the roof system.

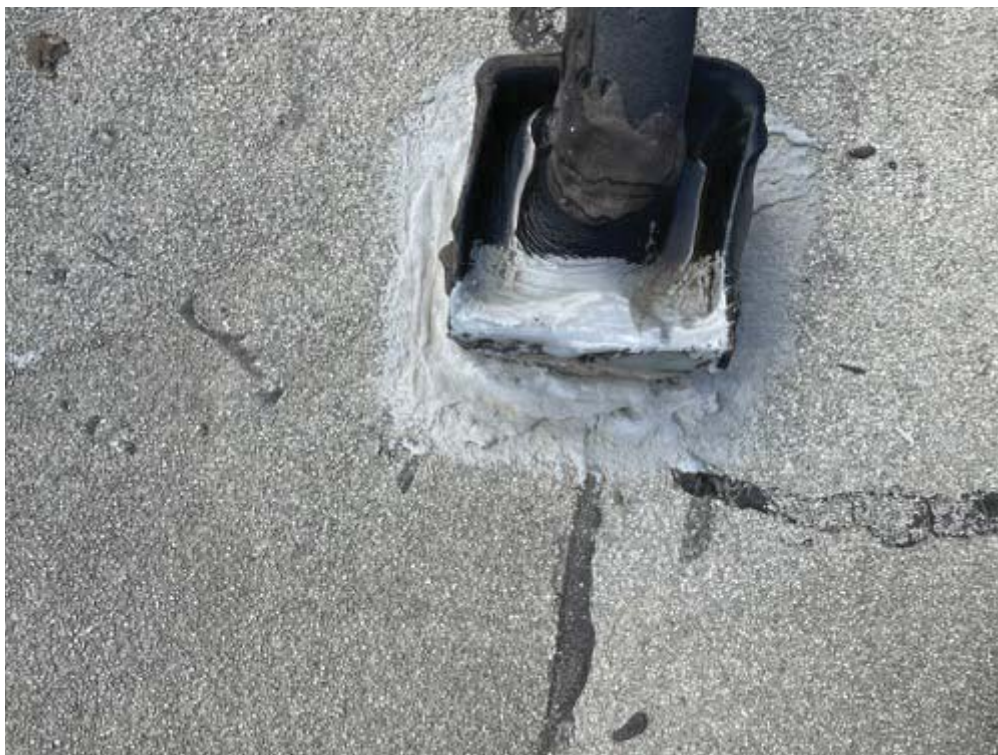
Photo 8

Pitch Pocket Deterioration: Metal protrusions that penetrate the roof system to allow conduits to run from the rooftop into the building. Movement from the protrusion can break the waterproofing compound, creating cracks. Over time, the release of solvents from the compound can cause the material to shrink, leaving gaps along the edges of the pan and around structural support. Water can enter through a defective pitch pan and find its way into the interior of the building. Moisture can also penetrate into the roof system leading to premature failure.

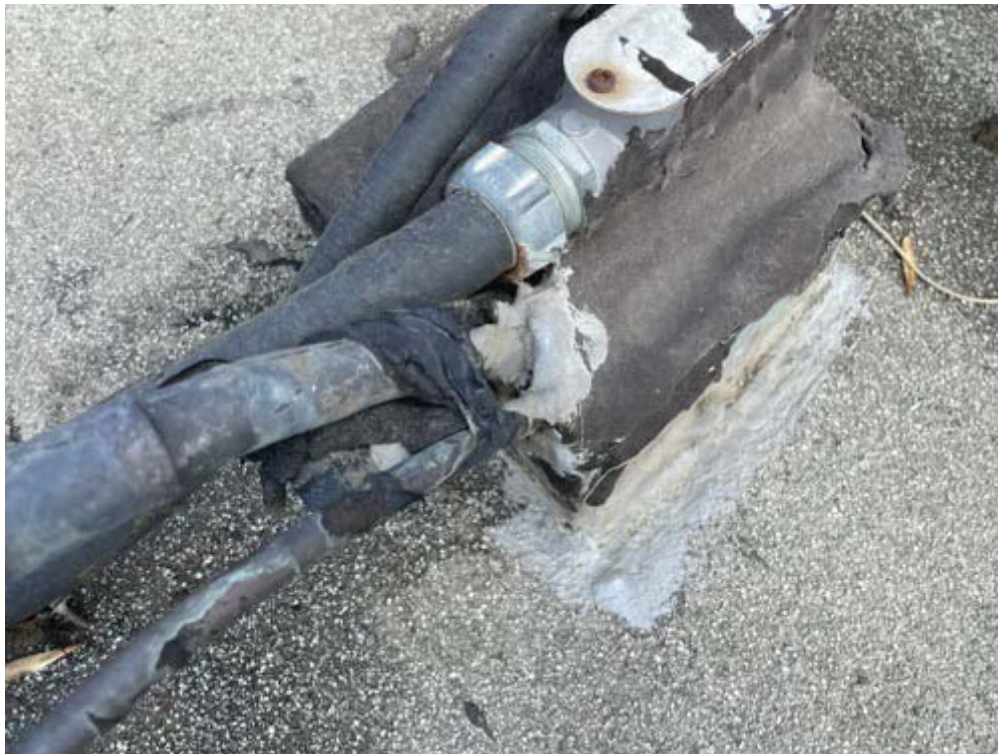
Photo 9

Pitch Pocket Deterioration: Metal protrusions that penetrate the roof system to allow conduits to run from the rooftop into the building. Movement from the protrusion can break the waterproofing compound, creating cracks. Over time, the release of solvents from the compound can cause the material to shrink, leaving gaps along the edges of the pan and around structural support. Water can enter through a defective pitch pan and find its way into the interior of the building. Moisture can also penetrate into the roof system leading to premature failure.

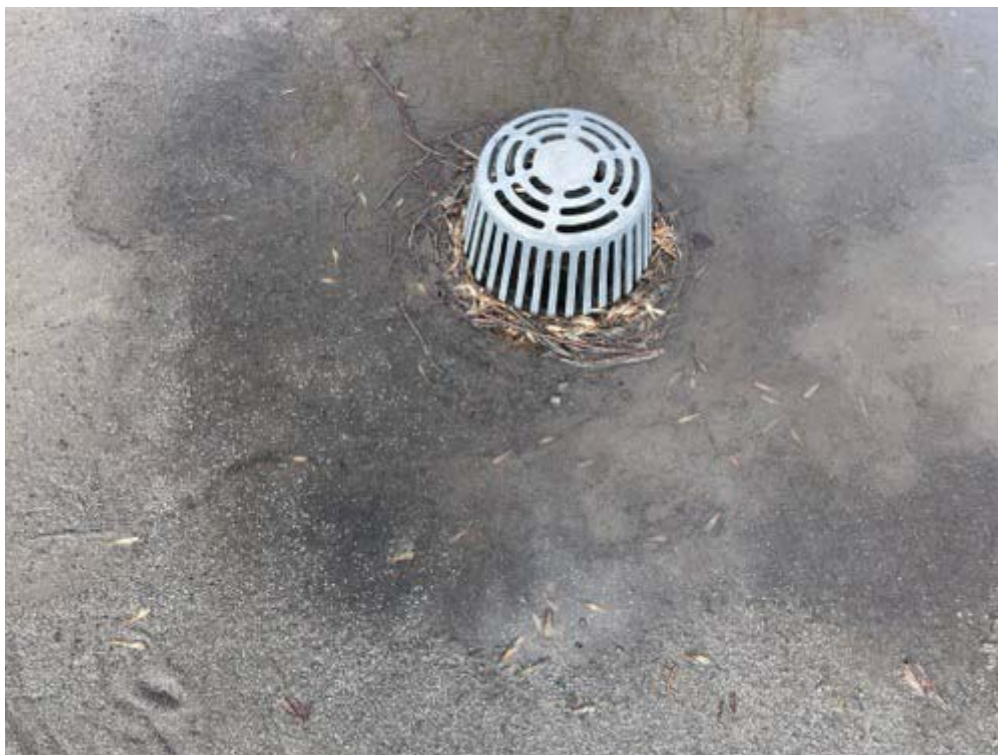
Photo 10

Debris - Leafs and Pine Needles: Pine needles and other leaves build up on the roof membrane causing plugged drains and scuppers thereby causing ponding water and structural weight loading. As the leaves and pine needles rot a "compost effect" occurs, this in effect causes soil to form on top of the roof membrane. This soil creates a perfect medium for plant and weed growth. When seeds take hold the roots will often penetrate through the membrane causing immediate leaks and damage internally.

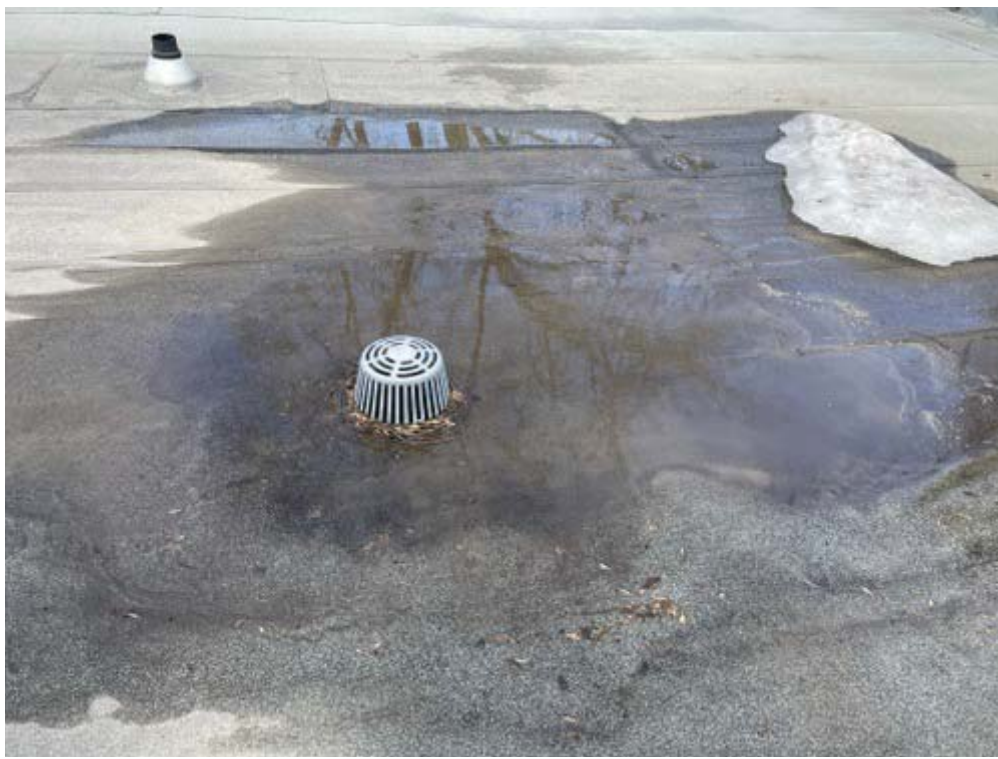
Photo 11

Debris - Leafs and Pine

Needles: Pine needles and other leaves build up on the roof membrane causing plugged drains and scuppers thereby causing ponding water and structural weight loading. As the leaves and pine needles rot a "compost effect" occurs, this in effect causes soil to form on top of the roof membrane. This soil creates a perfect medium for plant and weed growth. When seeds take hold the roots will often penetrate through the membrane causing immediate leaks and damage internally.

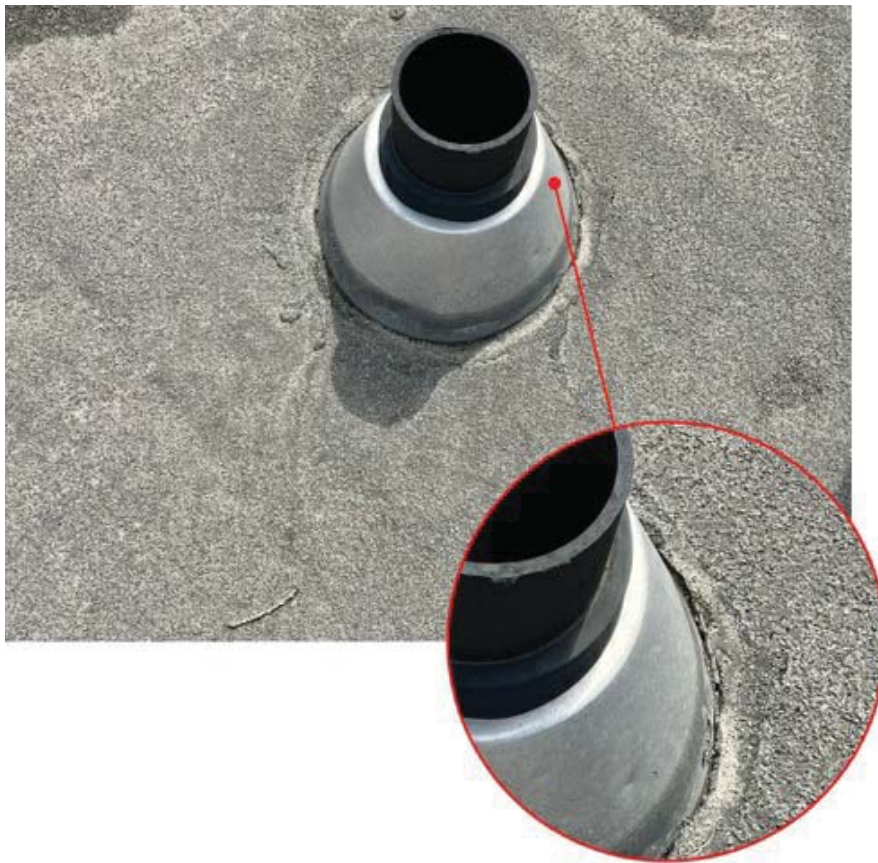
Photo 12

Penetration Waterproofing:

Beginning to deteriorate around the perimeter allowing for potential moisture access.

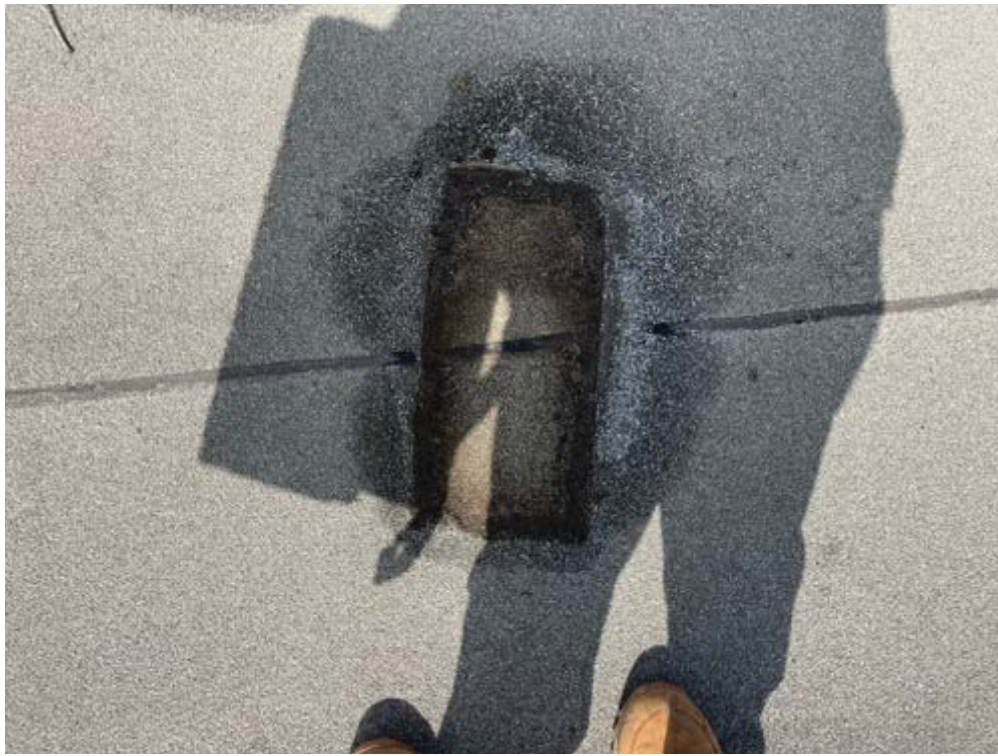
Photo 13

Debris: Left on field of roof deteriorating waterproofing membrane.

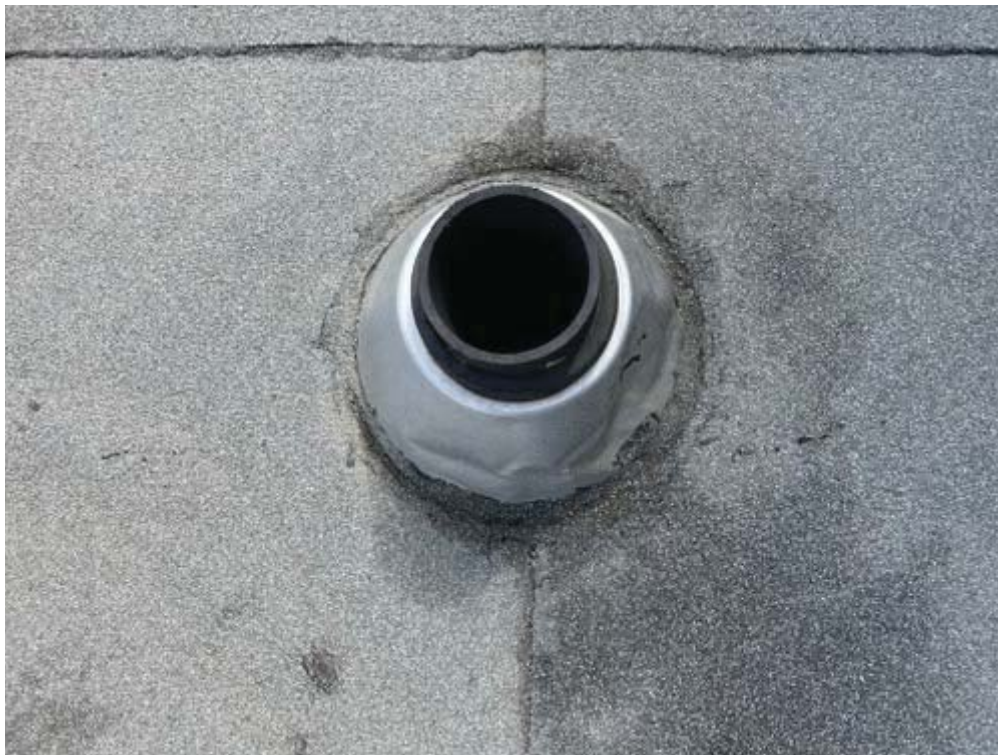
Photo 14

Penetration Waterproofing: Beginning to deteriorate around the perimeter allowing for potential moisture access.
