FACILITY REVIEW 2025 – 2029

Parks, Recreation &
Culture Department

City of
Prince Albert

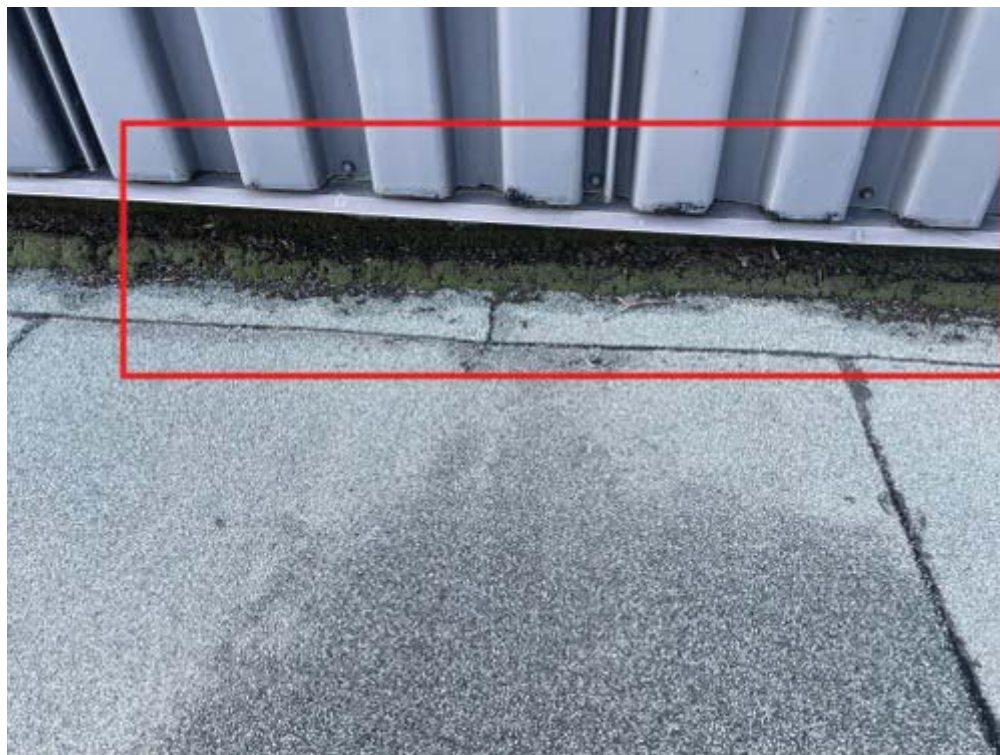
Photo 15

Vegetation Growth:

Vegetation often occurs when dirt and debris collect on roof systems. Over time this creates a perfect medium for plant and weed growth. When seeds take hold the roots will often penetrate through the membrane causing immediate leaks and damage internally.

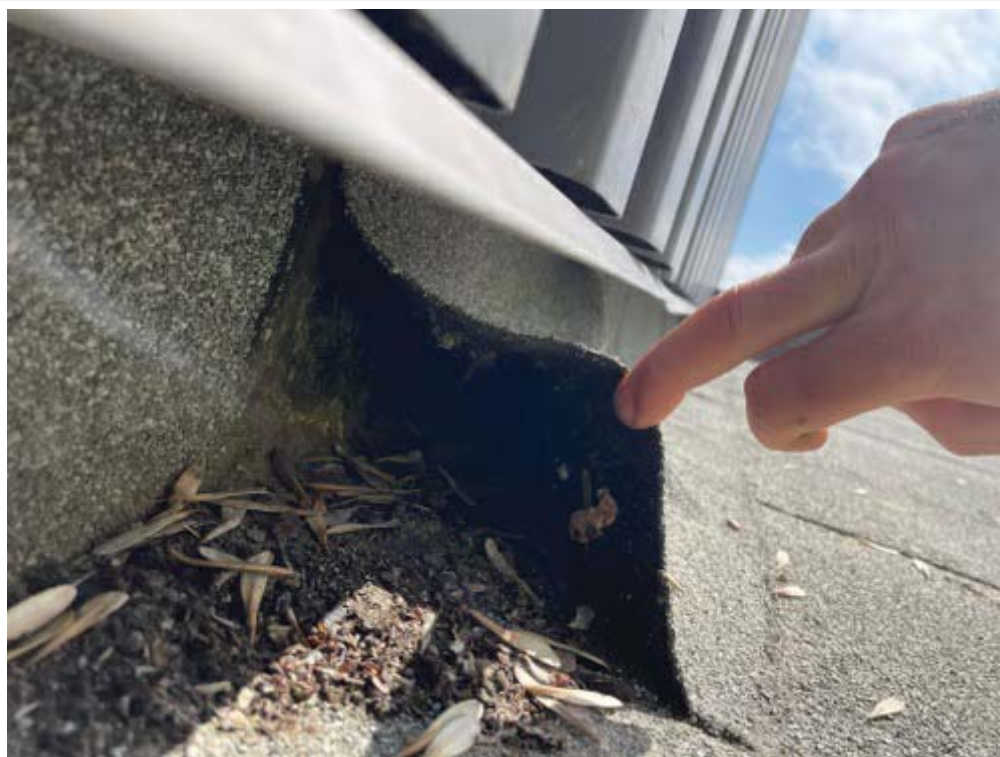
Photo 16

Fish mouths: Wrinkles or openings at the edge of the membrane caused by poor adhesion or installation. Fish mouths are a common cause of early failure on 2-ply torch down and single ply roof systems. These systems are prone to workmanship error due to two factors (1) the manual heating/welding of the adhesive, which is very unpredictable for constant heat, and (2) the roof system only consists of 1 to 2 plies, which translates in to a very thin layer of water protection.

1. Repair all open fish mouths using high grade mastic reinforced with mesh
2. Re caulk all coping cap seams
3. Fill all pitch pockets using high grade mastic
4. Re seal around all penetrations using high grade mastic
5. Repair sagging curb flashings on units and around perimeter

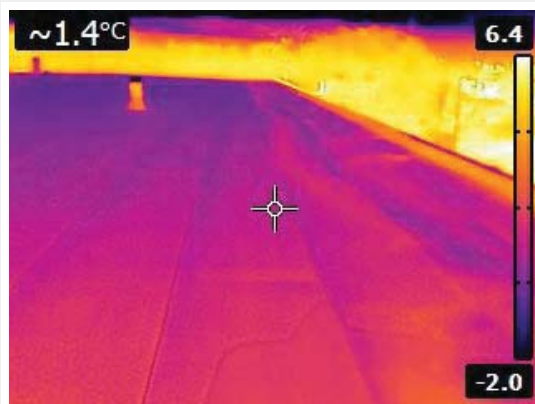
Photo 1

General view of section A2 (upper est) with the infrared camera.
 No thermal anomaly related to wet insulation was found on this section.
 Accumulation of granules were visible on the perimeters of the roof.

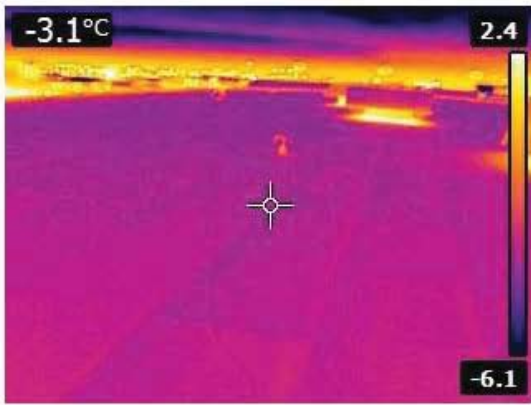
Photo 2

General view of section A2 (upper est) with the infrared camera.
 No thermal anomaly related to wet insulation was found on this section.

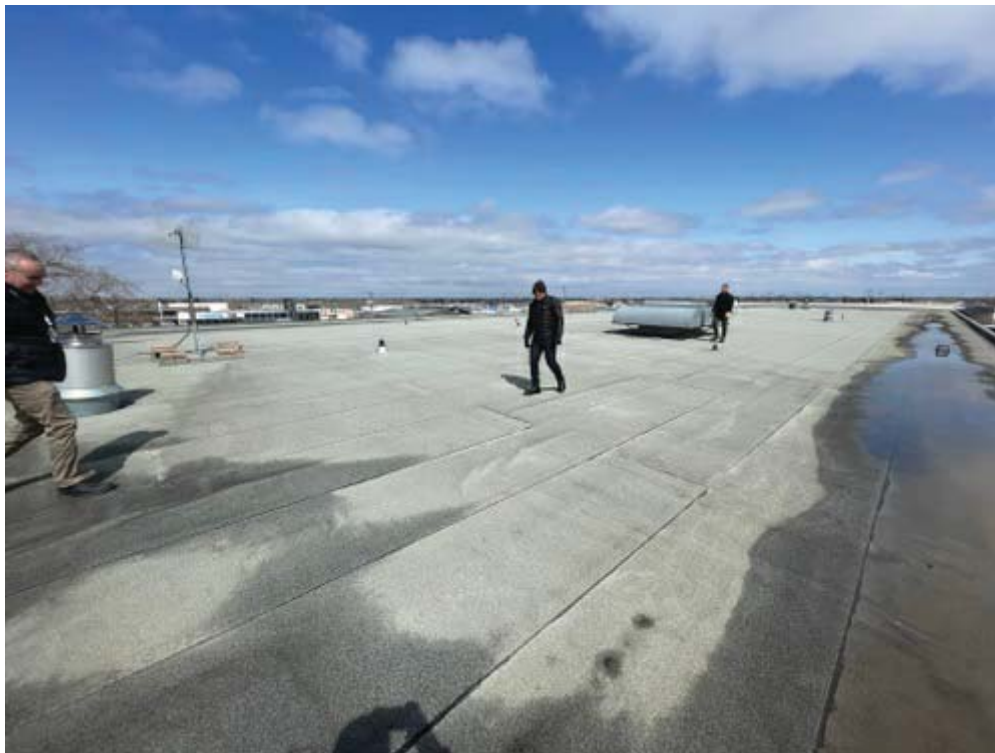
Photo 1

Lower Middle Section: Modified Bitumen

Overall Condition: Good - Fair

CLEAR Analysis: The 25 year old core samples are from a 2 ply modified roof system with fiberglass felt interplies in an asphalt adhesive. After visual inspection, both cores from the system appear to be in similar condition, implying that both sections of the roof have aged at a similar rate. For this reason, testing values were reported from the East section core. The interplies were very easily delaminated by hand as shown in Figures 12 and 15. Some mineral loss is expressed by exposed asphalt spots on the surface of the core but overall the coverage is still fairly good. The softening point and pen tests show that the asphalt adhesive responsible for keeping the system intact has lost its oils over time, causing the system to become more brittle. The core tested below the recommended tensile strength, but elongation was well

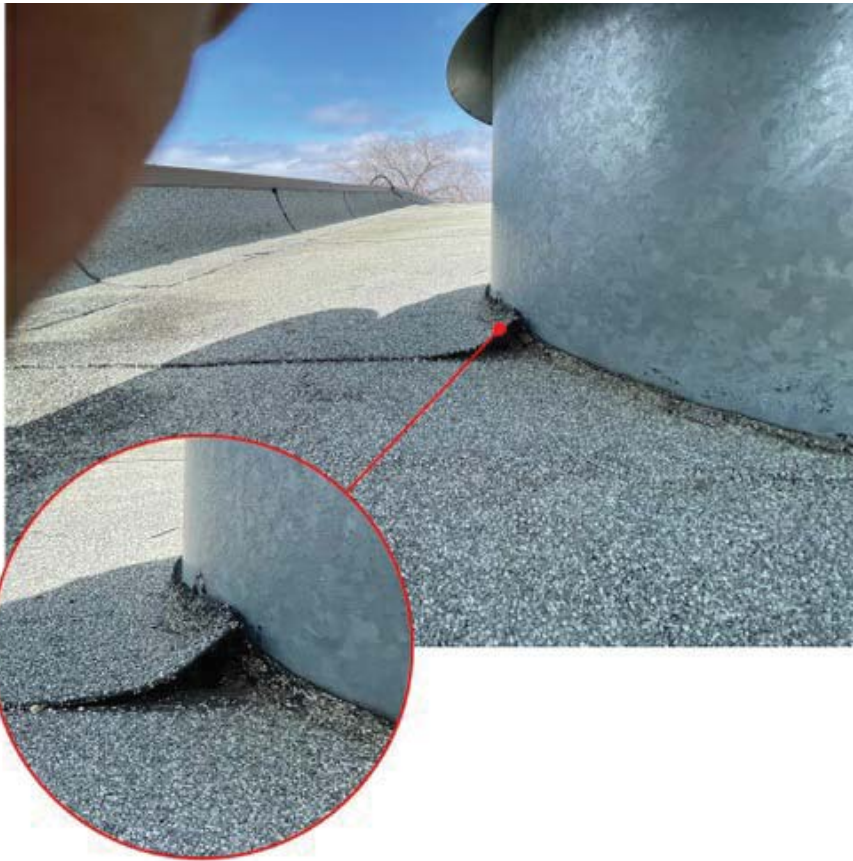
Photo 2

Fish mouths: Wrinkles or openings at the edge of the membrane caused by poor adhesion or installation. Fish mouths are a common cause of early failure on 2-ply torch down and single ply roof systems. These systems are prone to workmanship error due to two factors (1) the manual heating/welding of the adhesive, which is very unpredictable for constant heat, and (2) the roof system only consists of 1 to 2 plies, which translates in to a very thin layer of water protection.

1. Repair all open fish mouths using high grade mastic reinforced with mesh
2. Re caulk all coping cap seams
3. Fill all pitch pockets using high grade mastic
4. Re seal around all penetrations using high grade mastic
5. Repair sagging curb flashings on units and around perimeter

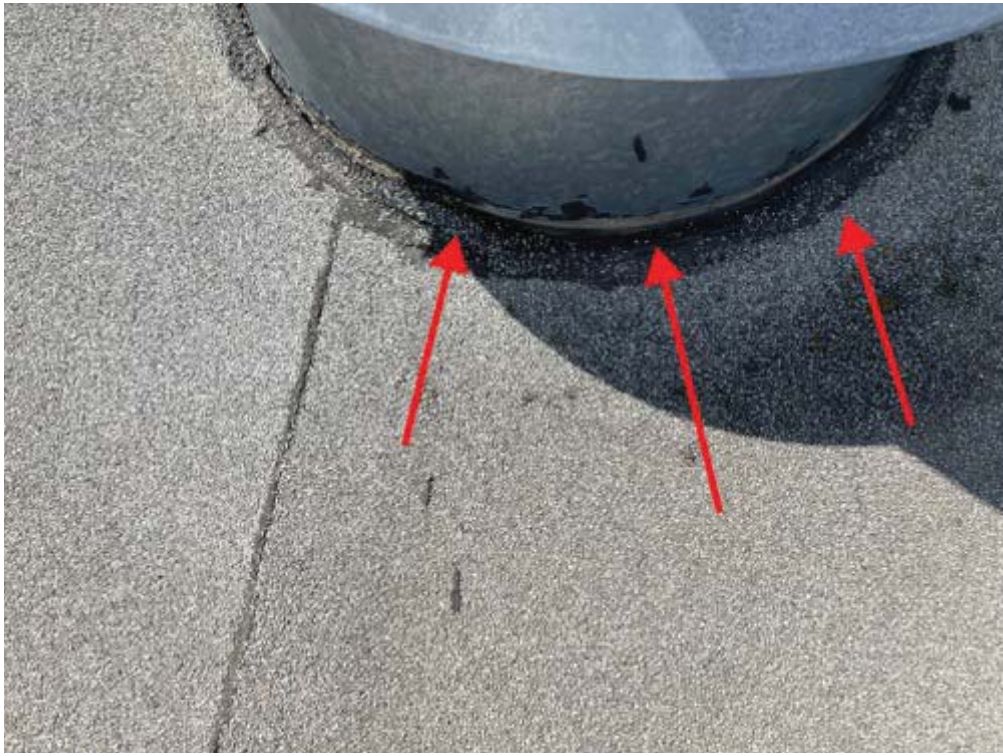
Photo 3

Penetration
Waterproofing: Beginning to deteriorate around the perimeter allowing for potential moisture access.

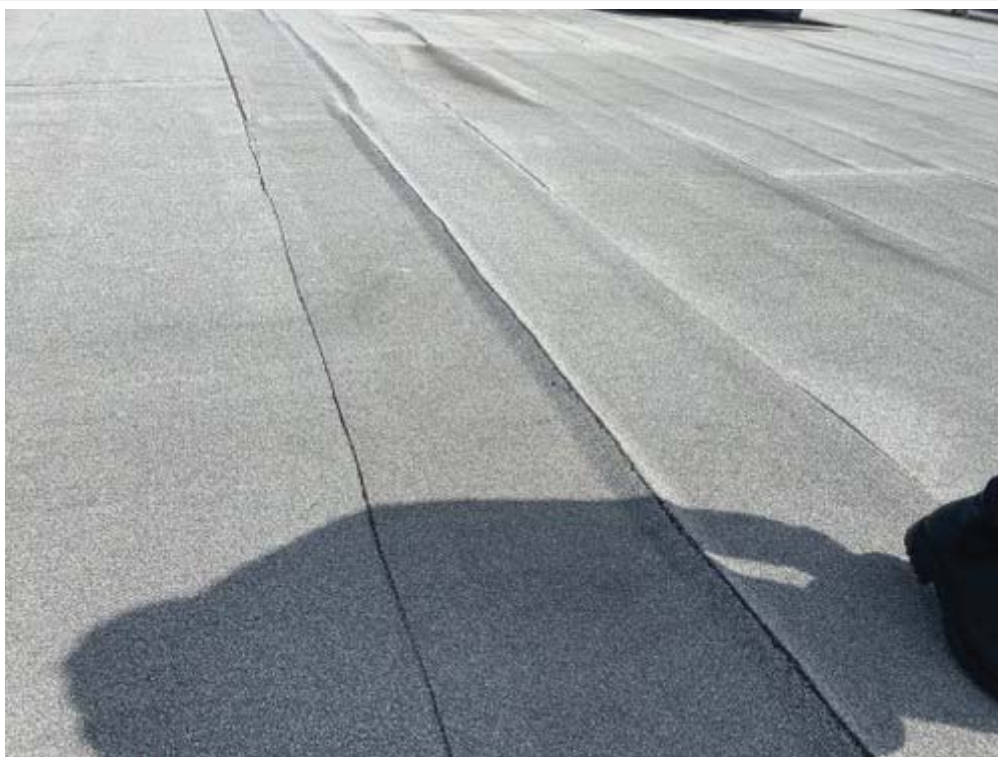
Photo 5

Ridges: These show up on the surface of built up roofs as linear buckling felt lines protruding upward through the surface layers of asphalt and aggregate. Ridges are formed by either thermal changes expanding and contracting the roofing felts or by gaps in the underlying insulation that allow vapor to migrate upwards through the roof system. Over a period of time ridges will grow and erode until they are stripped of their protective asphalt. These exposed ridges, through repeated weather cycling, will eventually crack and split to allow water into the roof system.

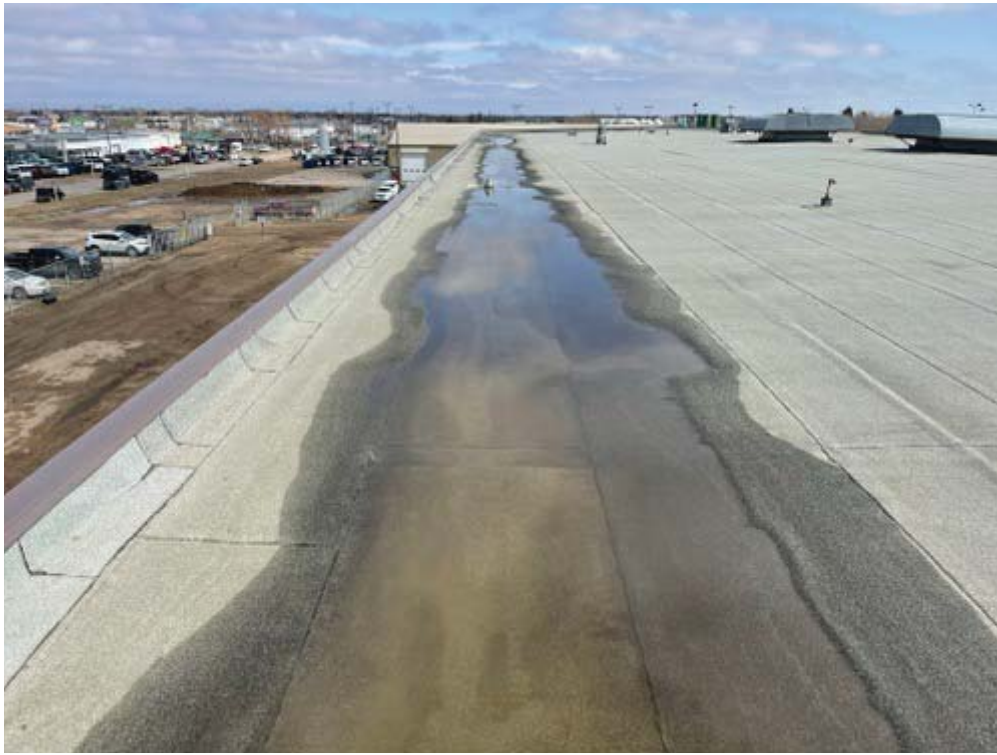
Photo 7

Ponding: Ponding water occurs when moisture collects in large pools on the surface of a roof system. These pools begin to form

due to the following: 1) roof drains are blocked or clogged with debris, 2) the insulation package has lost dimensional stability and has reduced in thickness, 3) poor slope to drain design via overbuilt crickets or tapered insulation system, 4) roof drains are built along side building support columns which maintain a consistent height under load while the balance of the roof system is applied over a live deck which tends to move and deflect under normal seasonal load. In all cases, roof depressions that collect and hold water will tend to grow in size as the added weight of the ponding water will continue to deflect the roof deck even further.

This condition can damage the roof in a number of ways. Additional structural loads create more movement of the roof assembly creating more tear stress and of course a potential for structural failure. UV intensity also increases under ponding conditions as the sun's rays are increased to the point where it accelerates deterioration in most all roof systems. In asphalt based assemblies the natural waterproofing oils in the asphalt will separate from the membrane if the system remains submerged under water for sustained periods. Single ply roof system rot and burn out when the ponding area is exposed to sunlight. The added weight can crush insulation increasing the ponding condition and creating a condition where the insulation becomes a useless thermal barrier. This condition then affects the

mechanical system and the cost of heating and cooling the building. In the winter ponding water will expand as it freezes. This expansion will weaken small imperfections in the roof system. Small cracks and tears will widen until they rupture to allow water into the building. And finally, a negatively deflected deck becomes a structural concern.

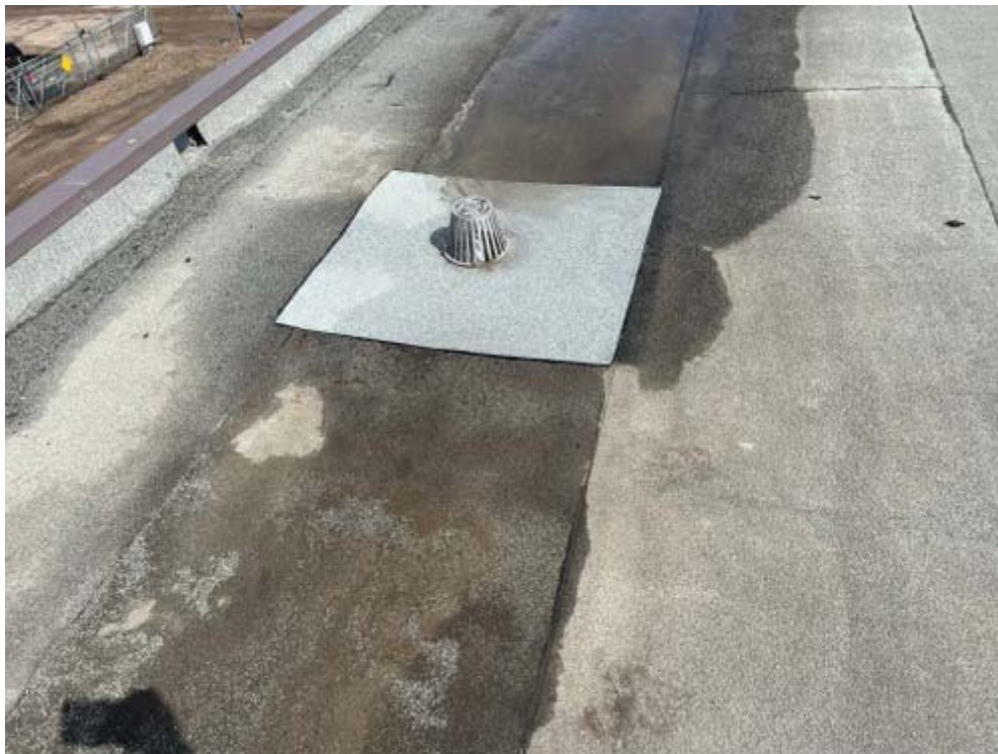
Photo 8

Ponding: Ponding water occurs when moisture collects in large pools on the surface of a roof system.

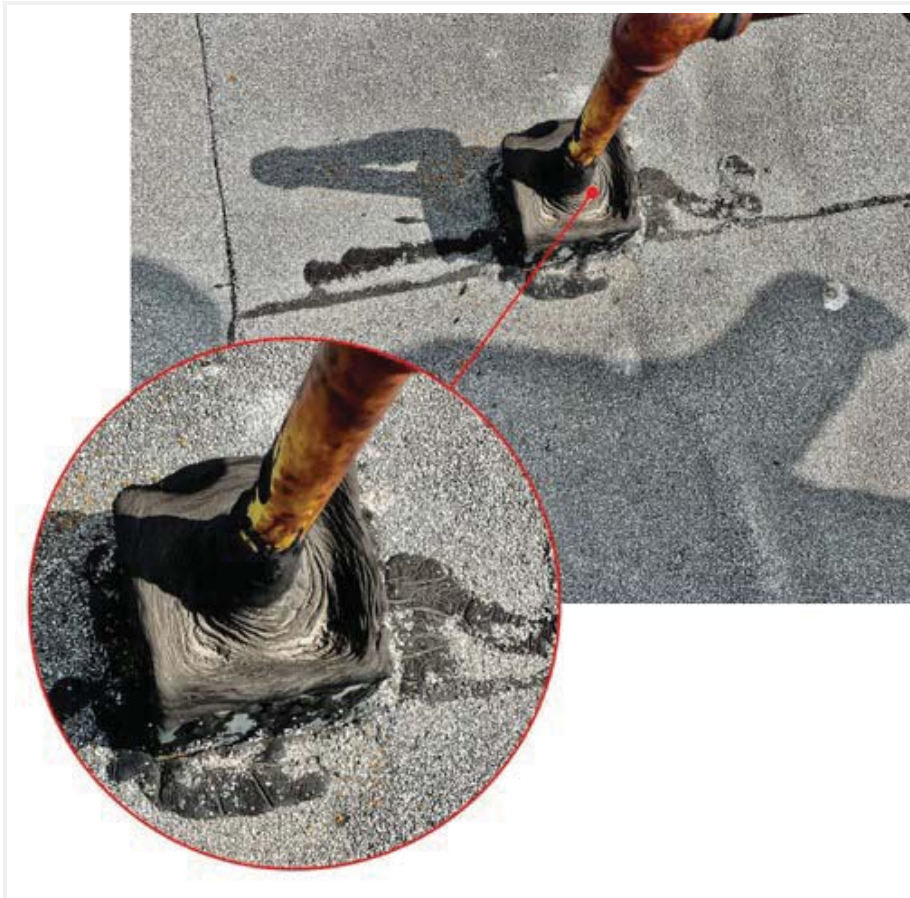
Photo 10

Pitch Pocket Deterioration: Metal protrusions that penetrate the roof system to allow conduits to run from the rooftop into the building. Movement from the protrusion can break the waterproofing compound, creating cracks. Over time, the release of solvents from the compound can cause the material to shrink, leaving gaps along the edges of the pan and around structural support. Water can enter through a defective pitch pan and find its way into the interior of the building. Moisture can also penetrate into the roof system leading to premature failure.

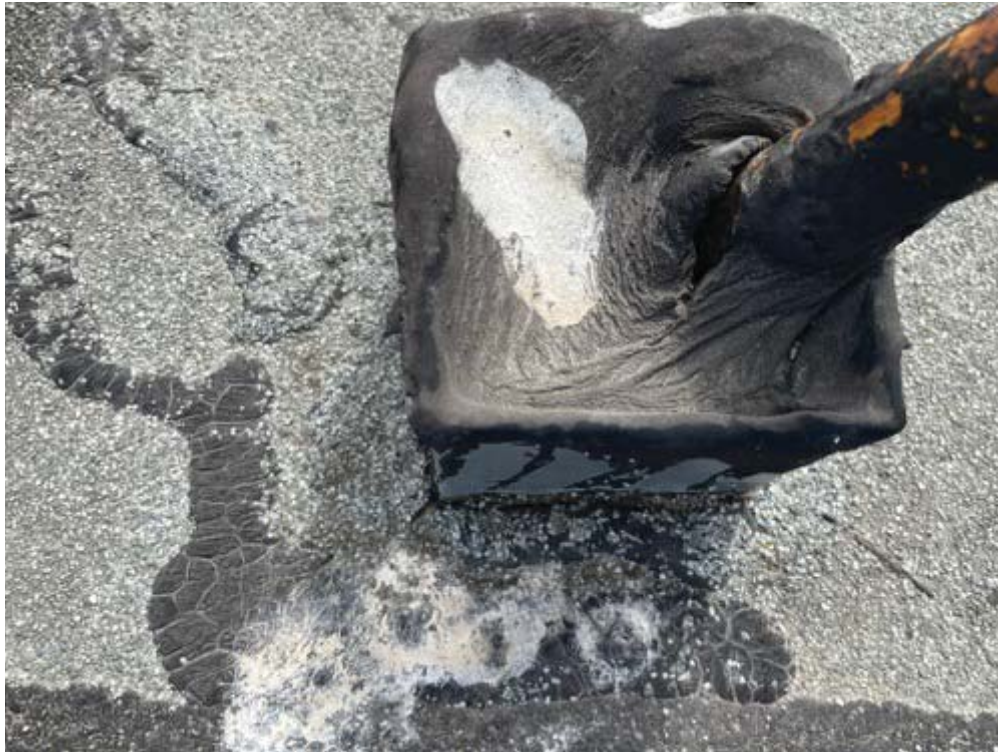
Photo 11

Pitch Pocket

Deterioration: Metal protrusions that penetrate the roof system to allow conduits to run from the rooftop into the building. Movement from the protrusion can break the waterproofing compound, creating cracks.

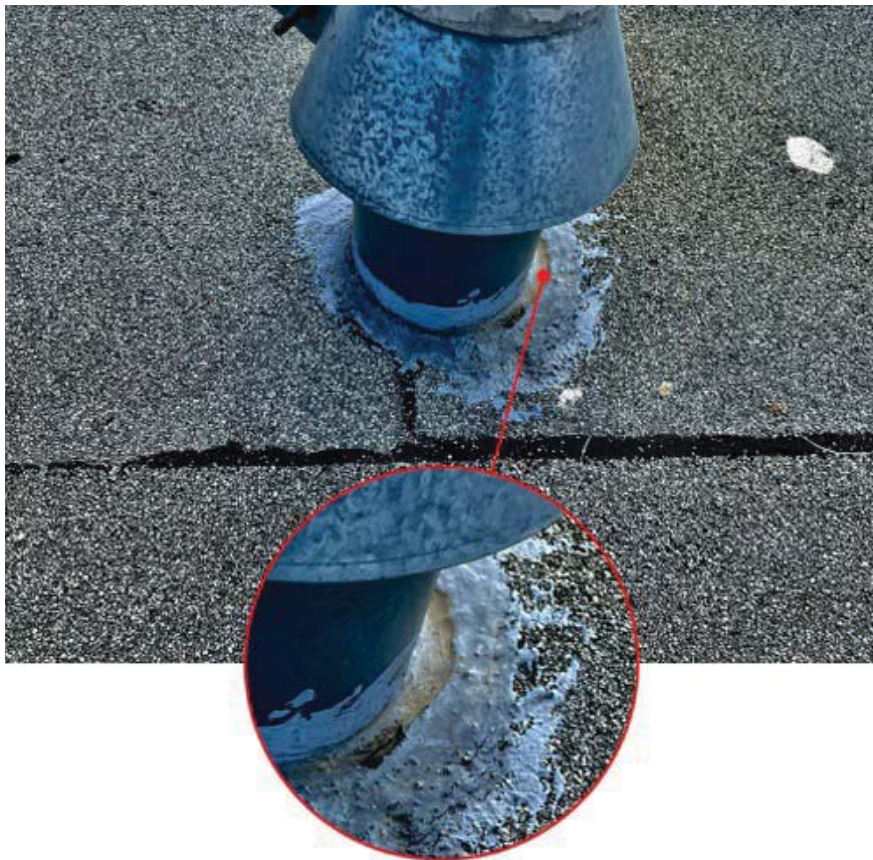
Photo 12

Penetration Waterproofing: Beginning to deteriorate around the perimeter allowing for potential moisture access.

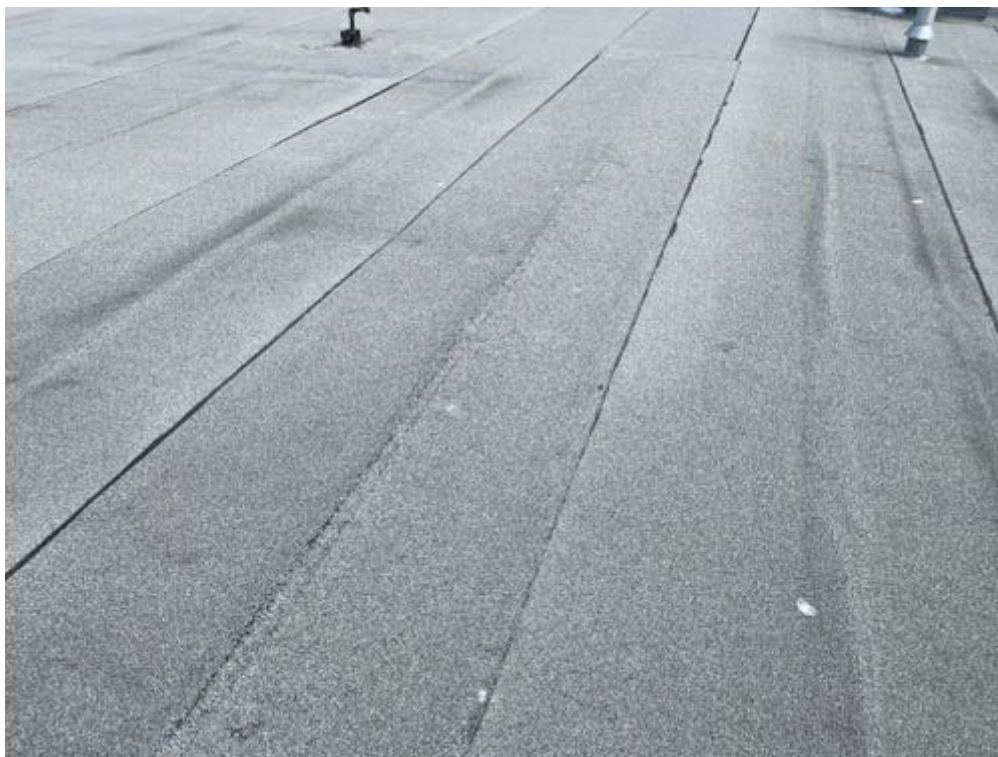
Photo 13

Ridges: These show up on the surface of built up roofs as linear buckling felt lines protruding upward through the surface layers of asphalt and aggregate.

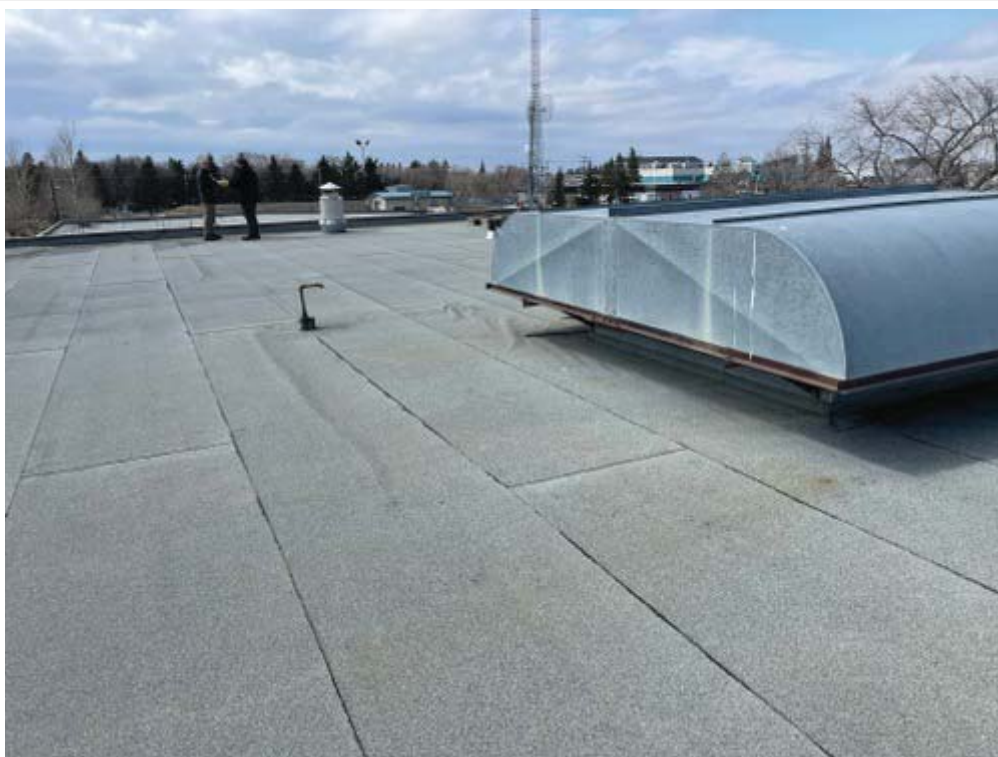
Photo 14

Ridges: These show up on the surface of built up roofs as linear buckling felt lines protruding upward through the surface layers of asphalt and aggregate.

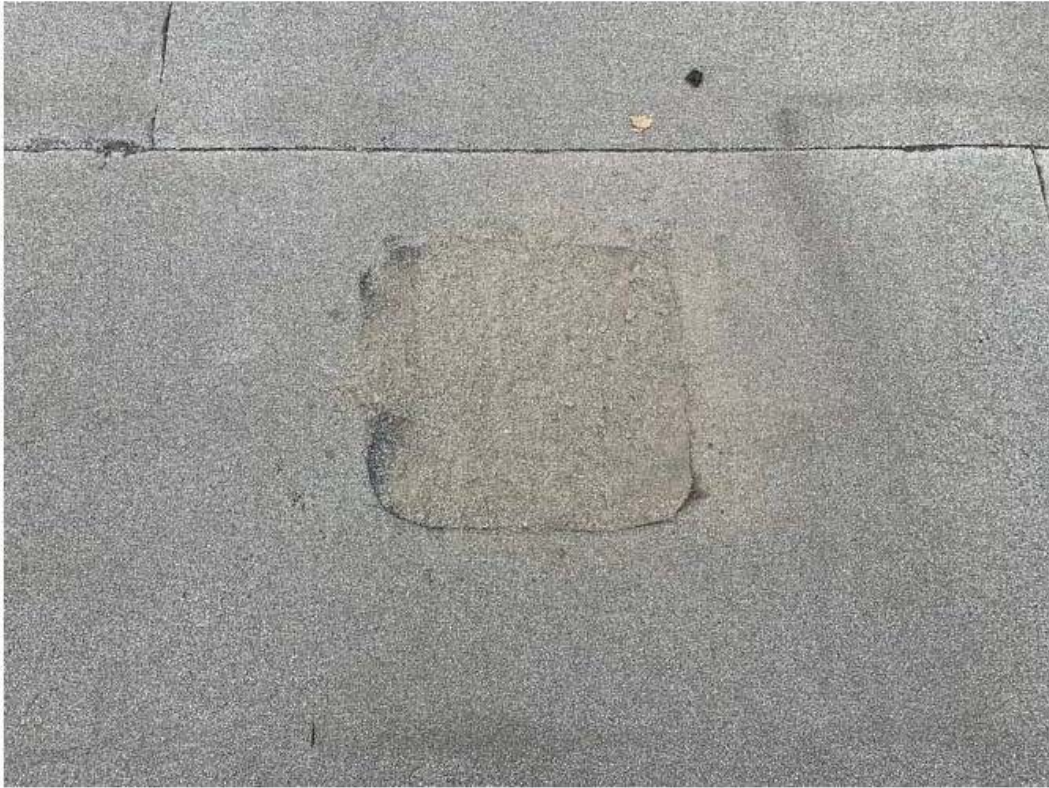
Photo 17

CLEAR Analysis:
Imbedded using granules from perimeter to reinforce mastic repair and protect from UV.

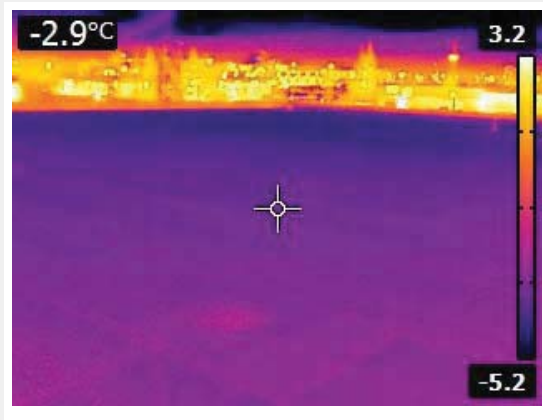
Photo 1

General view of section A1 (upper west)

No thermal anomaly related to wet insulation was found on this section.
The thermal patterns are homogeneous.

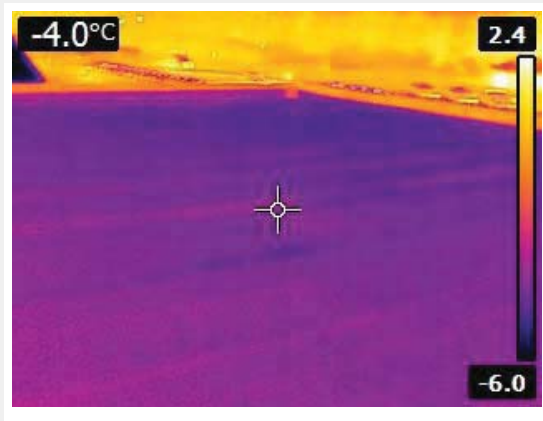
Photo 2

General view of section A1 (upper west)

No thermal anomaly related to wet insulation was found on this section.

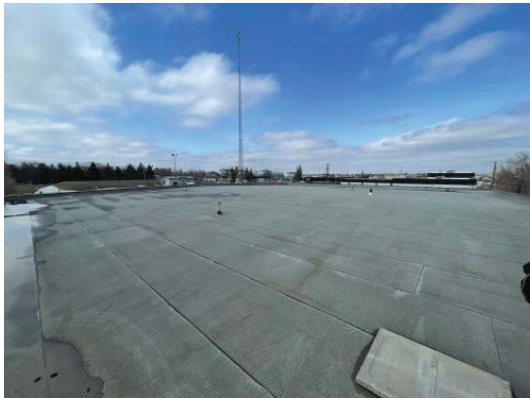
Photo 1

Lower Middle Section: Modified Bitumen

Overall Condition: Good - Fair

Scan: 0% Wet

CLEAR Analysis: The 25 year old core samples are from a 2 ply modified roof system with fiberglass felt interplies in an asphalt adhesive. After visual inspection, both cores from the system appear to be in similar condition, implying that both sections of the roof have aged at a similar rate. For this reason, testing values were reported from the East section core. The interplies were very easily delaminated by hand as shown in Figures 12 and 15. Some mineral loss is expressed by exposed asphalt spots on the surface of the core but overall the coverage is still fairly good. The softening point and pen tests show that the asphalt adhesive responsible for keeping the system intact has lost its oils over time, causing the system to become more brittle. The core tested below the recommended tensile strength, but elongation was well above the recommendation. The sample performed well when undergoing puncture testing, implying that the system can withstand foot traffic and most weather phenomena. Please contact Garland's Technical Team to discuss the best options for these roof systems. The above results are based solely on the core samples examined and may not be representative of the condition of the roof. No representations or warranties are hereby made as to the condition of the roof.

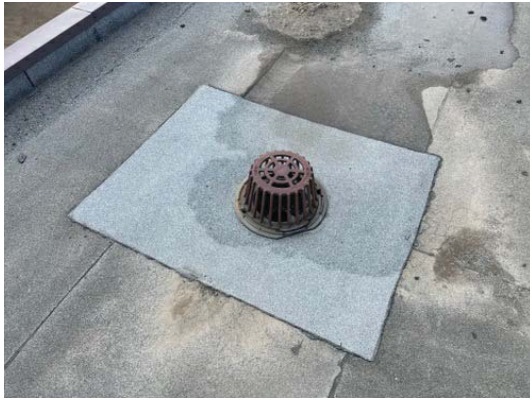
Photo 2

Drains: Membrane replaced around drains.

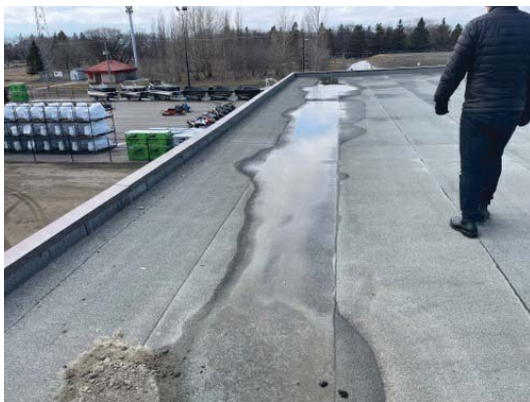
Photo 3

Ponding: Ponding water occurs when moisture collects in large pools on the surface of a roof system. These pools begin to form due to the following: 1) roof drains are blocked or clogged with debris, 2) the insulation package has lost dimensional stability and has reduced in thickness, 3) poor slope to drain design via overbuilt crickets or tapered insulation system, 4) roof drains are built along side building support columns which maintain a consistent height under load while the balance of the roof system is applied over a live deck which tends to move and deflect under normal seasonal load. In all cases, roof depressions that collect and hold water will tend to grow in size as the added weight of the ponding water will continue to deflect the roof deck even further.

This condition can damage the roof in a number of ways. Additional structural loads create more movement of the roof assembly creating more tear stress and of course a potential for structural failure. UV intensity also increases under ponding conditions as the sun's rays are increased to the point where it accelerates deterioration in most all roof systems. In asphalt based assemblies the natural waterproofing oils in the asphalt will separate from the membrane if the system remains submerged under water for sustained periods. Single ply roof system rot and burn out when the ponding area is exposed to sunlight. The added weight can crush insulation increasing the ponding condition and creating a condition where the insulation becomes a useless thermal barrier. This condition then affects the mechanical system and the cost of heating and cooling the building. In the winter ponding water will expand as it freezes. This expansion will weaken small imperfections in the roof system. Small cracks and tears will widen until they rupture to allow water into the building. And finally, a negatively deflected deck becomes a structural concern.

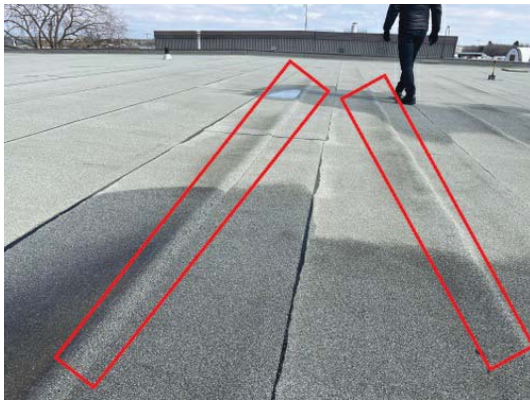
Photo 4

Ridges: These show up on the surface of built up roofs as linear buckling felt lines protruding upward through the surface layers of asphalt and aggregate. Ridges are formed by either thermal changes expanding and contracting the roofing felts or by gaps in the underlying insulation that allow vapor to migrate upwards through the roof system. Over a period of time ridges will grow and erode until they are stripped of their protective asphalt. These exposed ridges, through repeated weather cycling, will eventually crack and split to allow water into the roof system.

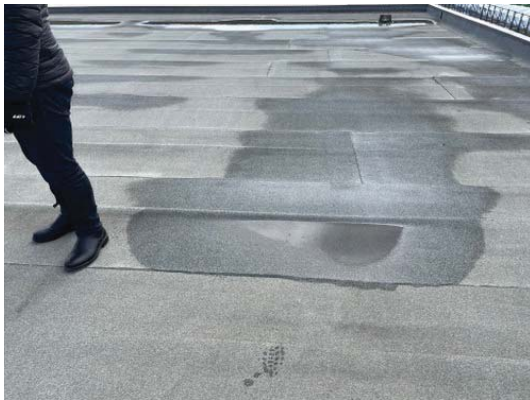
Photo 5

Ponding: Ponding water occurs when moisture collects in large pools on the surface of a roof system.

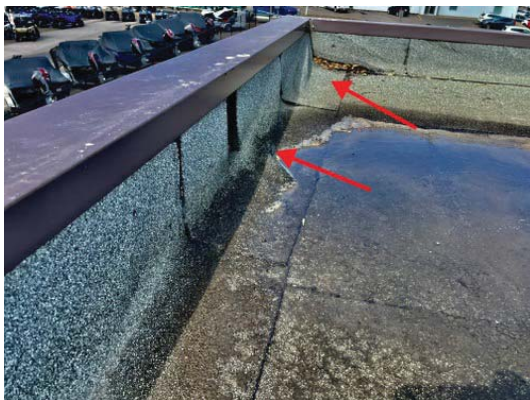
Photo 6

Perimeter Flashing Deterioration: Most roof failures start at perimeter and penetration locations. Perimeter wall flashings can be damaged due to normal seasonal building movement and thermal shock. Additional damage can also be seen from UV degradation as well. At all of these deteriorated or failed points, moisture can gain direct access to the roof system insulation and the buildings interior.

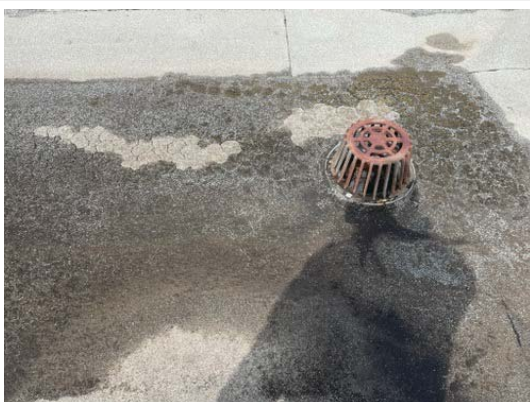
Photo 7

Mineral Roof Granule Deterioration: It is very common for mineral finished roofs to experience bare felts as early as five years after installation. Manufacturing quality control issues as well as weather "washing off" the factory applied mineral coating causes these areas. Typically this is indicated by accumulations of mineral where ponding is present. Bare felts cause exposure of the membrane to the sun/UV rays, which cause rapid membrane deterioration. Therefore, it is extremely important to coat these areas as soon as they appear.

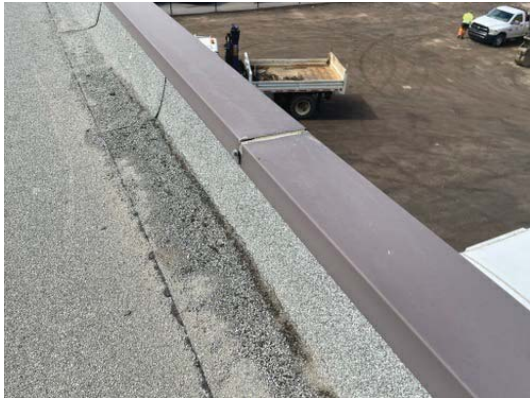
Photo 8

Mineral Roof Granule Deterioration: It is very common for mineral finished roofs to experience bare felts as early as five years after installation. Manufacturing quality control issues as well as weather “washing off” the factory applied mineral coating causes these areas. Typically this is indicated by accumulations of mineral where ponding is present. Bare felts cause exposure of the membrane to the sun/UV rays, which cause rapid membrane deterioration. Therefore, it is extremely important to coat these areas as soon as they appear.

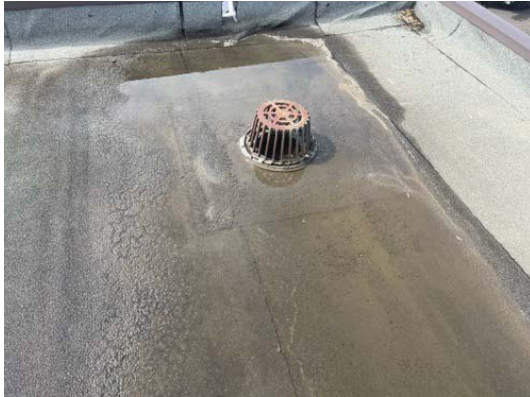
Photo 9

Ponding: Ponding water occurs when moisture collects in large pools on the surface of a roof system. These pools begin to form due to the following: 1) roof drains are blocked or clogged with debris, 2) the insulation package has lost dimensional stability and has reduced in thickness, 3) poor slope to drain design via overbuilt crickets or tapered insulation system, 4) roof drains are built along side building support columns which maintain a consistent height under load while the balance of the roof system is applied over a live deck which tends to move and deflect under normal seasonal load. In all cases, roof depressions that collect and hold water will tend to grow in size as the added weight of the ponding water will continue to deflect the roof deck even further.

This condition can damage the roof in a number of ways. Additional structural loads create more movement of the roof assembly creating more tear stress and of course a potential for structural failure. UV intensity also increases under ponding conditions as the sun’s rays are increased to the point where it accelerates deterioration in most all roof systems. In asphalt based assemblies the natural waterproofing oils in the asphalt will separate from the membrane if the system remains submerged under water for sustained periods. Single ply roof system rot and burn out when the ponding area is exposed to sunlight. The added weight can crush insulation increasing the ponding condition and creating a condition where the insulation becomes a useless thermal barrier. This condition then affects the mechanical system and the cost of heating and cooling the building. In the winter ponding water will expand as it freezes. This expansion will weaken small imperfections in the roof system. Small cracks and tears will widen until they rupture to allow water into the building. And finally, a negatively deflected deck becomes a structural concern.

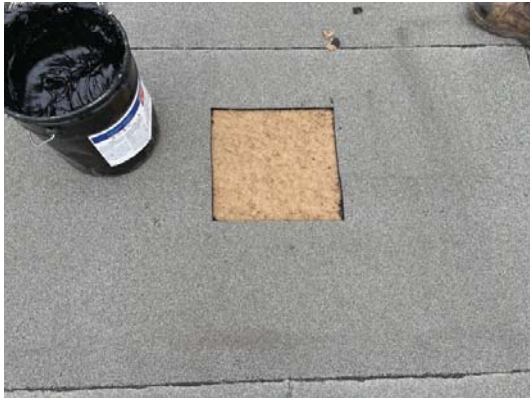
Photo 10

CLEAR Analysis: Removal of membrane sample.

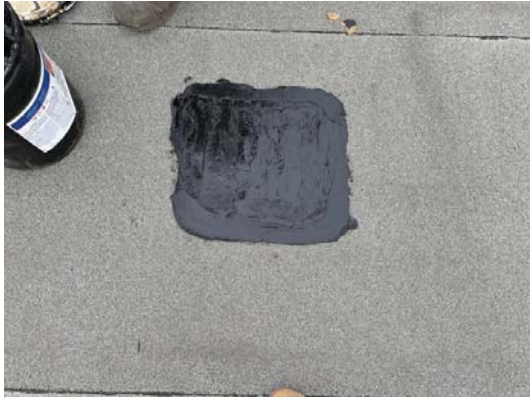
Photo 11

CLEAR Analysis: Repair of membrane sample.

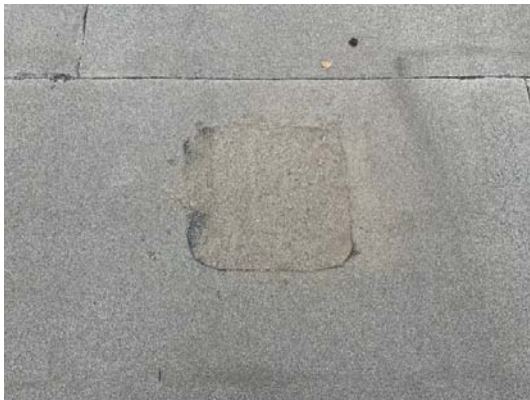
Photo 12

CLEAR Analysis: Imbedded with granules from perimeter to reinforce and protect against UV.

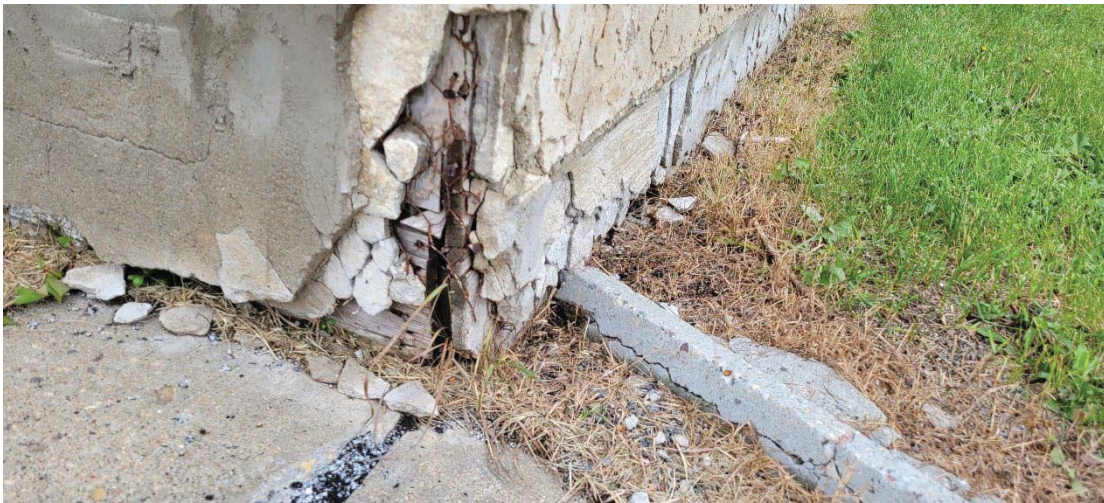
Photo 2: Damaged stucco, exposed wood framing

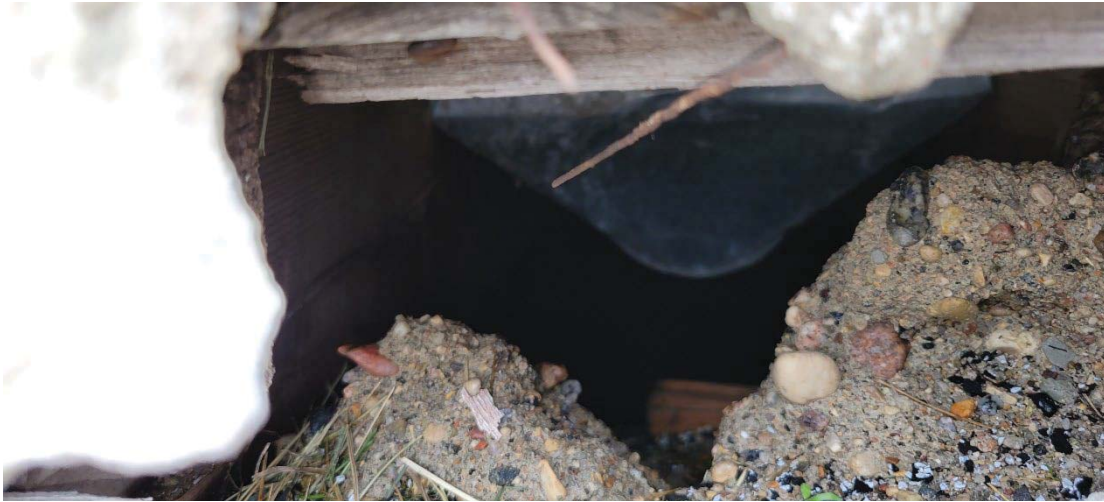
Photo 3: Holes in exterior foundation wall

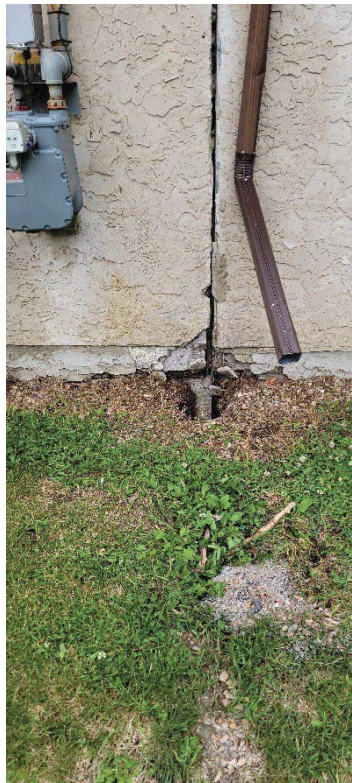
- Voids/sinkholes are present around the building perimeter exposing the foundation to water ingress and likely rodents, see photos 4,7 &8. Wood construction in these areas are exposed and rotten.

Photo 4: Deterioration at building joint, sinkhole into crawlspace

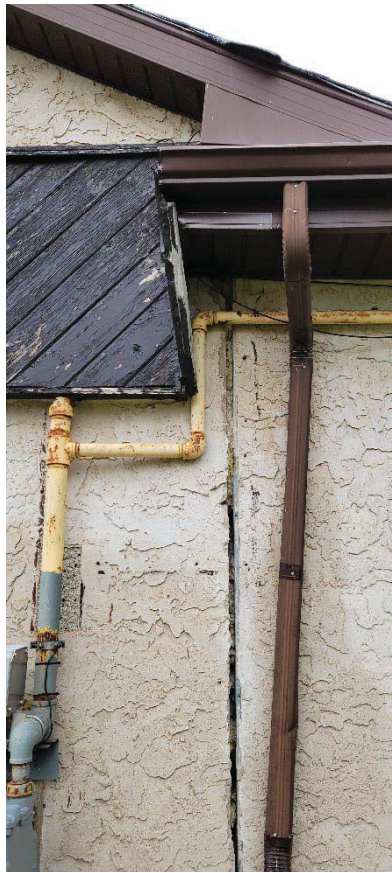
- Gaps exist between the hall and presumed relocated buildings, see photo 5, at the wood framed structure and foundations appear to be separate at this location.

Photo 5: Building separation between North & South wings

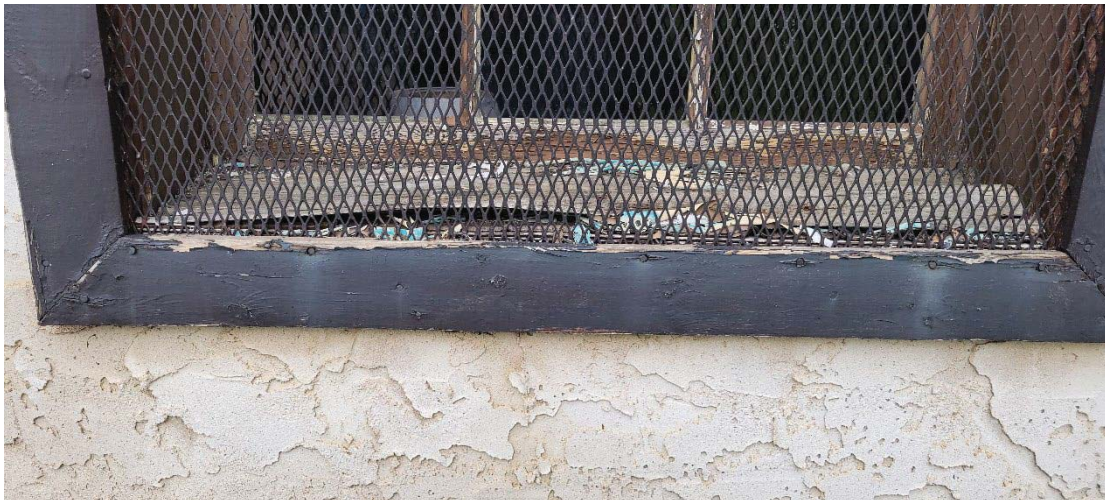
Photo 6: Rotten window frames

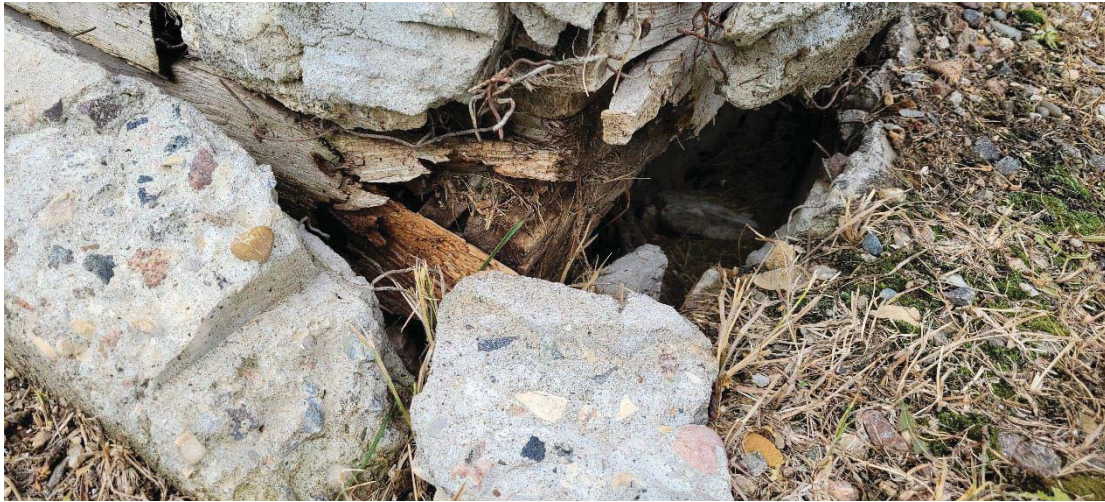
Photo 7: Exposed and deteriorated foundation at Northeast corner

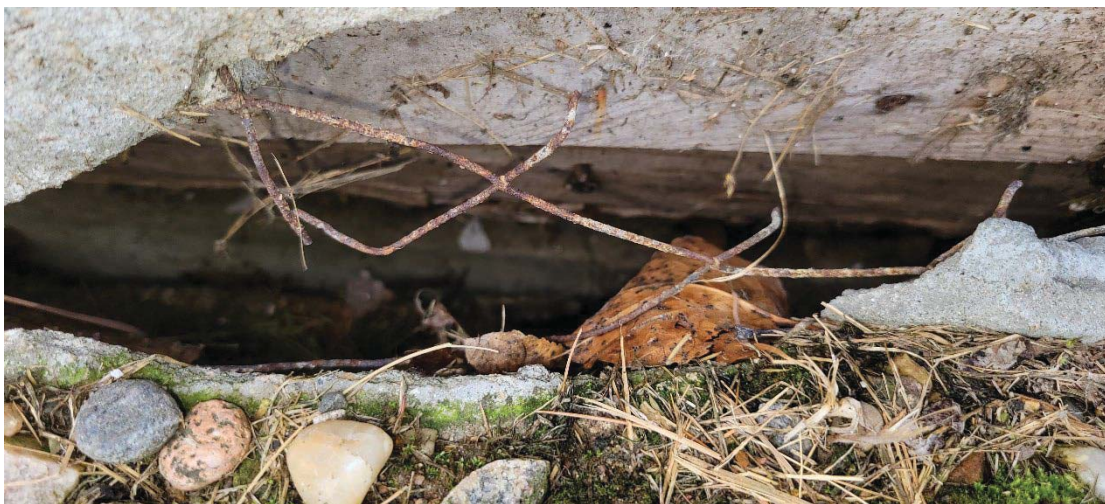
Photo 8: North wall, exposed and rotten foundation

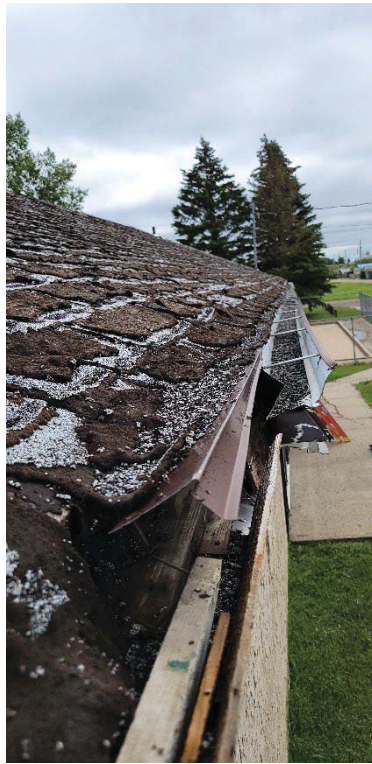
- The North deck is constructed of wood and is in fair condition.
- The roof is finished with asphalt shingles on roofing felt. Overall the roof system is in extremely poor condition. Shingles have deteriorated to the point of full granule loss, heavily deteriorated with areas of exposed shiplap boards. Gutters are missing and poorly fastened. Fascia boards are deteriorated and unfastened. Exposed rafter ends are deteriorated, see photo 9.

Photo 9: Roof edge and gutters Southside

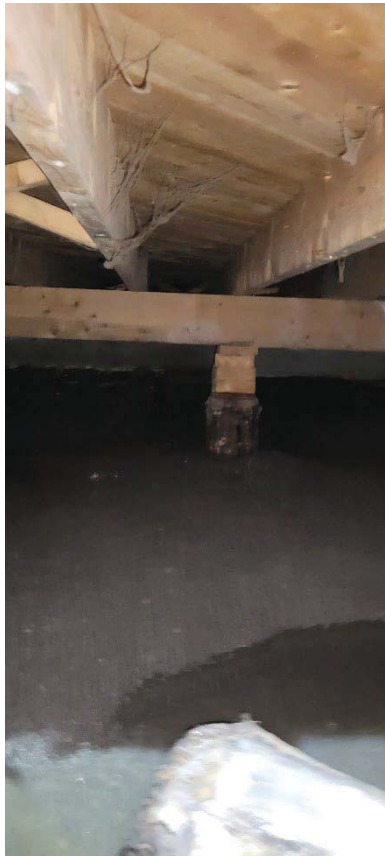
- The beam supporting the floor sits on blocking on top of timbers, see photo 10. The original drawings note driven timber piles. These are likely treated with creosote that produce a noticeable smell that effects air quality.

Photo 10: Foundation under hall with creosote timbers
