FACILITY REVIEW 2025 – 2029

Parks, Recreation &
Culture Department

City of
Prince Albert

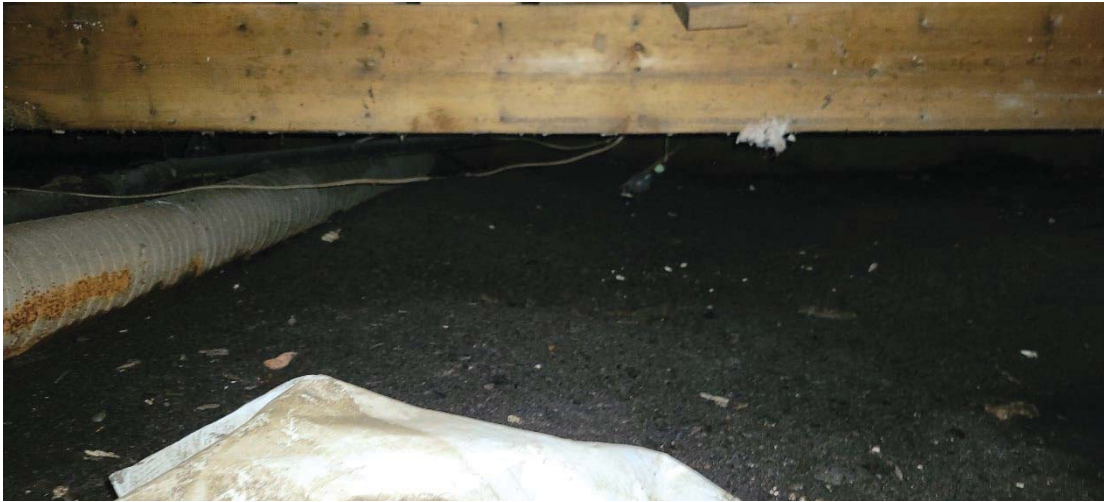
- The crawlspace under the skate shack was similarly constructed, see photo 11. There is standing water on the floor of the crawlspace.
- At the perimeter of the crawlspace opening, you can note at least 3 layers of flooring that are heavily deteriorated, see photo 12.

Photo 11: Crawlspace under skate shack

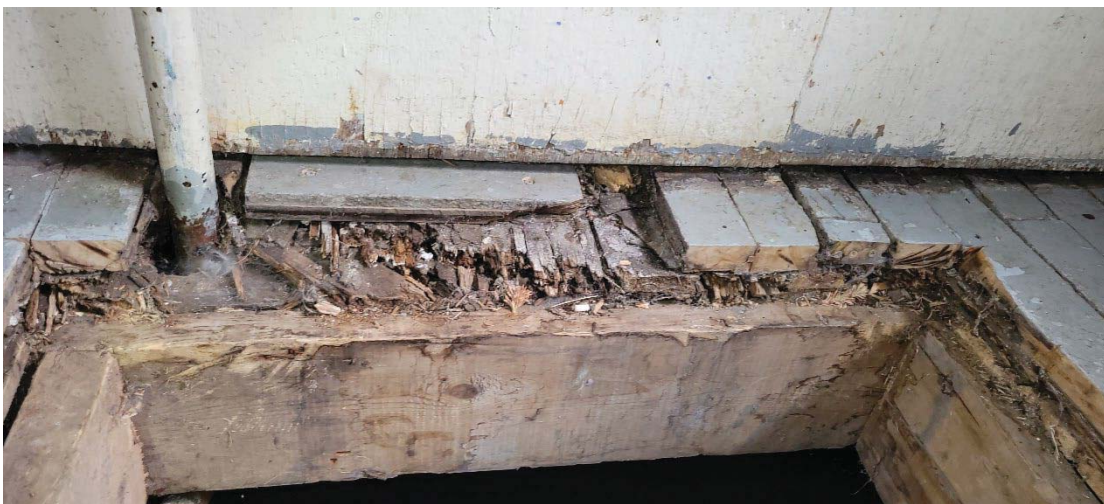
Photo 12: Crawlspace access – skate shack

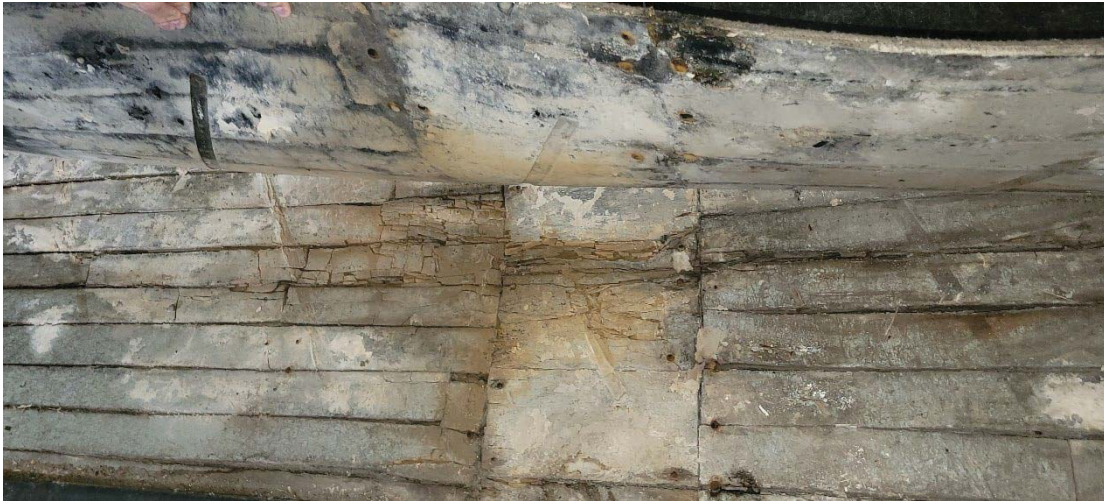
- The floor of the skate shack, under the rubber mats, is heavily deteriorated and sagging, see photos 13 & 14.
- The floor in the central storage area is covered by 9x9 tiled flooring. These historically contain asbestos, see photo 15.

Photo 13: Floor of skate shack

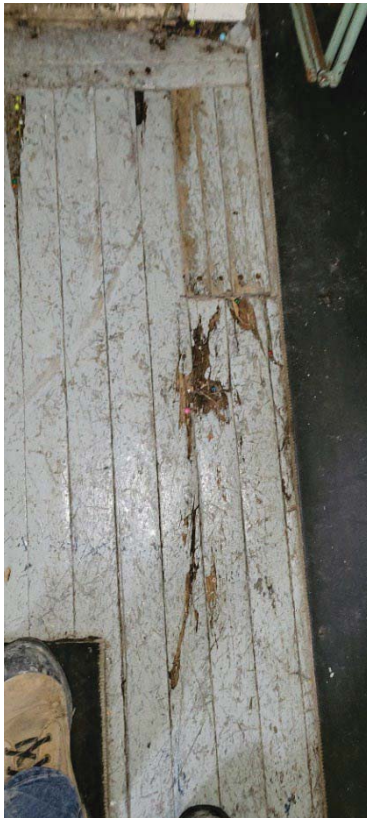
Photo 14: Floor of skate shack

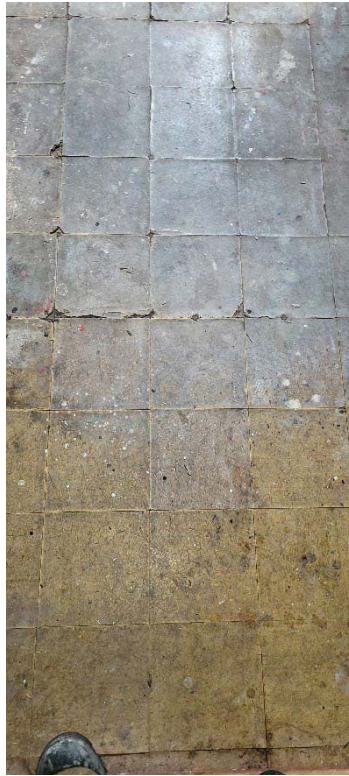
Photo 15: Floor of storage room – 9x9 tiles

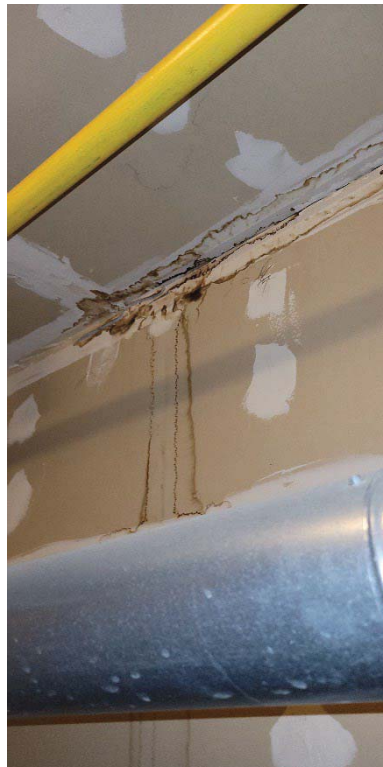
- There are numerous stains on walls and ceiling on the North wing, indicative of roof leaks, see photos 16 & 17.
- The roof above the hall was accessed. This area has site built trusses that appear to be in fair condition. Daylight is visible through the roof finish and the insulation is wet. Some noted areas of the roof board have water staining and deterioration, see photo 18.

Photo 16: Leaks, ceiling of mechanical room

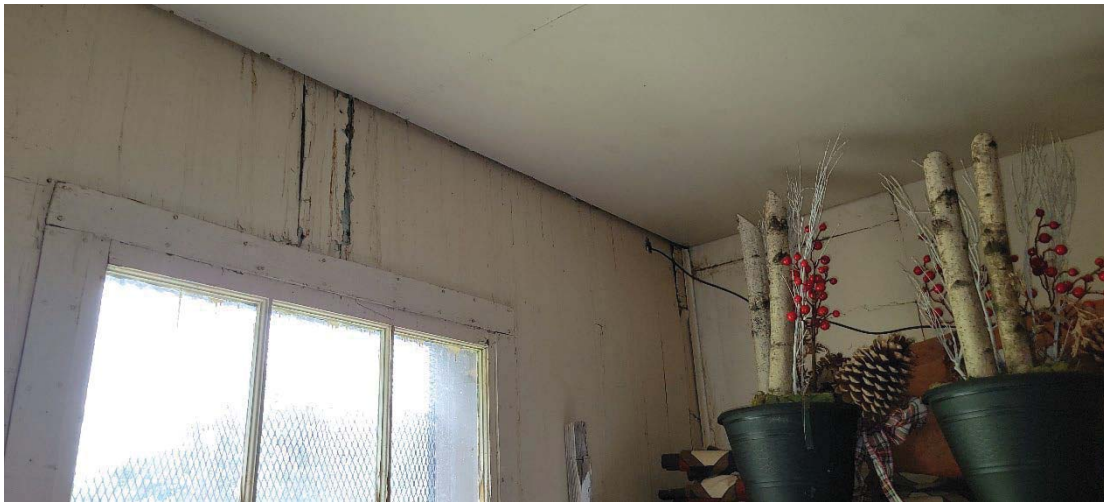
Photo 17: Leaks where ceiling abuts wall

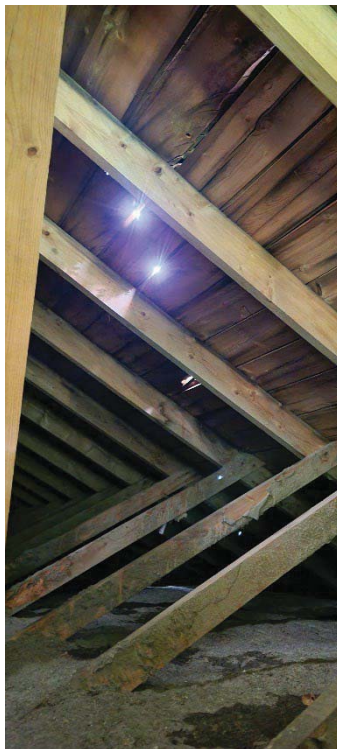
Photo 18: Daylight visible through attic above hall

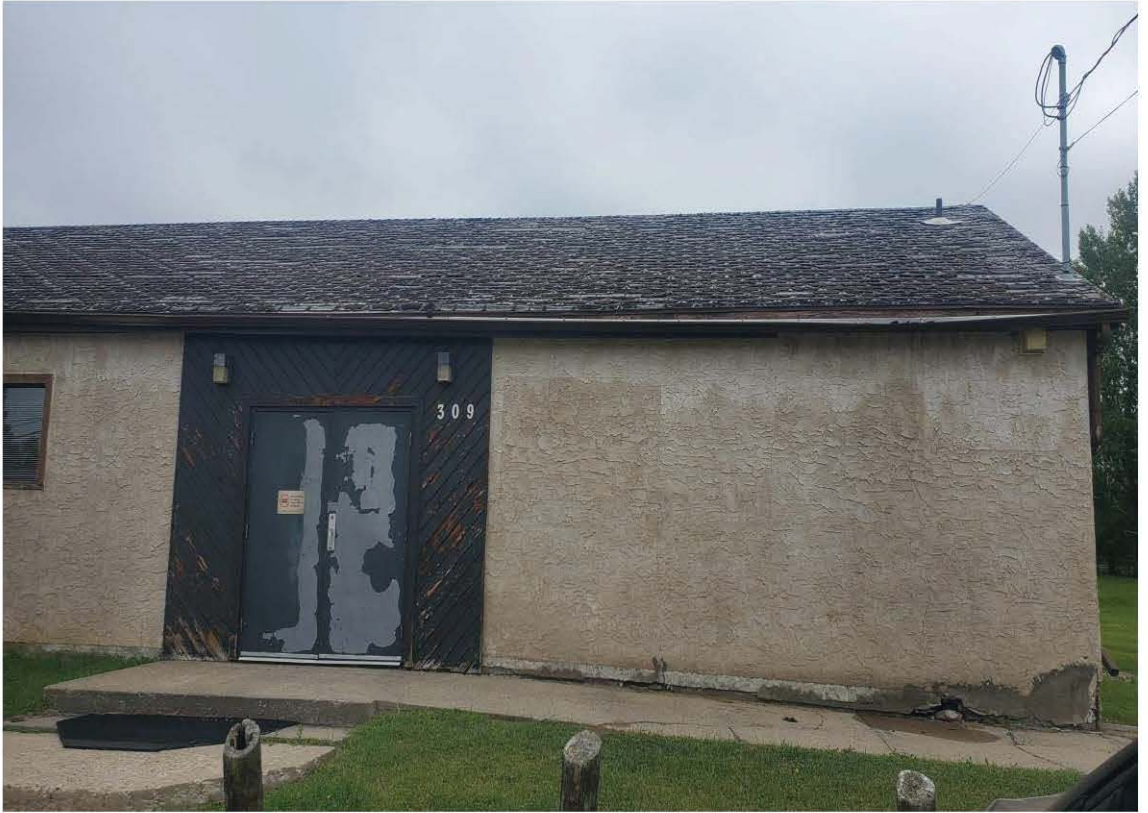
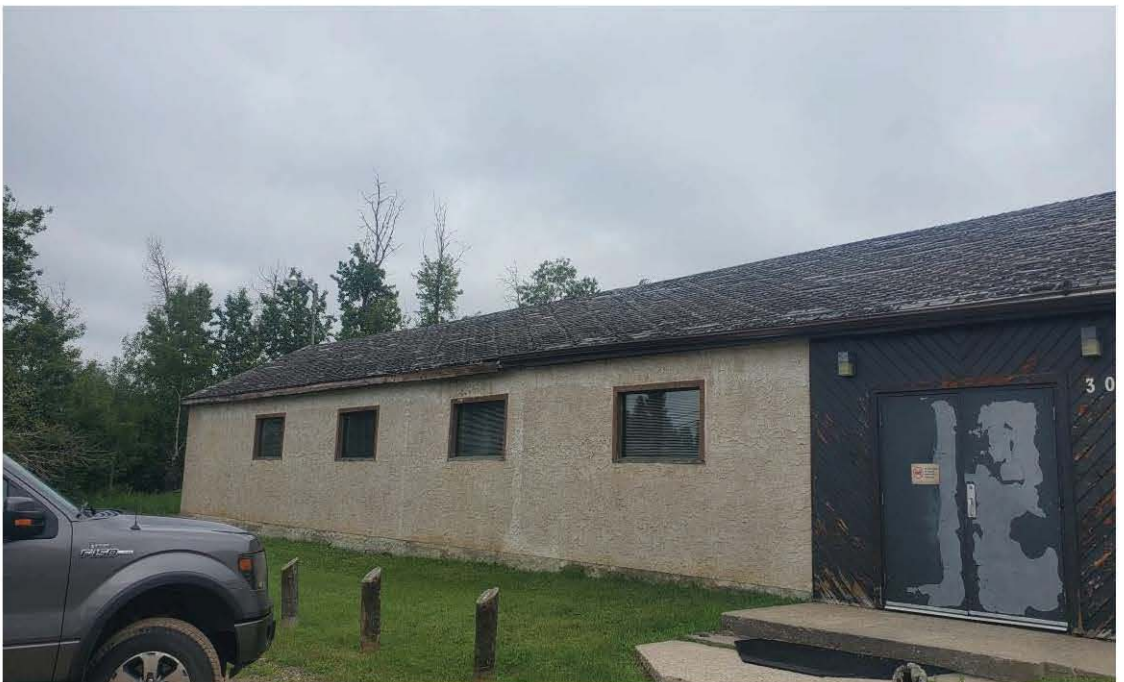
- South side of roof – shingles are completely baked

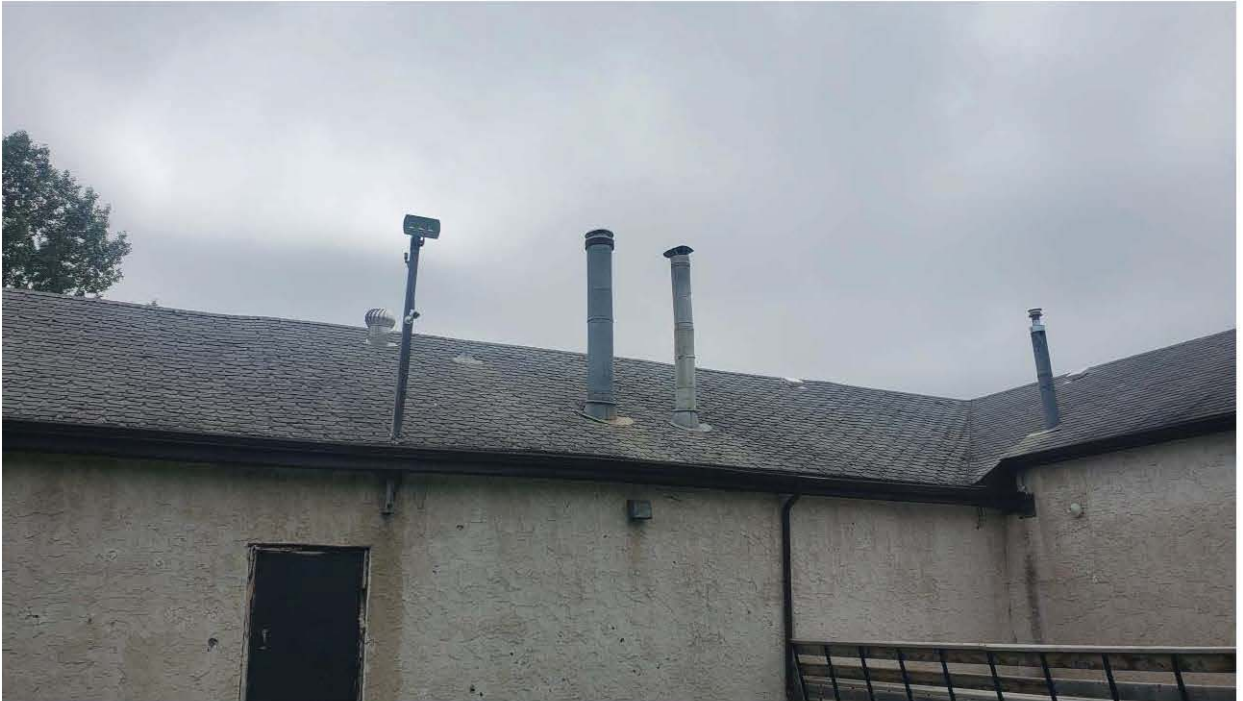
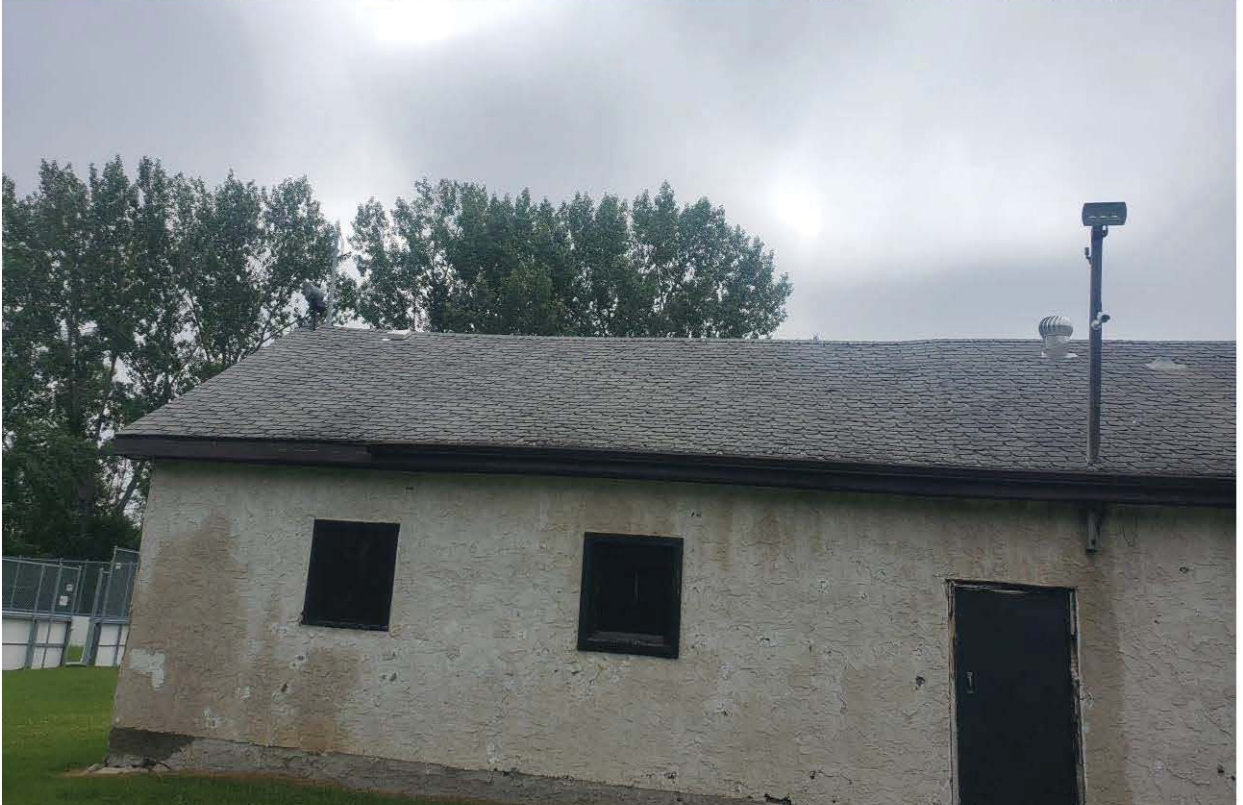
- North side shingles are not as bad

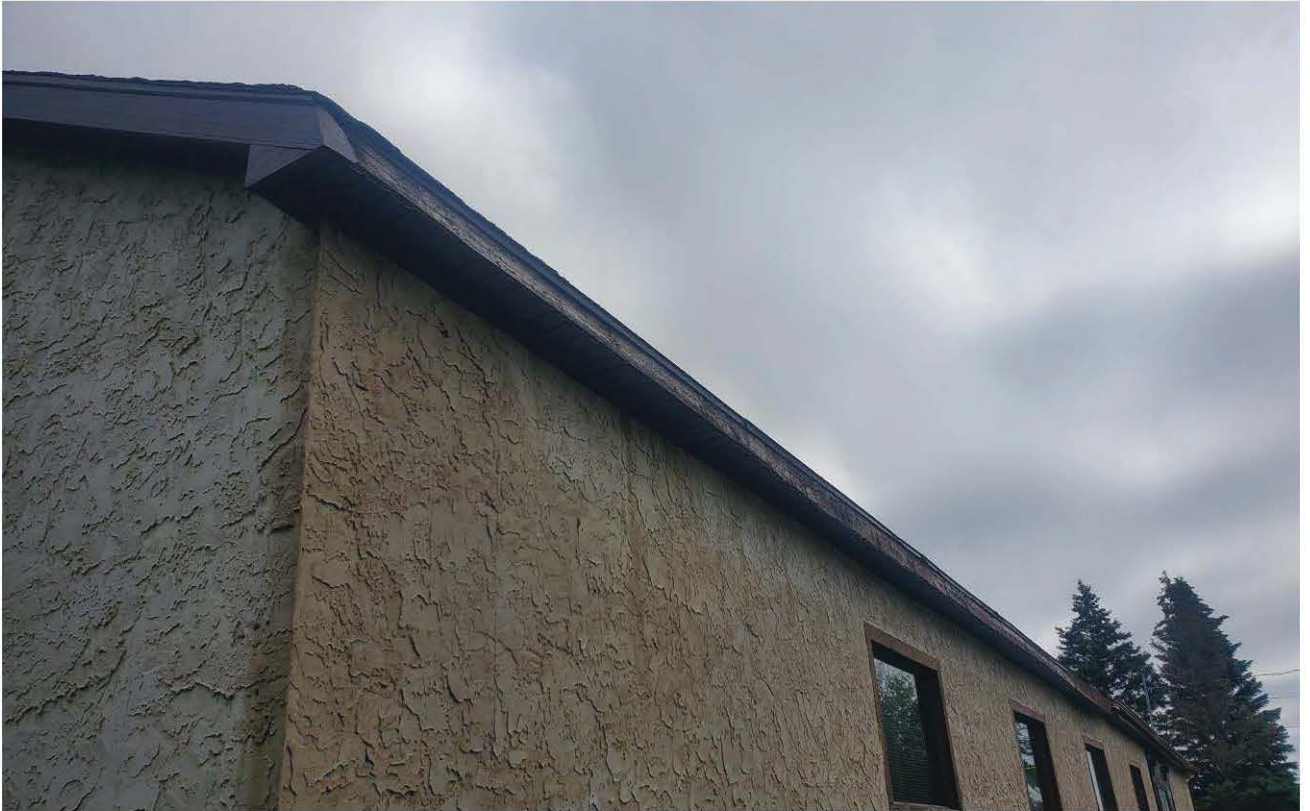
- Missing fascia and gutter

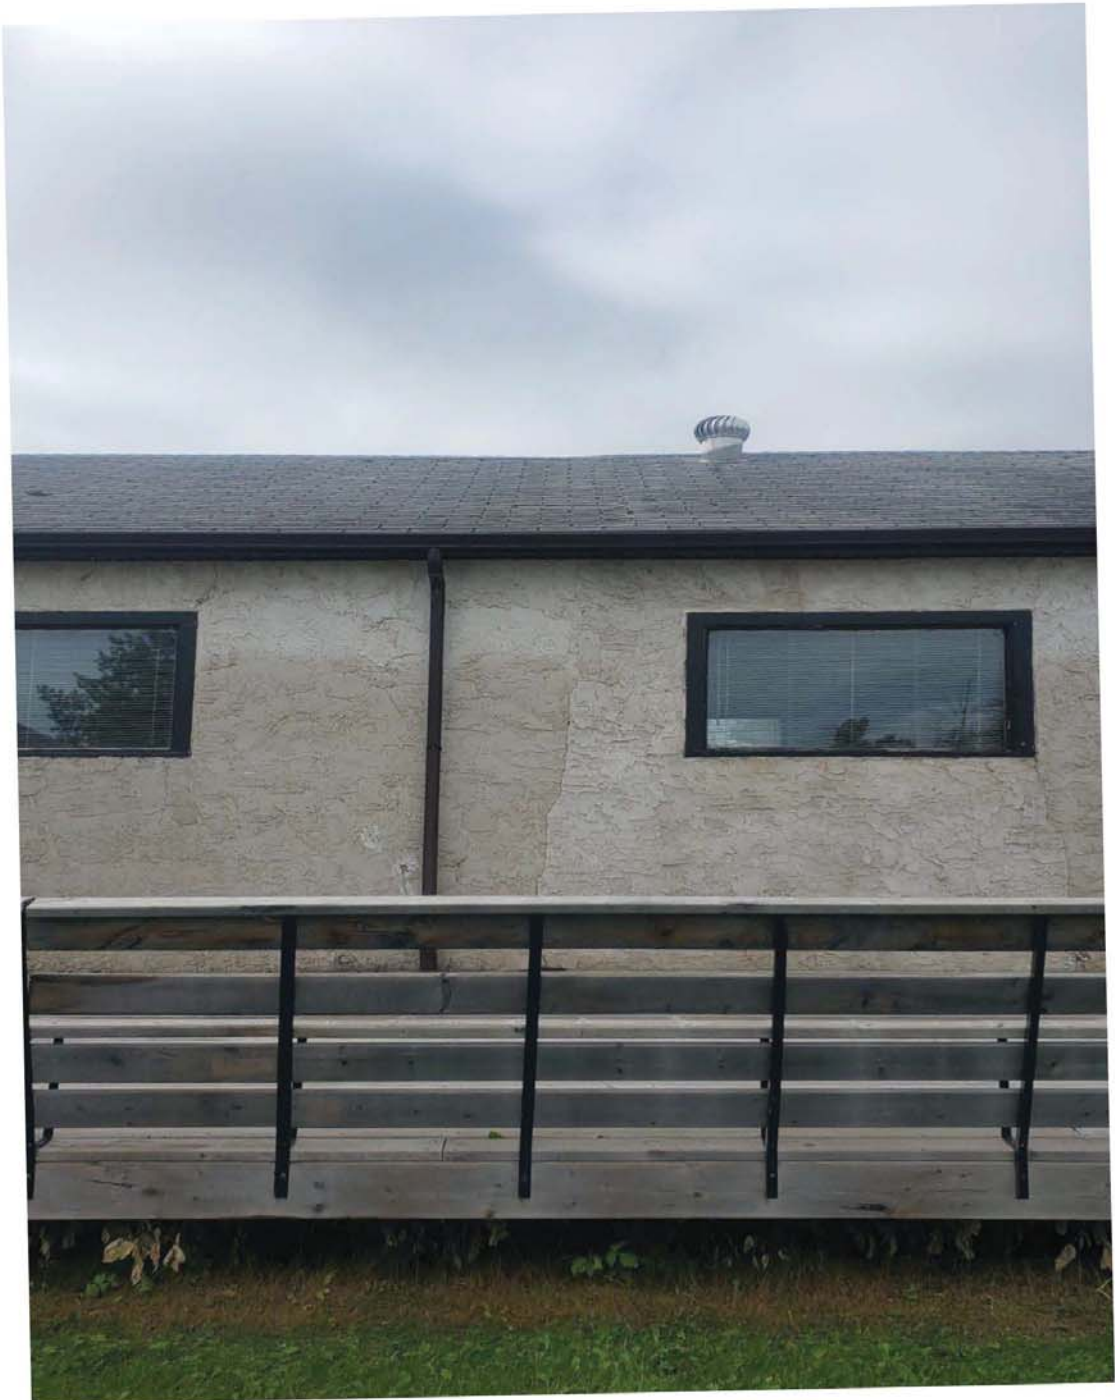
- Dip where buildings are joined

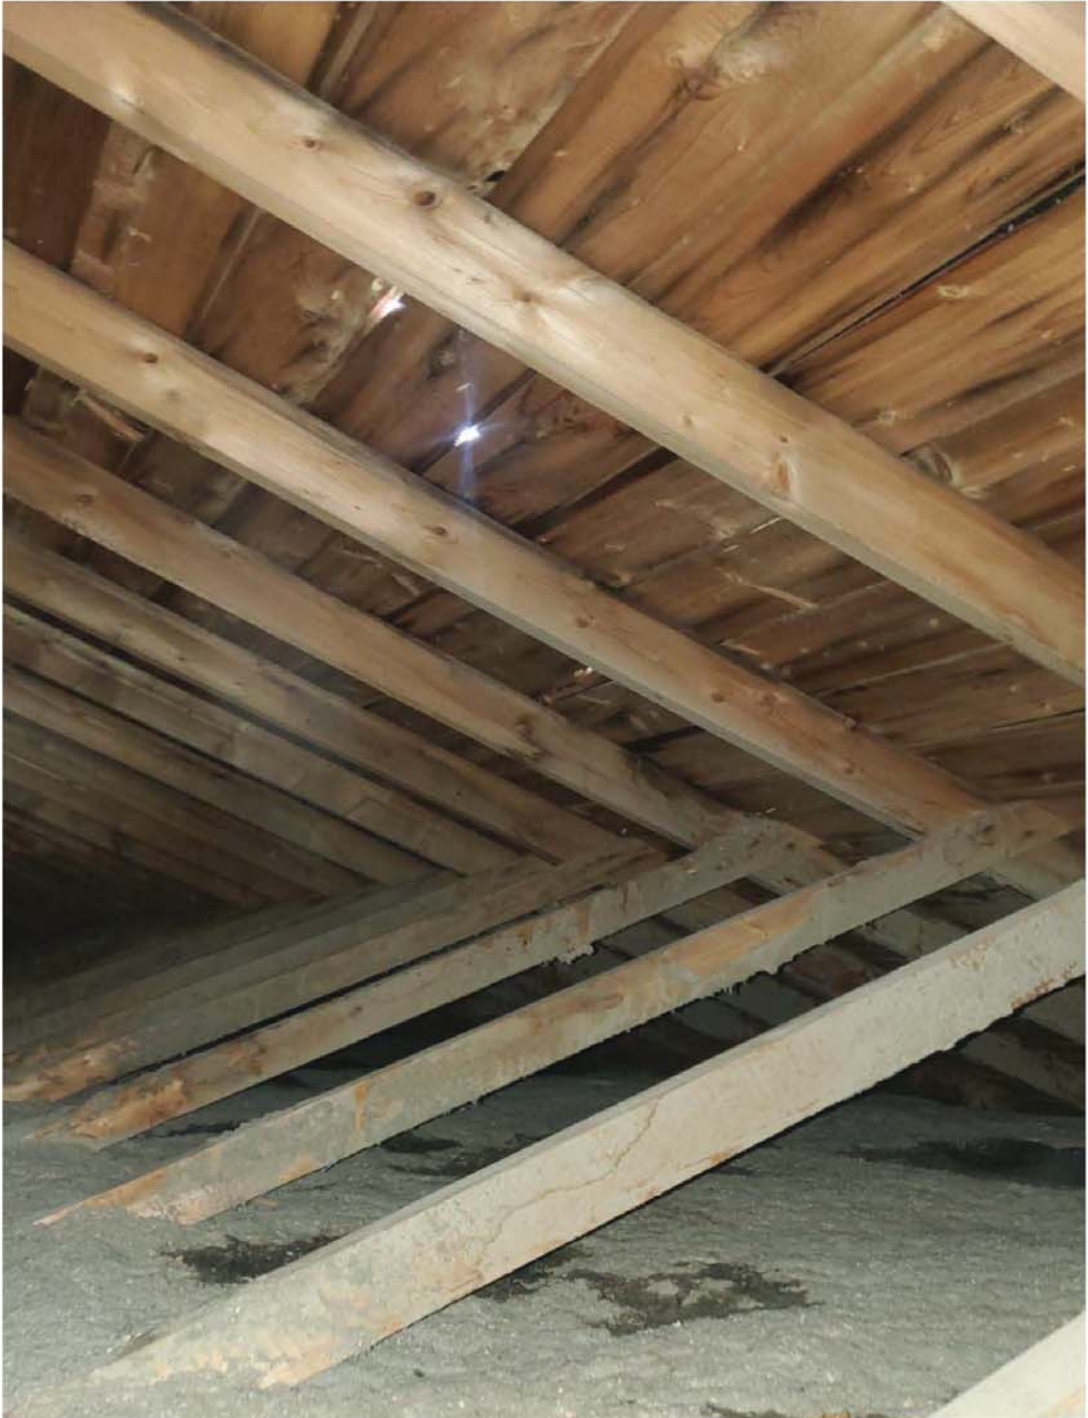
- Leaks in the attic
- Lots of blown in insulation over wood shavings

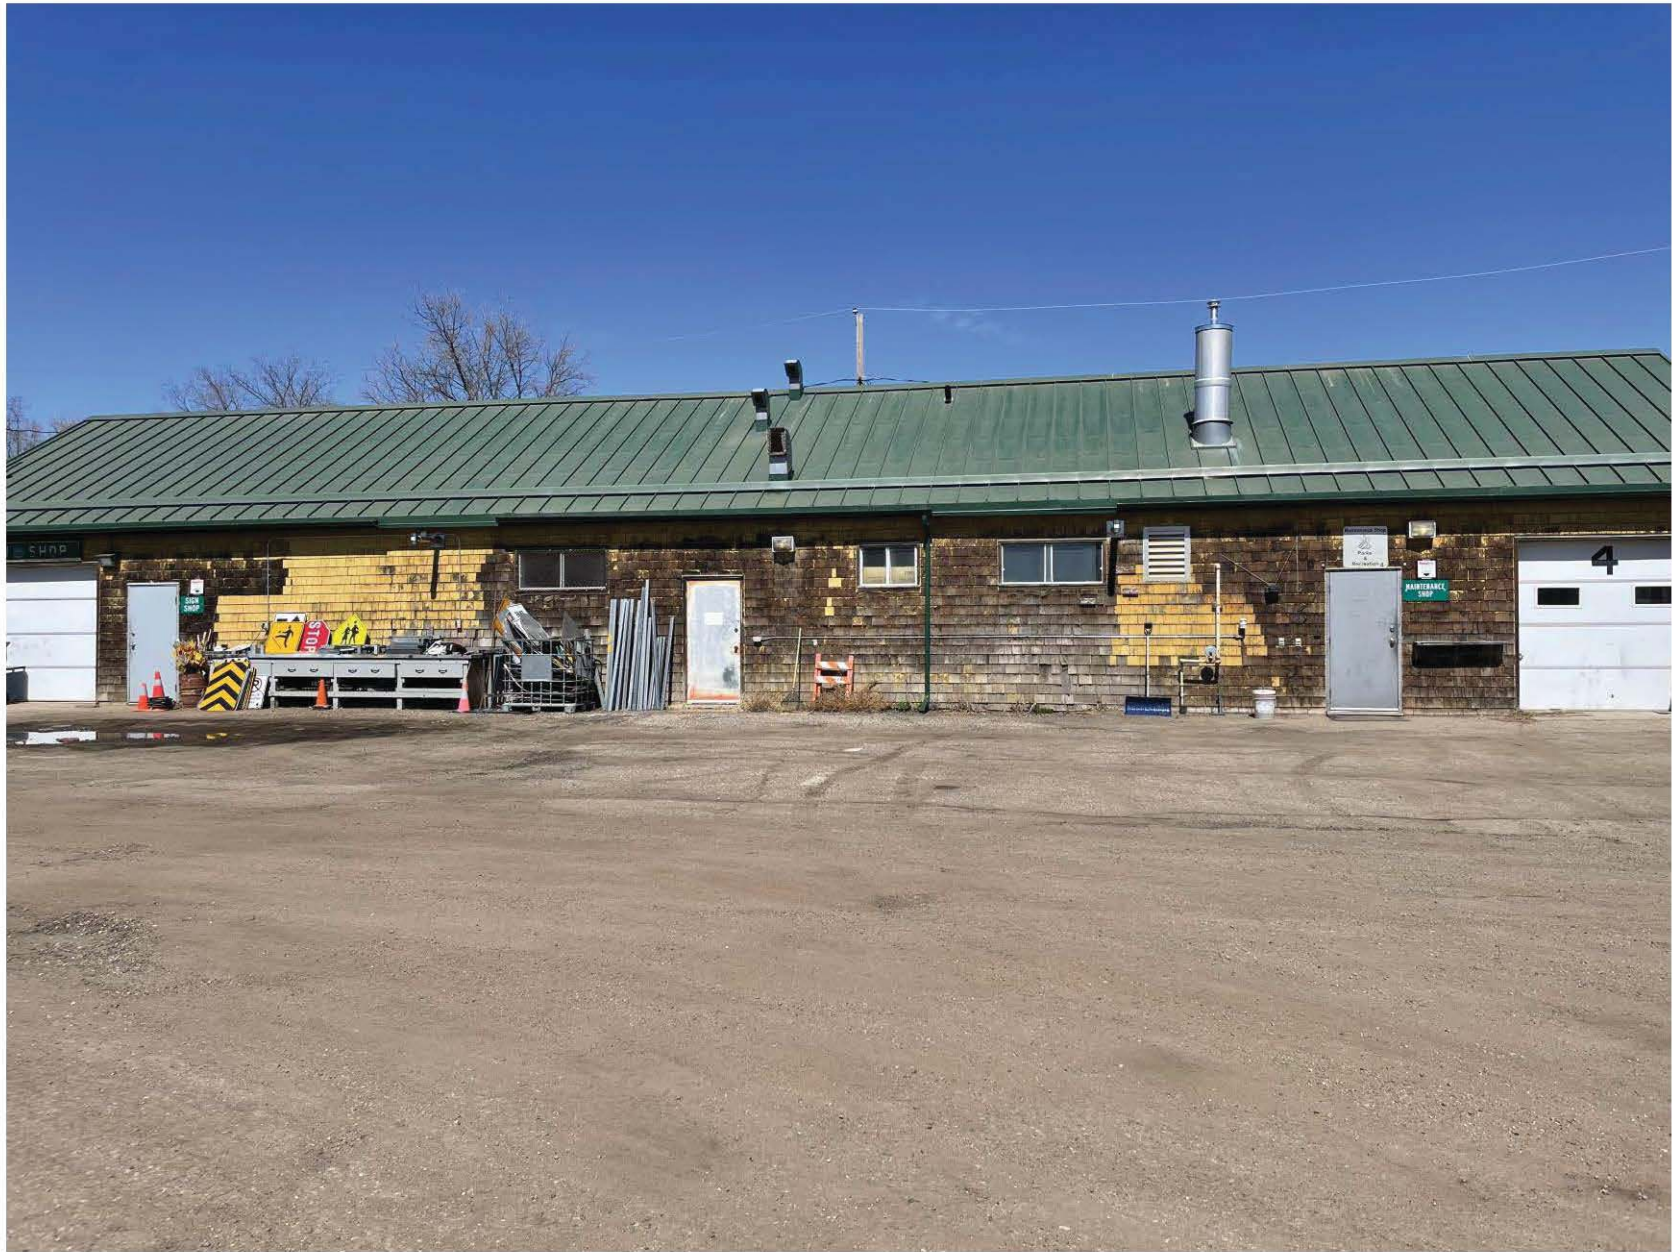
Attachments: Recent/Current City Pictures

Significant or Hazardous Issues: Rain water litre pipe contains asbestos

Facility Condition: (Good, Fair or Poor) Good

Summary: This building is a big part of the City's day to day operation with staff coming and going all day long, and like all other city facilities it does lack storage space.

2025	
Replacement of 11 windows cost		\$8,000.00

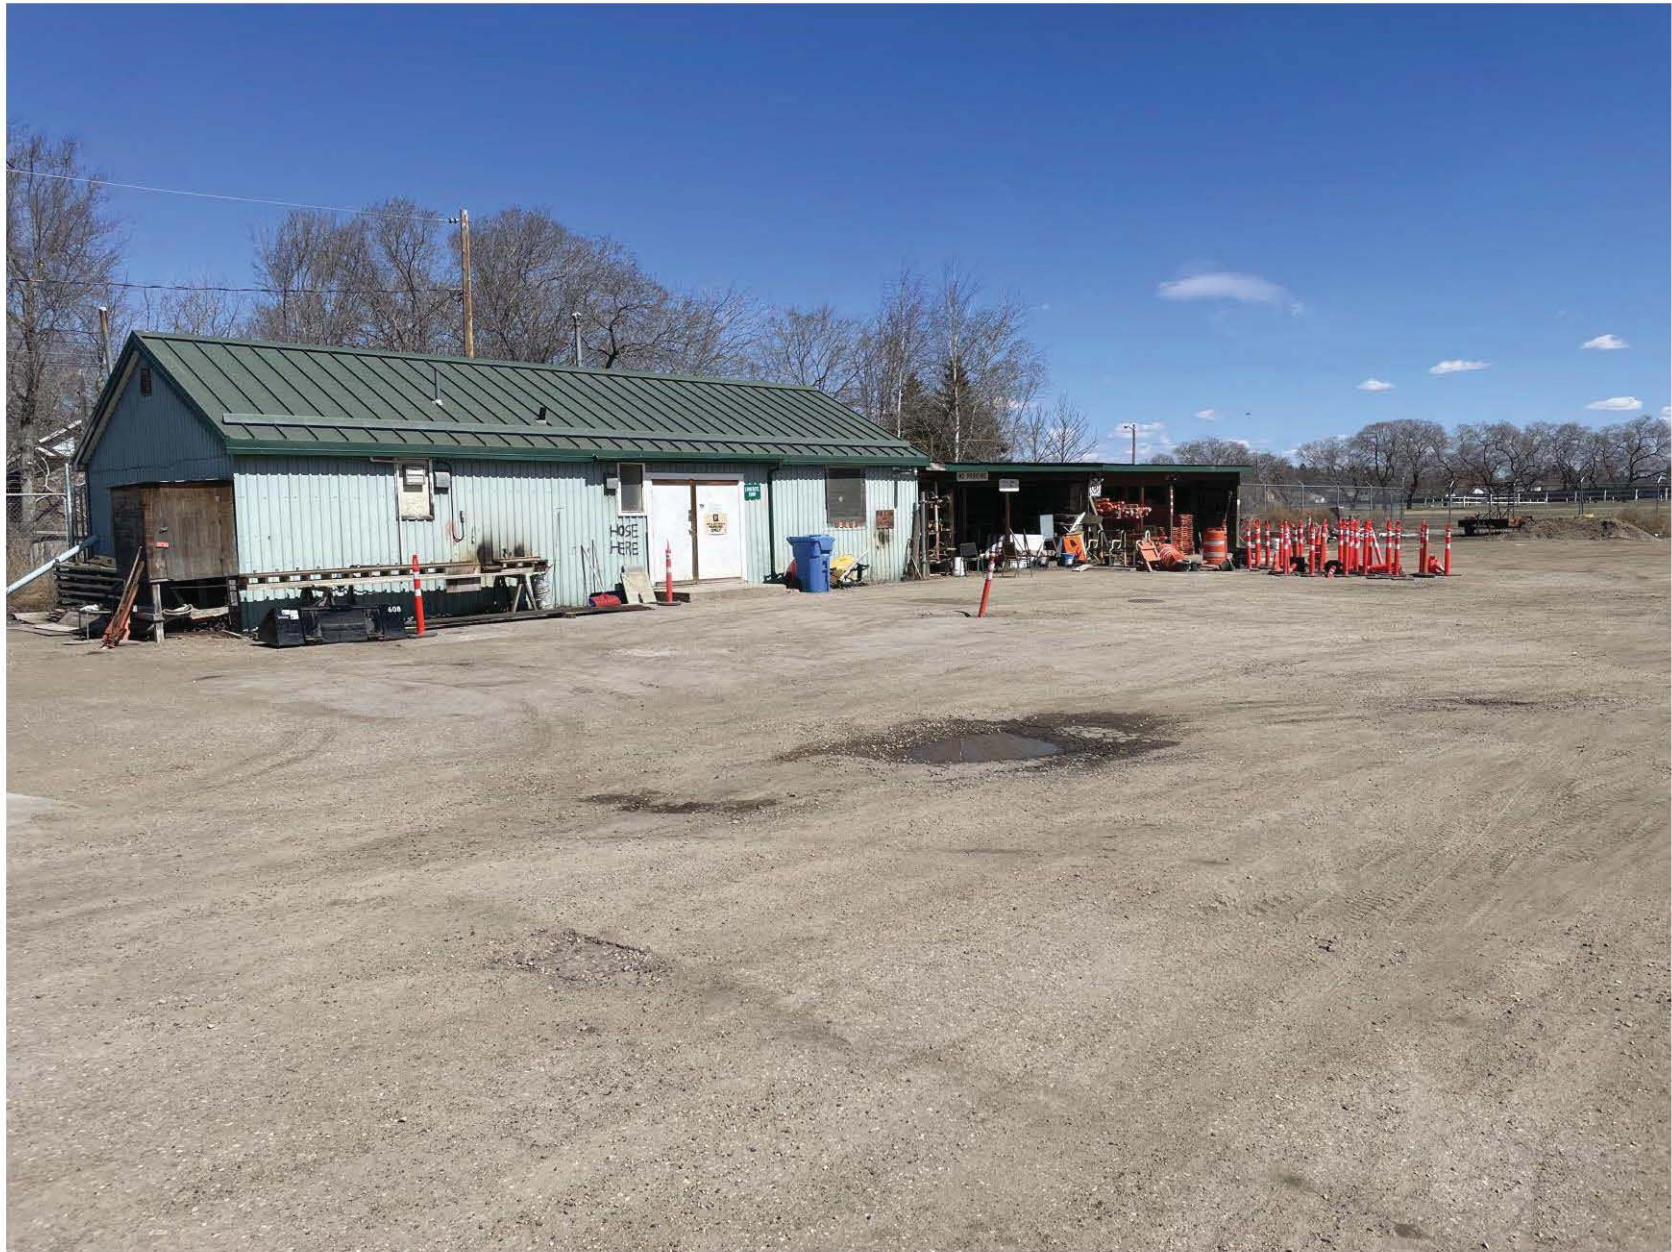
Attachments: Recent/Current City Pictures

Significant or Hazardous Issues: Rain water litre pipe contains asbestos

Facility Condition: (Good, Fair or Poor) Good

Summary: This building is a big part of the City's day to day operation with staff coming and going all day long, and as like all other city facilities it does lack storage space.

2025
Replace base cabinet and plumbing fixtures in washroom cost	\$2,100.00

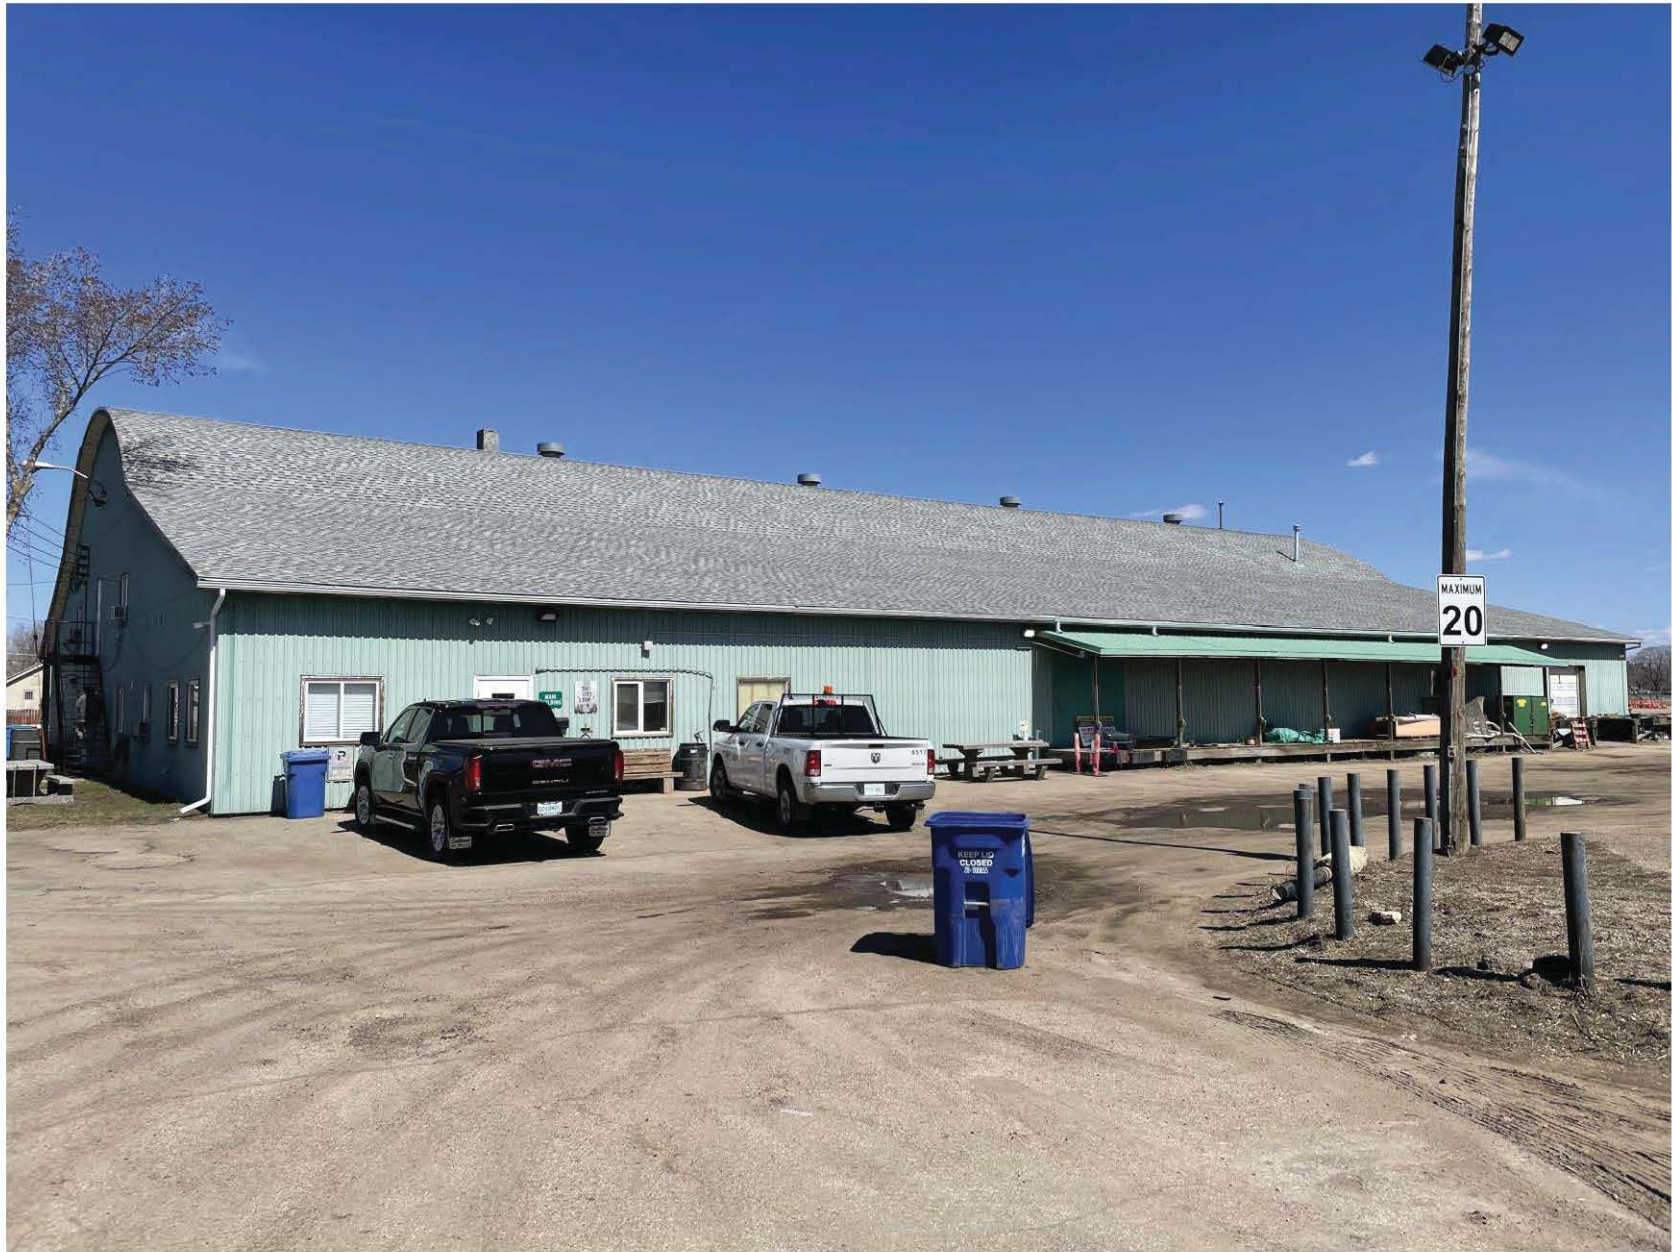
Attachments: Recent/Current City Pictures

Significant or Hazardous Issues: Asbestos containing material in attic space, also floor tile on main floor does contain asbestos.

Facility Condition: (Good, Fair or Poor) Fair

Summary: This building services the staff that use it well, but like all other City facilities it lacks storage space.

2025
Replacement of unit heater #2	\$8,000.00

2026
Clean west and north fence line and replace fence	\$46,000.00
Replacement of unit heater # 2 in main garage bay	\$8,000.00

2027
Replace 7 exterior windows	\$5,700.00
Clean and paint exterior of building cost unknown.

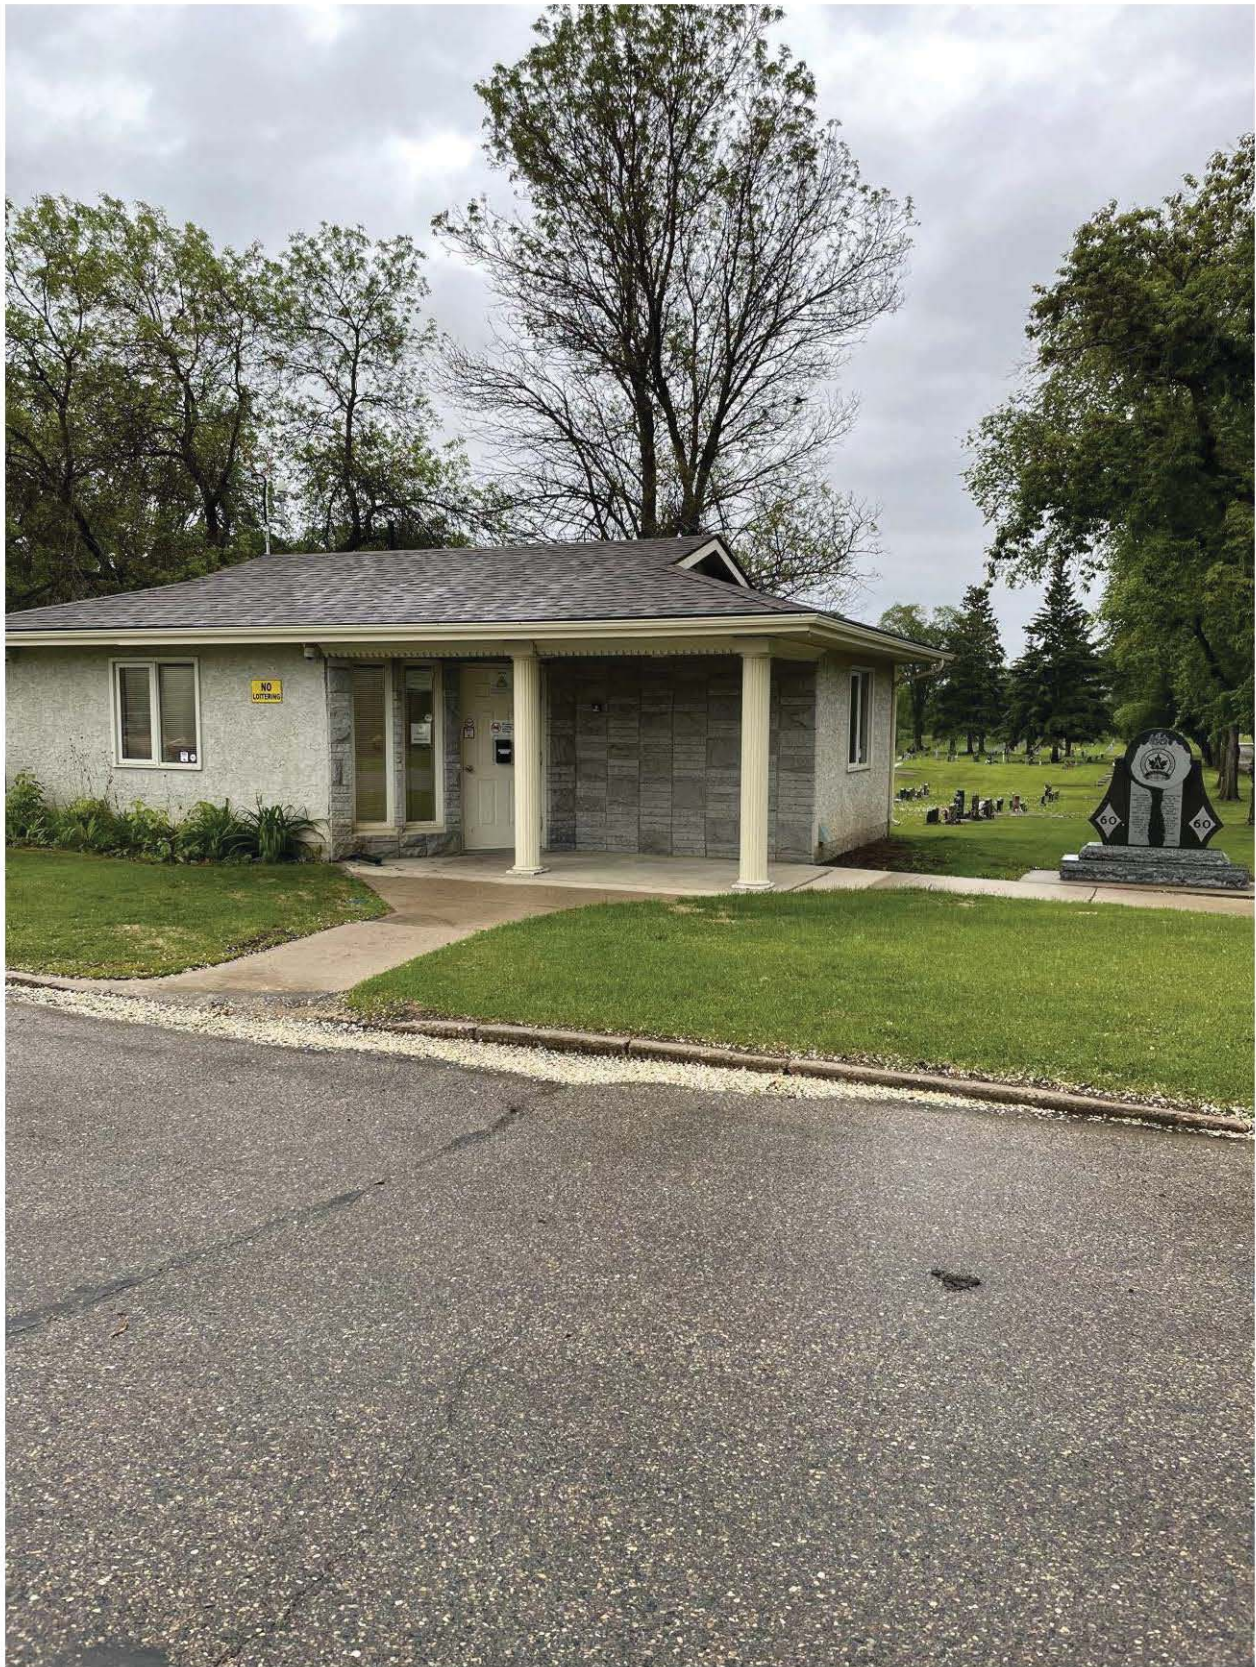
Attachments: Recent/Current City Pictures

Facility Condition: (Good, Fair or Poor) Fair

Summary: This facility has been well maintained, in 2013 we replaced the aging furnace and had the shingles replaced in 2019. In 2024 water heater replacement.

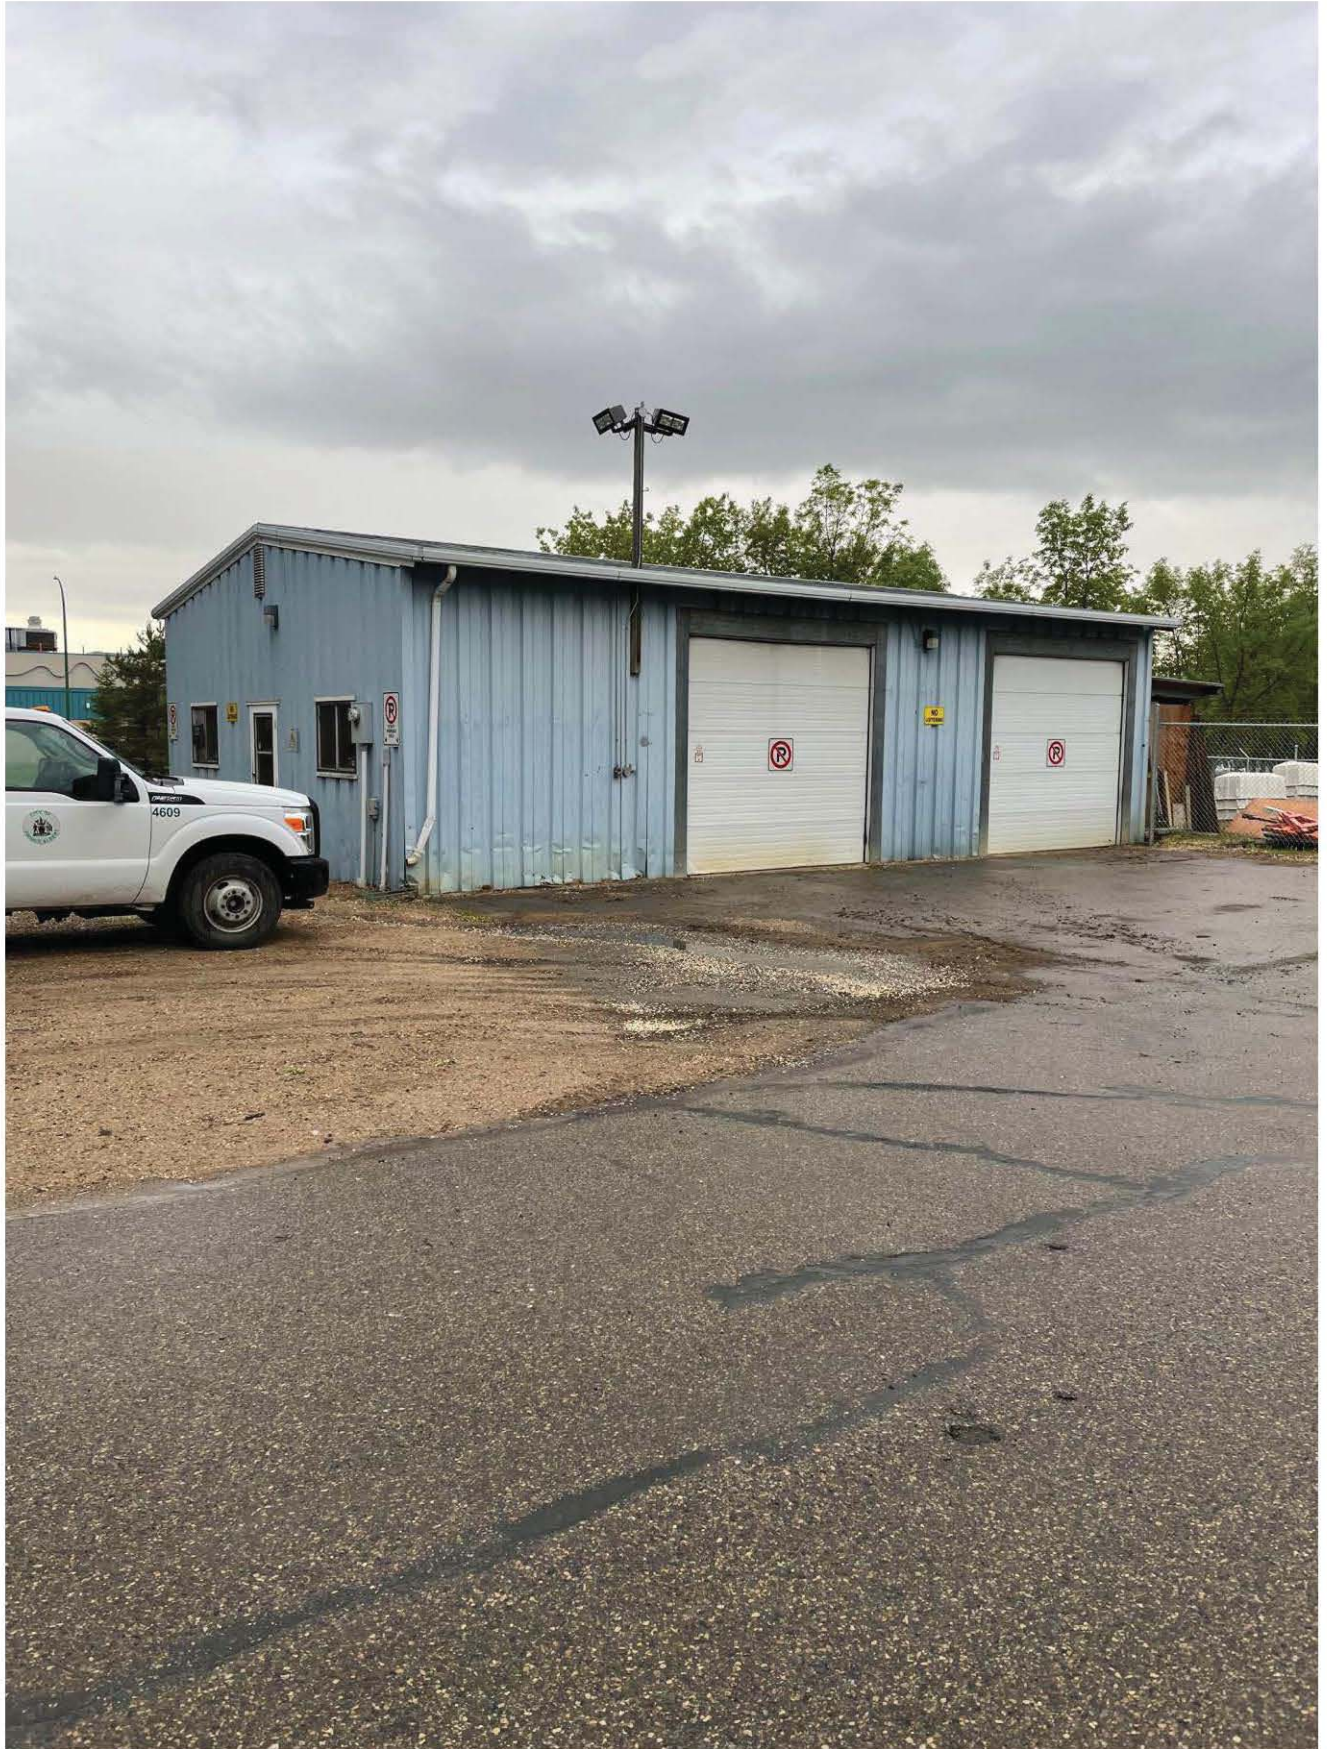
Attachments: Recent/Current City Pictures

Facility Condition: (Good, Fair or Poor) Fair

Summary: This facility requires a renovation to increase the foot print of the building to make it more functional for the staff that use it.

2025
Put together a package to replace the maintenance building and the rationale behind it.
