City of Prince Albert - Municipal Services Centre Roof Inspection

Prepared By  
Brett Foote

June 10, 2022

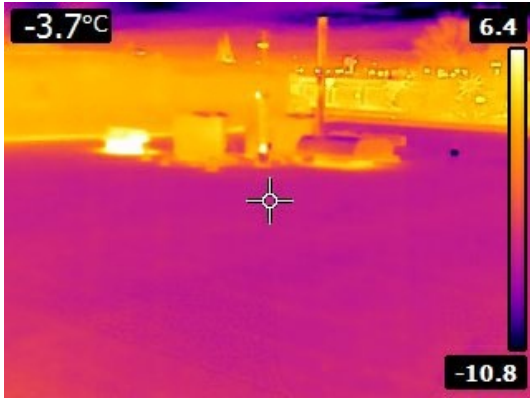
*Photo 3*

General view of the lower section (B1) from the roof surface.  
The thermal patterns on the roof surface were homogeneous.

No thermal anomaly related to wet insulation was found on this section

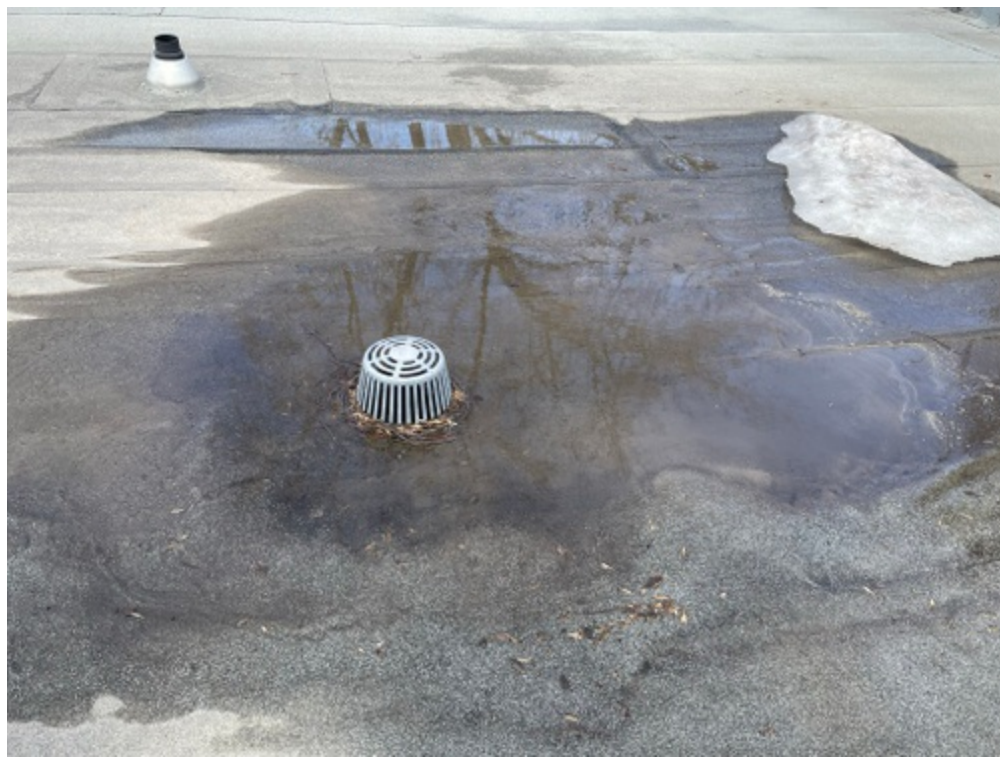
*Photo 11*

**Debris - Leafs and Pine**

**Needles:** Pine needles and other leaves build up on the roof membrane causing plugged drains and scuppers thereby causing ponding water and structural weight loading. As the leaves and pine needles rot a "compost effect" occurs, this in effect causes soil to form on top of the roof membrane. This soil creates a perfect medium for plant and weed growth. When seeds take hold the roots will often penetrate through the membrane causing immediate leaks and damage internally.

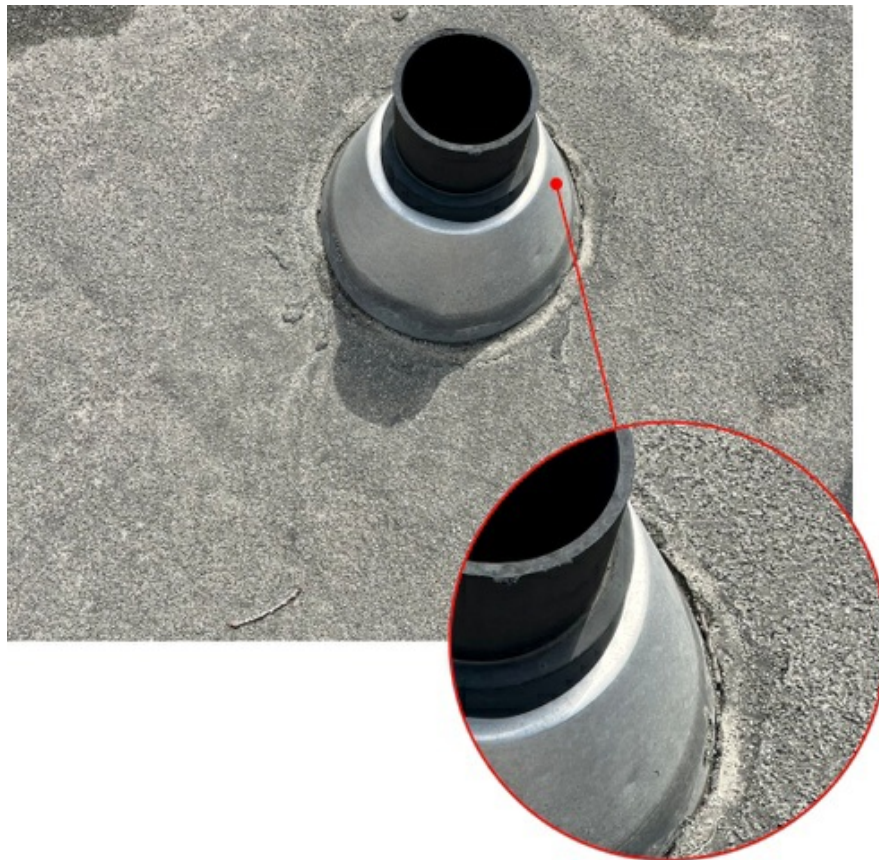
*Photo 12*

**Penetration Waterproofing:**

Beginning to deteriorate around the perimeter allowing for potential moisture access.

1. Repair all open fish mouths using high grade mastic reinforced with mesh
2. Re caulk all coping cap seams
3. Fill all pitch pockets using high grade mastic
4. Re seal around all penetrations using high grade mastic
5. Repair sagging curb flashings on units and around perimeter

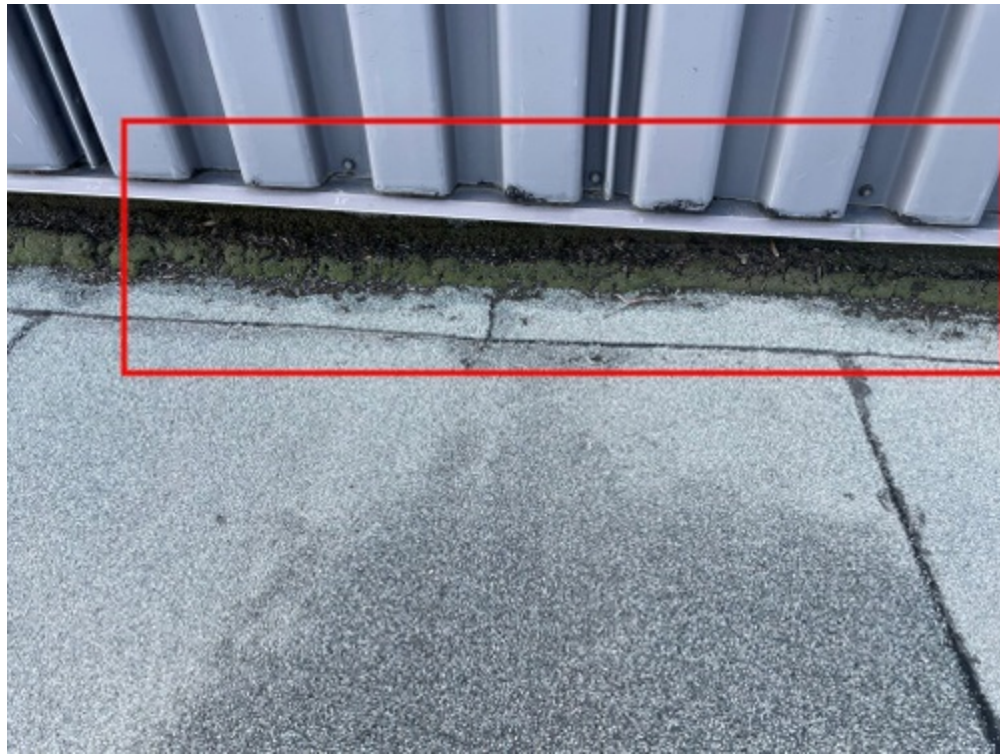
*Photo 15*

**Vegetation Growth:**

Vegetation often occurs when dirt and debris collect on roof systems. Over time this creates a perfect medium for plant and weed growth. When seeds take hold the roots will often penetrate through the membrane causing immediate leaks and damage internally.

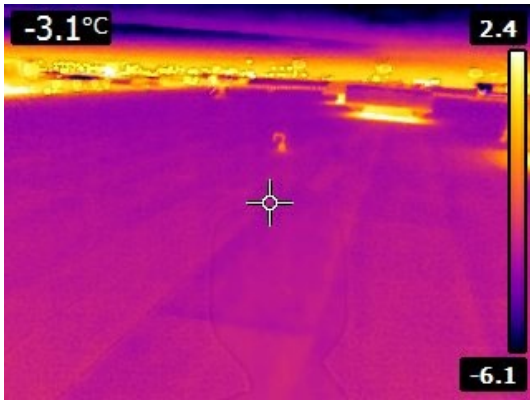
*Photo 3*

General view of section A2 (upper est) with the infrared camera.

No thermal anomaly related to wet insulation was found on this section.

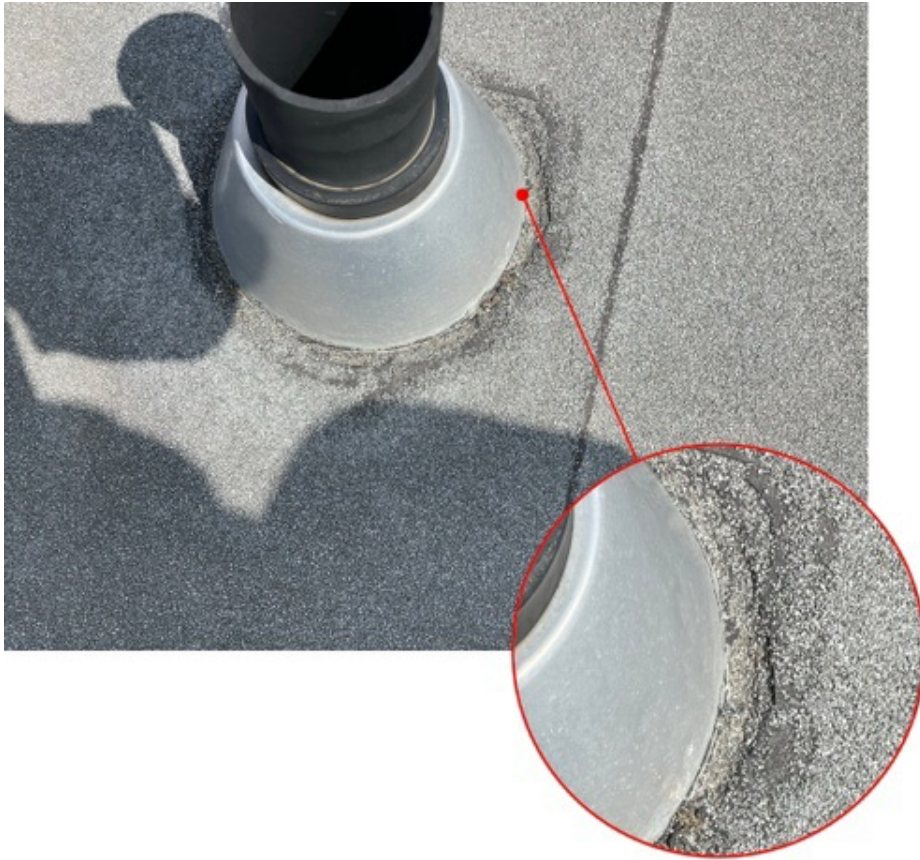
*Photo 3*

**Penetration**

**Waterproofing:** Beginning to deteriorate around the perimeter allowing for potential moisture access.

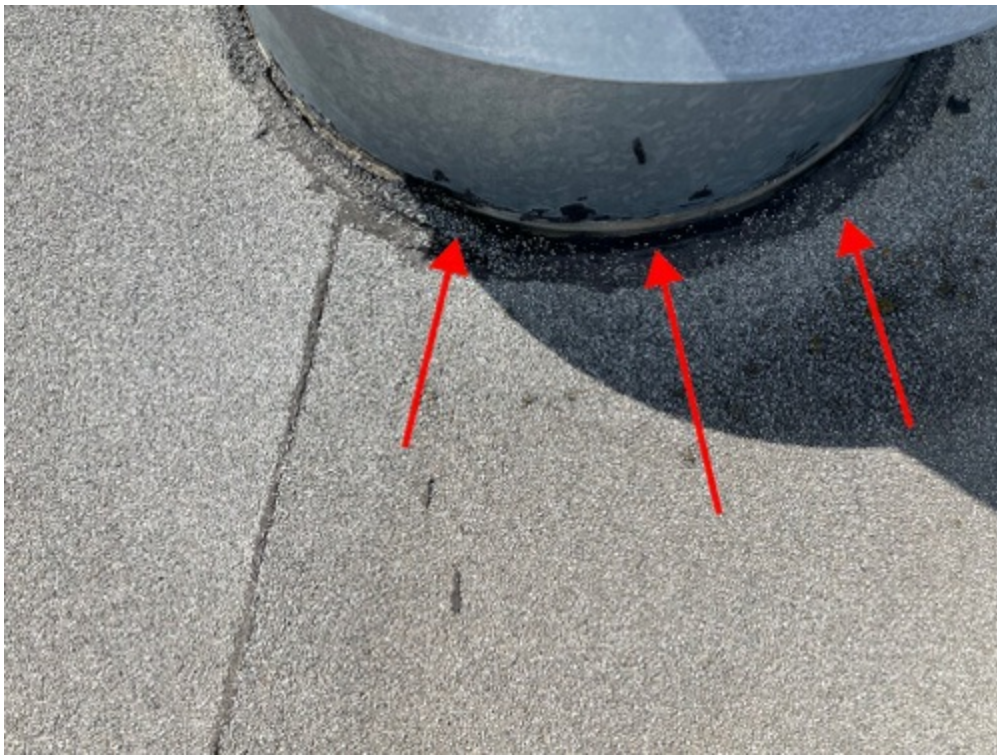
*Photo 4*

**Penetration**

**Waterproofing:** Beginning to deteriorate around the perimeter allowing for potential moisture access.

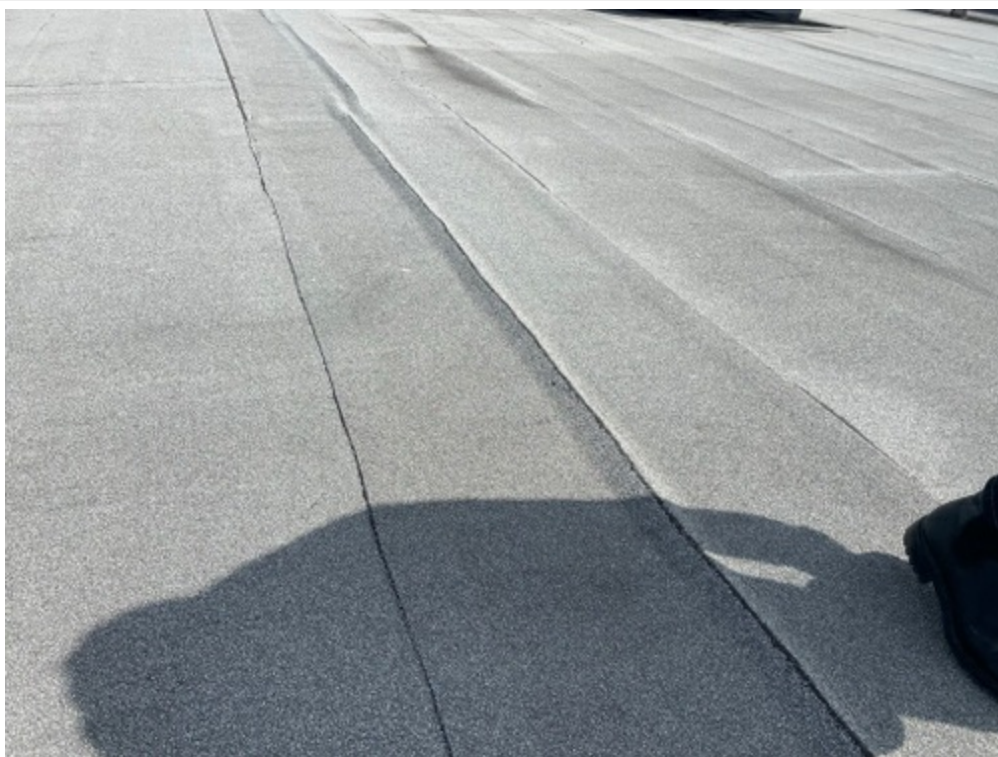
*Photo 6*

**Ridges:** These show up on the surface of built up roofs as linear buckling felt lines protruding upward through the surface layers of asphalt and aggregate.

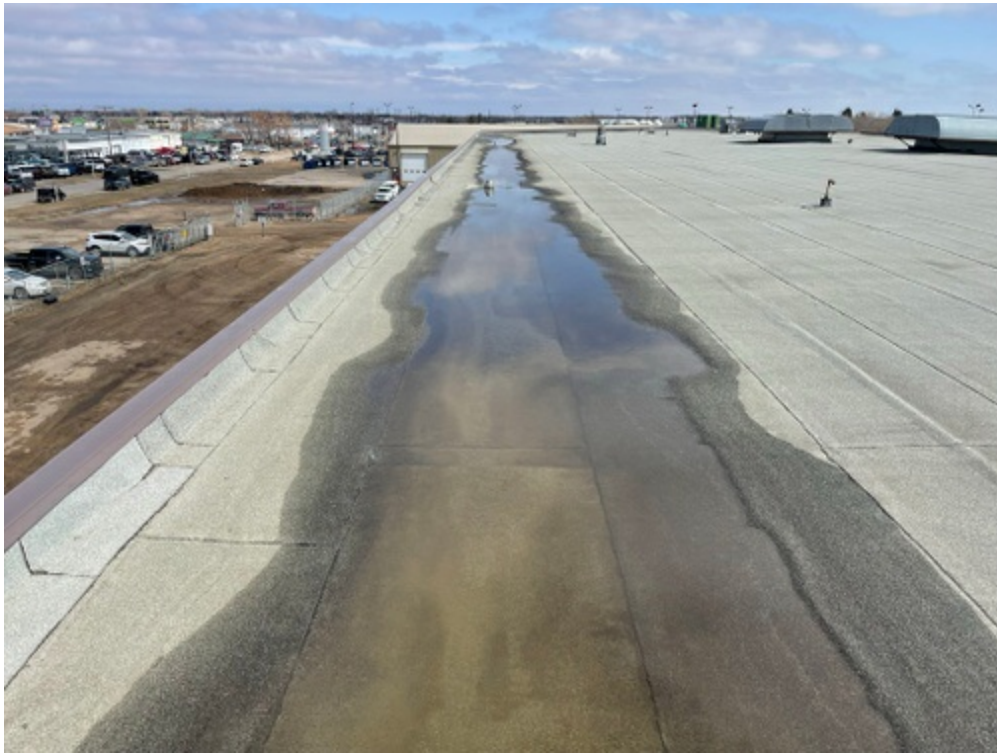
*Photo 7*

**Ponding:** Ponding water occurs when moisture collects in large pools on the surface of a roof system. These pools begin to form

due to the following: 1) roof drains are blocked or clogged with debris, 2) the insulation package has lost dimensional stability and has reduced in thickness, 3) poor slope to drain design via overbuilt crickets or tapered insulation system, 4) roof drains are built along side building support columns which maintain a consistent height under load while the balance of the roof system is applied over a live deck which tends to move and deflect under normal seasonal load. In all cases, roof depressions that collect and hold water will tend to grow in size as the added weight of the ponding water will continue to deflect the roof deck even further.

This condition can damage the roof in a number of ways. Additional structural loads create more movement of the roof assembly creating more tear stress and of course a potential for structural failure. UV intensity also increases under ponding conditions as the sun's rays are increased to the point where it accelerates deterioration in most all roof systems. In asphalt based assemblies the natural waterproofing oils in the asphalt will separate from the membrane if the system remains submerged under water for sustained periods. Single ply roof system rot and burn out when the ponding area is exposed to sunlight. The added weight can crush insulation increasing the ponding condition and creating a condition where the insulation becomes a useless thermal barrier. This condition then affects the

mechanical system and the cost of heating and cooling the building. In the winter ponding water will expand as it freezes. This expansion will weaken small imperfections in the roof system. Small cracks and tears will widen until they rupture to allow water into the building. And finally, a negatively deflected deck becomes a structural concern.

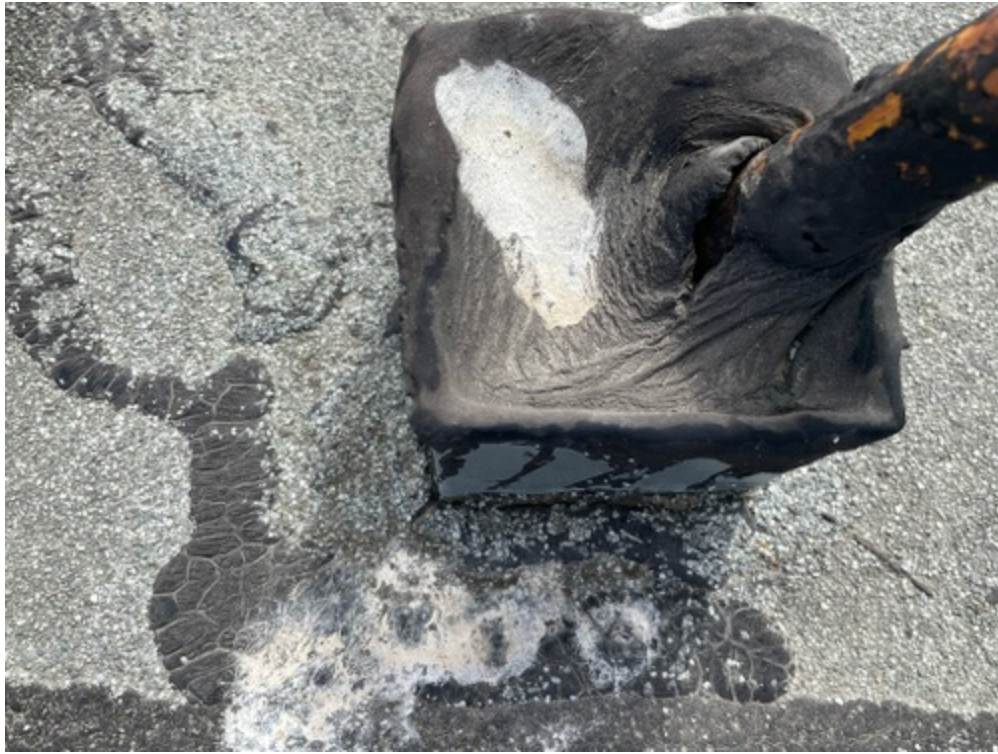
*Photo 11*

**Pitch Pocket**

**Deterioration:** Metal protrusions that penetrate the roof system to allow conduits to run from the rooftop into the building. Movement from the protrusion can break the waterproofing compound, creating cracks.

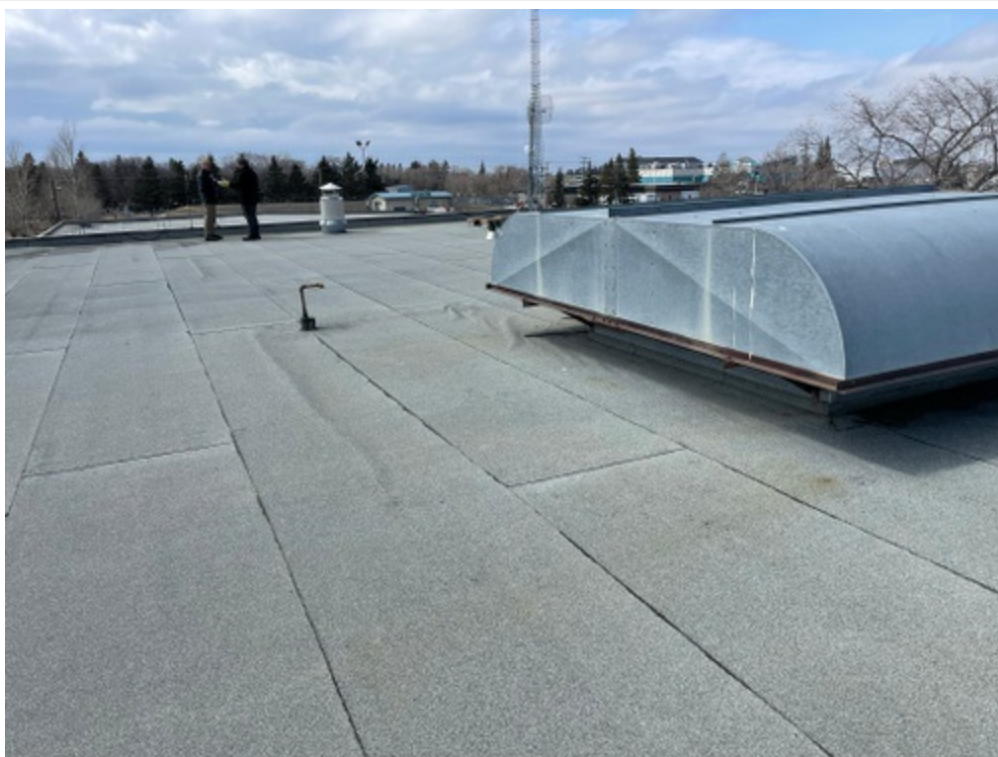
*Photo 14*

**Ridges:** These show up on the surface of built up roofs as linear buckling felt lines protruding upward through the surface layers of asphalt and aggregate.

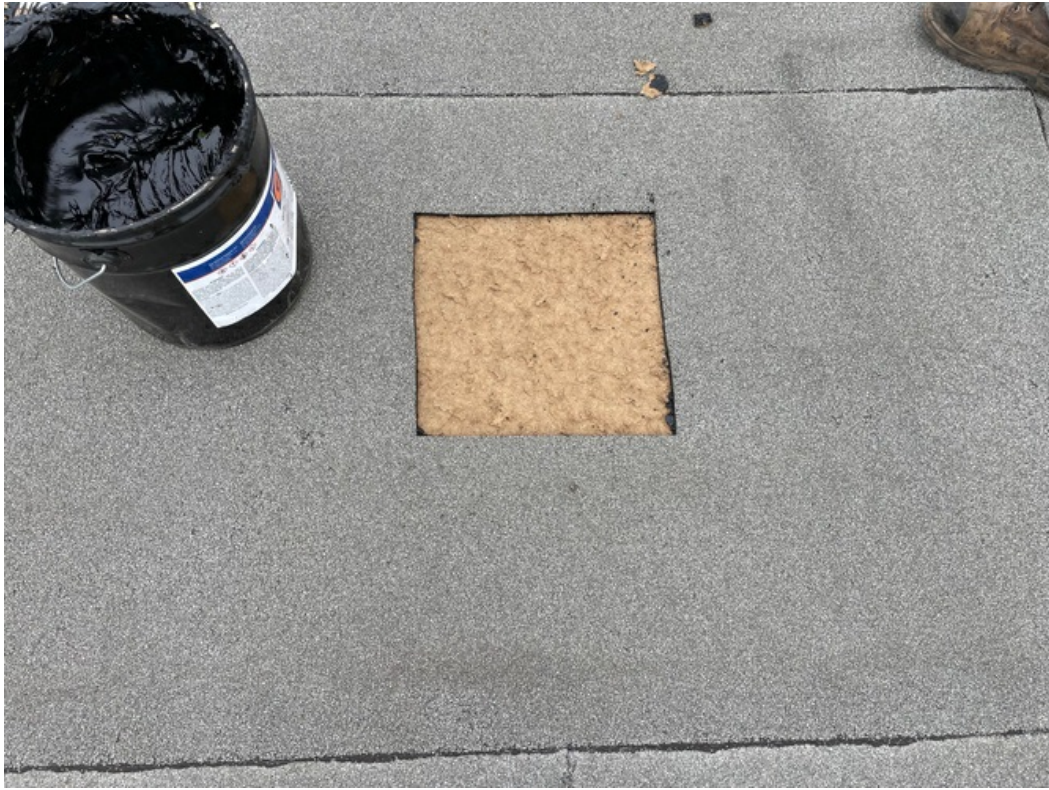
*Photo 15*

**CLEAR Analysis:**  
Removal of membrane  
sample.

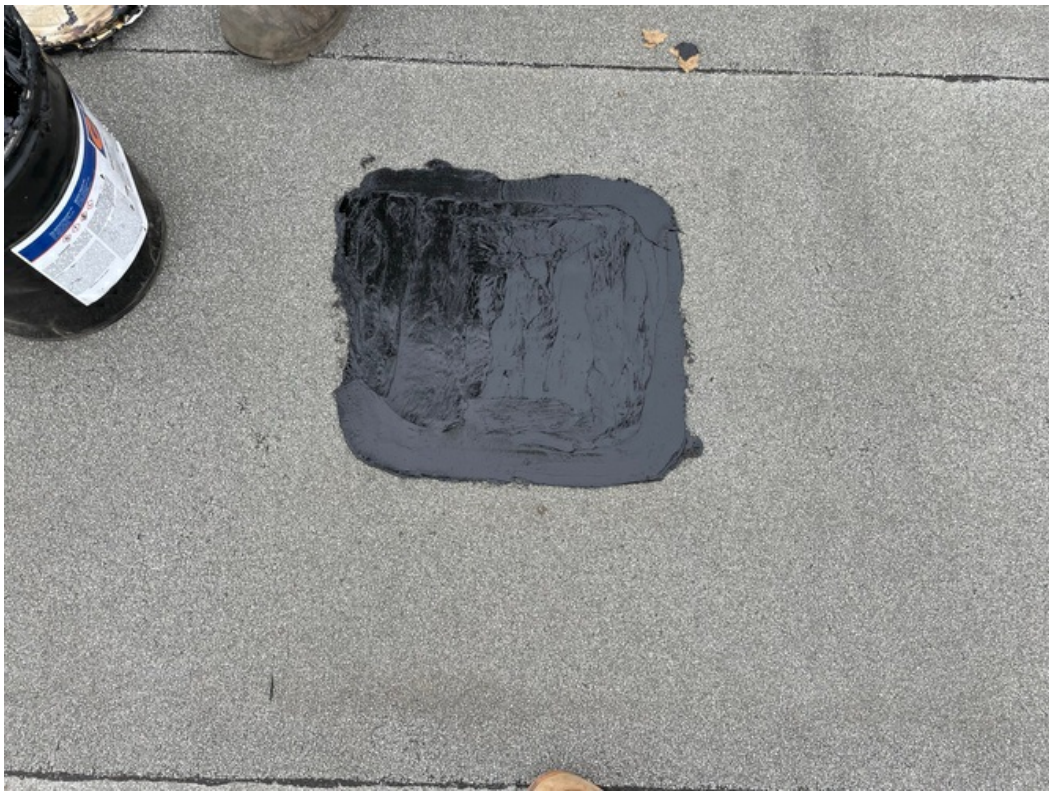
*Photo 16*

**CLEAR Analysis:** Repair  
of membrane cut.

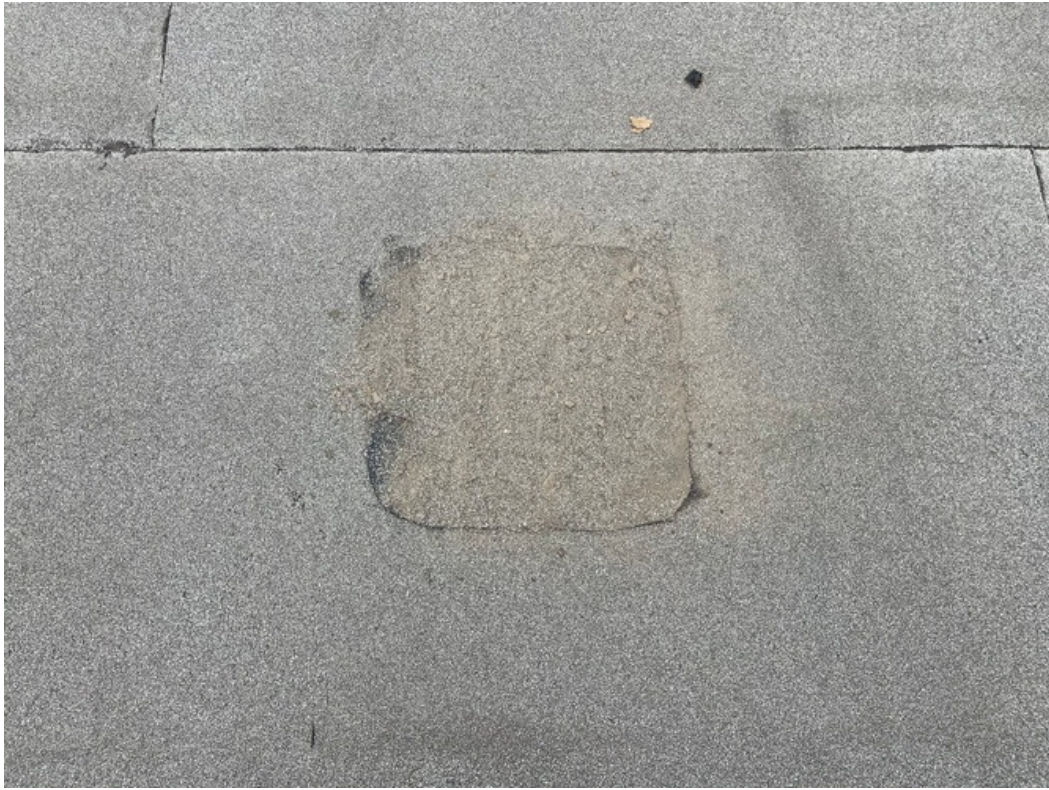
*Photo 17*

**CLEAR Analysis:**  
Imbedded using granules from perimeter to reinforce mastic repair and protect from UV.

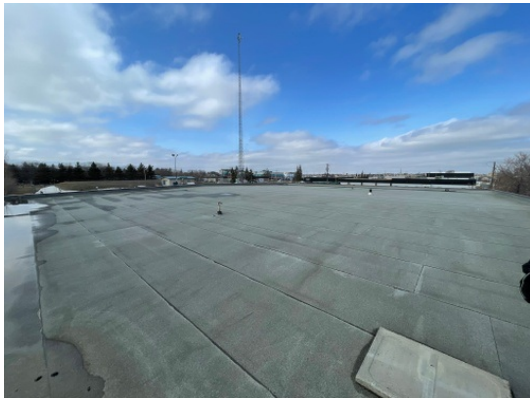
*Photo 1*

**Lower Middle Section:** Modified Bitumen

**Overall Condition:** Good - Fair

**CLEAR Analysis:** The 25 year old core samples are from a 2 ply modified roof system with fiberglass felt interplies in an asphalt adhesive. After visual inspection, both cores from the system appear to be in similar condition, implying that both sections of the roof have aged at a similar rate. For this reason, testing values were reported from the East section core. The interplies were very easily delaminated by hand as shown in Figures 12 and 15. Some mineral loss is expressed by exposed asphalt spots on the surface of the core but overall the coverage is still fairly good. The softening point and pen tests show that the asphalt adhesive responsible for keeping the system intact has lost its oils over time, causing the system to become more brittle. The core tested below the recommended tensile strength, but elongation was well above the recommendation. The sample performed well when undergoing puncture testing, implying that the system can withstand foot traffic and most weather phenomena. Please contact Garland's Technical Team to discuss the best options for these roof systems. The above results are based solely on the core samples examined and may not be representative of the condition of the roof. No representations or warranties are hereby made as to the condition of the roof.

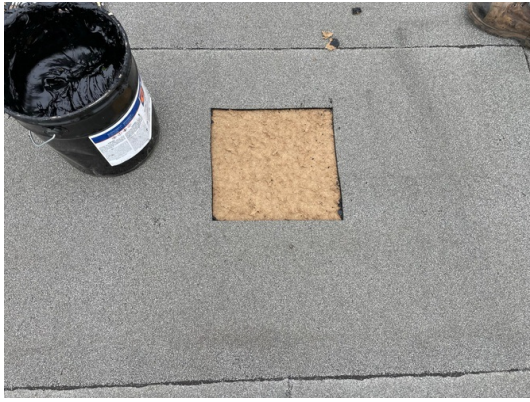
*Photo 10*

**CLEAR Analysis:** Removal of membrane sample.

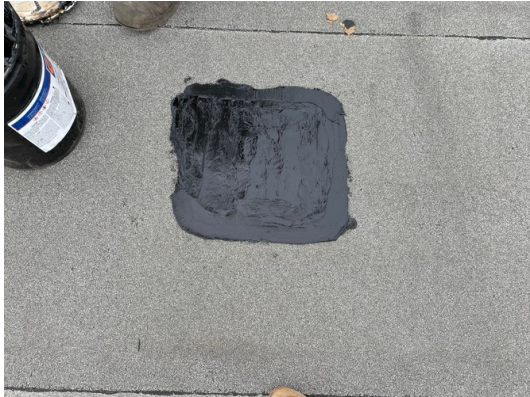
*Photo 11*

**CLEAR Analysis:** Repair of membrane sample.

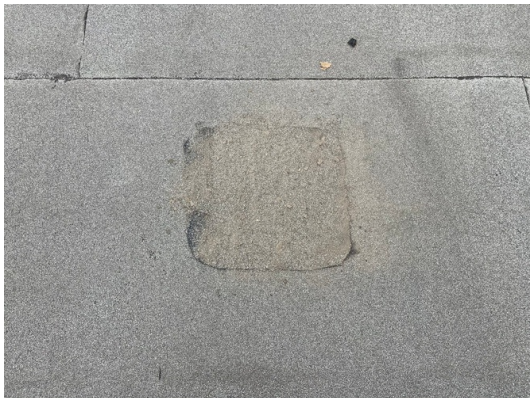
*Photo 12*

**CLEAR Analysis:** Imbedded with granules from perimeter to reinforce and protect against UV.
